Profile/Photo Observation Report

| Pipe Length (ft): | 368.0 | Owner: | City of Hobart | Pre Clean: | Heavy Cleaning |

| Street: | South Linda Street | Flow Control: | Not Controlled |
| US MH: | M-706-008.4 | DS MH: | M-706-008.5 |

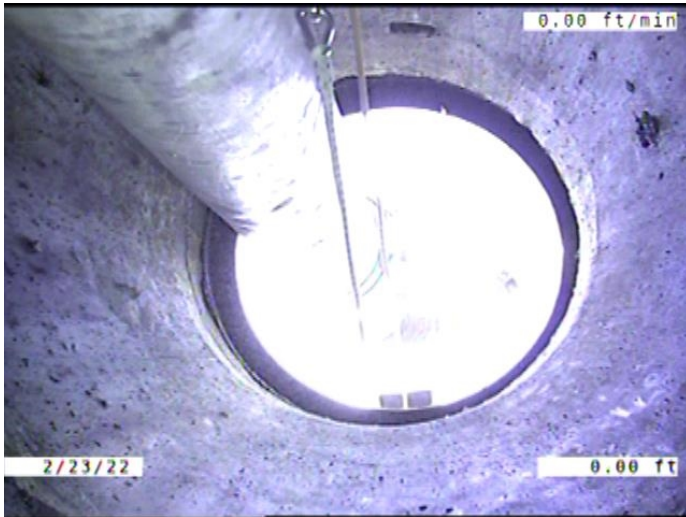
Code: **AMH**
Description: **Manhole**

Distance (ft): **.0**
Structural Grade: **0**
O&M Grade: **0**
Clock Start/From:
Clock To:
1st Value:
2nd Value:
Value Percent:
Continuous Index:
Within 8" of Joint: **NO**
Remarks: **M-706-008.5**

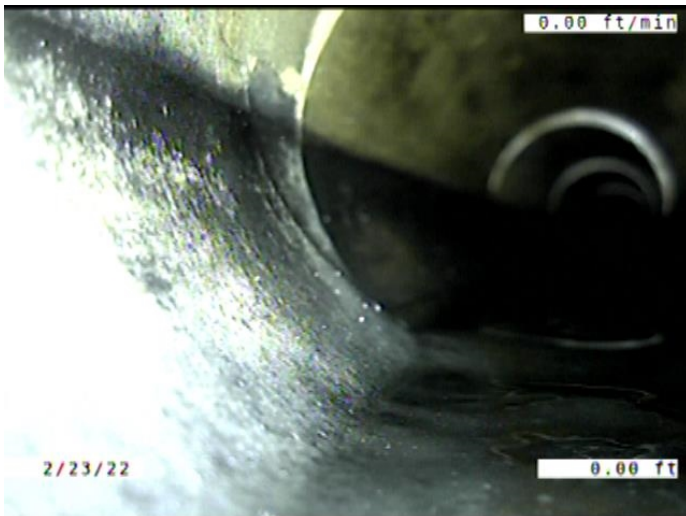
Code: **MWL**
Description: **Miscellaneous Water Level**

Distance (ft): **.0**
Structural Grade: **0**
O&M Grade: **0**
Clock Start/From:
Clock To:
1st Value:
2nd Value:
Value Percent: **5.000**
Continuous Index:
Within 8" of Joint: **NO**
Remarks:

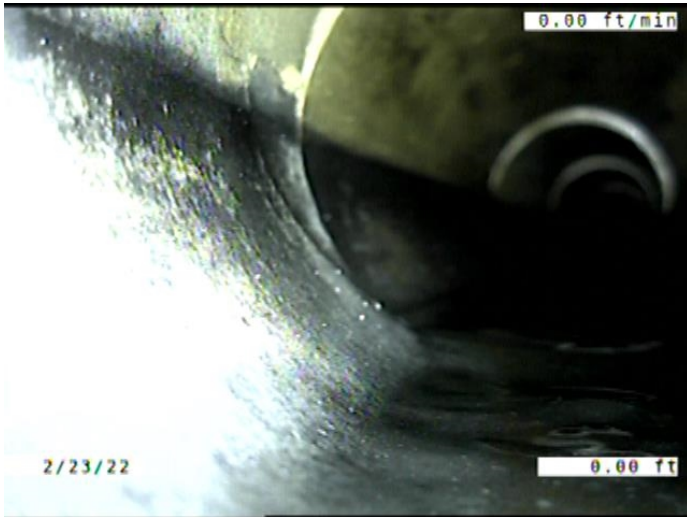
Code: **MGO**
 Description: **Miscellaneous General Observation**

Distance (ft): **.0**
 Structural Grade: **0**
 O&M Grade: **0**
 Clock Start/From:
 Clock To:
 1st Value:
 2nd Value:
 Value Percent:
 Continuous Index:
 Within 8" of Joint: **NO**
 Remarks: **HAD TO USE THE VAC TRUCK TO LOWER THE WATER LEVEL FOR AN I**

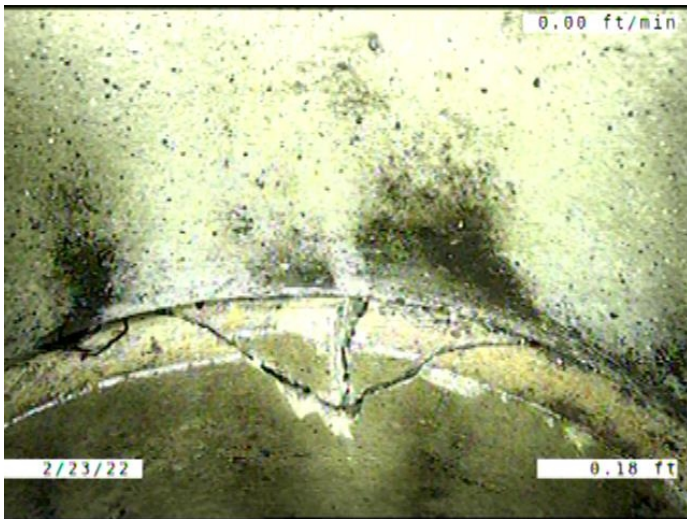
Code: **B**
 Description: **Broken**

Distance (ft): **.2**
 Structural Grade: **4**
 O&M Grade: **0**
 Clock Start/From: **11**
 Clock To: **1**
 1st Value:
 2nd Value:
 Value Percent:
 Continuous Index:
 Within 8" of Joint: **YES**
 Remarks:

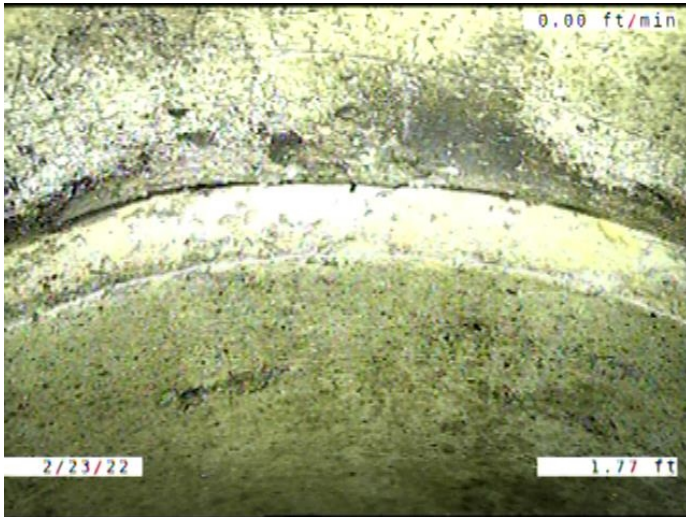
Code: **JOM**
 Description: **Joint Offset Medium**

Distance (ft): **1.8**
 Structural Grade: **3**
 O&M Grade: **0**
 Clock Start/From:
 Clock To:
 1st Value:
 2nd Value:
 Value Percent:
 Continuous Index: **S01**
 Within 8" of Joint: **NO**
 Remarks:

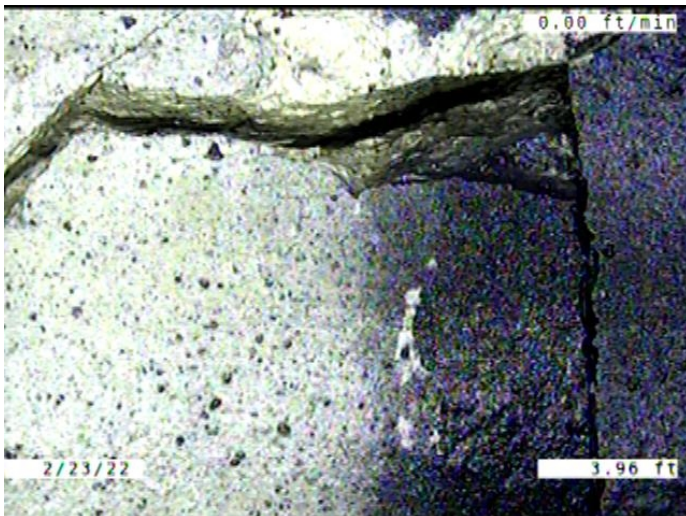
Code: **B**
 Description: **Broken**

Distance (ft): **4.0**
 Structural Grade: **4**
 O&M Grade: **0**
 Clock Start/From: **2**
 Clock To: **9**
 1st Value:
 2nd Value:
 Value Percent:
 Continuous Index:
 Within 8" of Joint: **YES**
 Remarks:

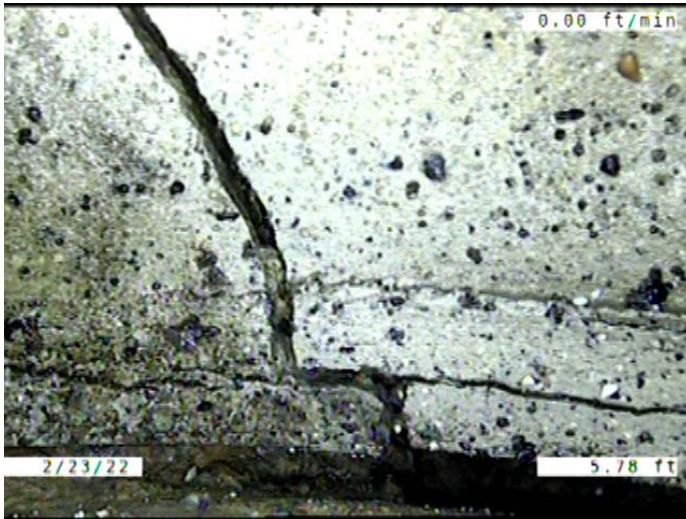
Code: **B**
Description: **Broken**

Distance (ft): **5.8**
Structural Grade: **4**
O&M Grade: **0**
Clock Start/From: **12**
Clock To: **12**
1st Value:
2nd Value:
Value Percent:
Continuous Index:
Within 8" of Joint: **YES**
Remarks:

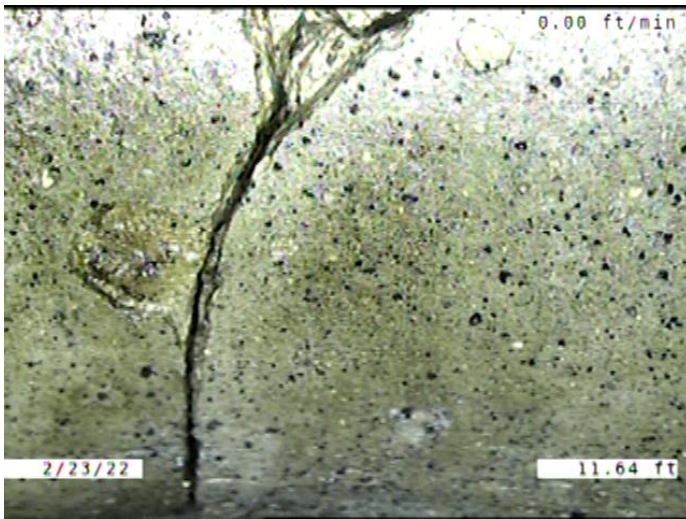
Code: **BSV**
Description: **Broken Soil Visible**

Distance (ft): **11.6**
Structural Grade: **5**
O&M Grade: **0**
Clock Start/From: **12**
Clock To: **12**
1st Value:
2nd Value:
Value Percent:
Continuous Index:
Within 8" of Joint: **YES**
Remarks:

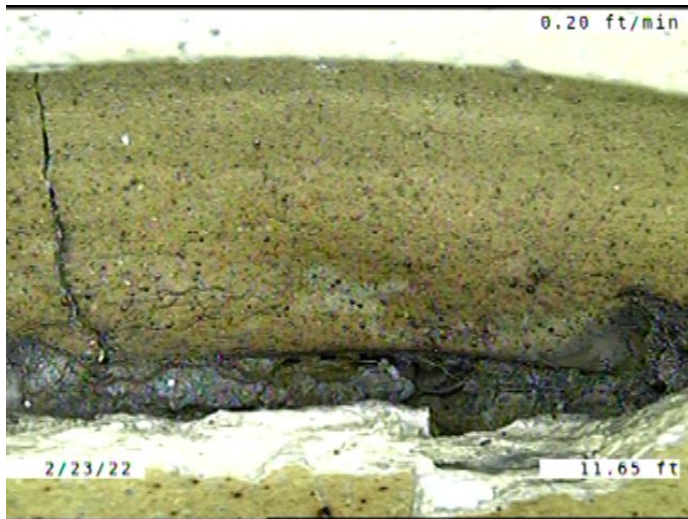
Code: **SMW**
 Description: **Surface Damage Missing Wall**

Distance (ft): **11.6**
 Structural Grade: **5**
 O&M Grade: **0**
 Clock Start/From: **1**
 Clock To: **3**
 1st Value:
 2nd Value:
 Value Percent:
 Continuous Index:
 Within 8" of Joint: **YES**
 Remarks:

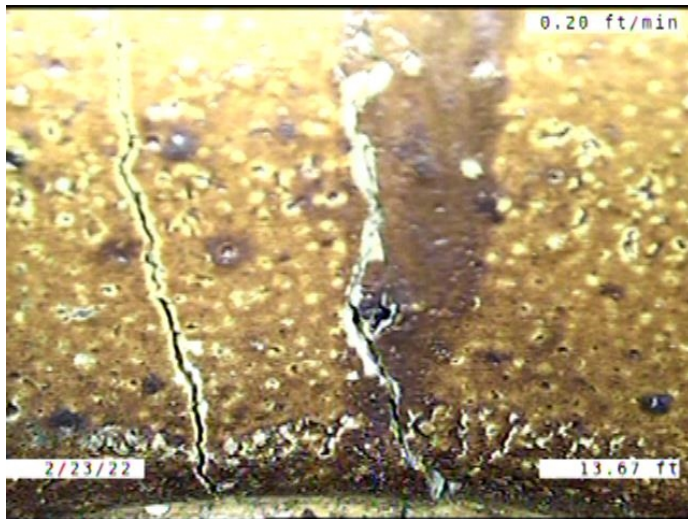
Code: **FM**
 Description: **Fracture Multiple**

Distance (ft): **13.7**
 Structural Grade: **4**
 O&M Grade: **0**
 Clock Start/From: **12**
 Clock To: **12**
 1st Value:
 2nd Value:
 Value Percent:
 Continuous Index:
 Within 8" of Joint: **YES**
 Remarks:

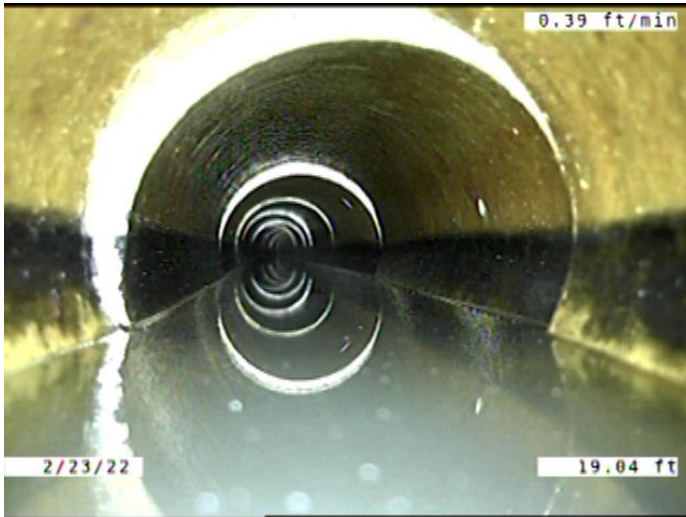
Code: **MWLS**
 Description: **Miscellaneous Water Level Sag**

Distance (ft): **19.0**
 Structural Grade: **3**
 O&M Grade: **0**
 Clock Start/From:
 Clock To:
 1st Value:
 2nd Value:
 Value Percent: **50.000**
 Continuous Index: **S03**
 Within 8" of Joint: **NO**
 Remarks:

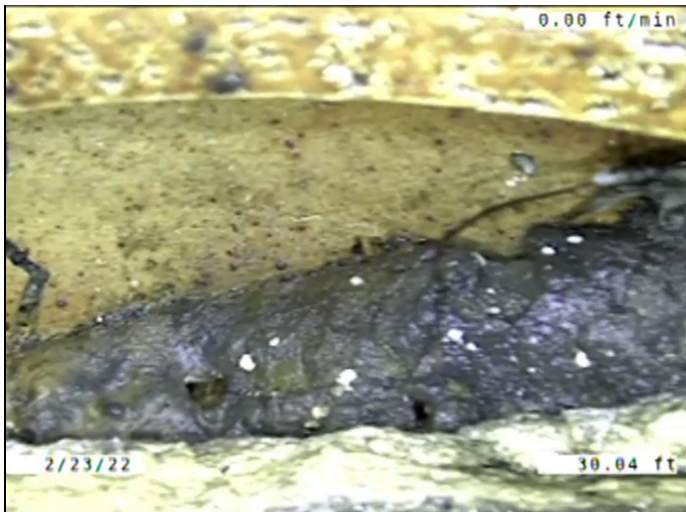
Code: **FM**
 Description: **Fracture Multiple**

Distance (ft): **30.0**
 Structural Grade: **4**
 O&M Grade: **0**
 Clock Start/From: **11**
 Clock To: **3**
 1st Value:
 2nd Value:
 Value Percent:
 Continuous Index:
 Within 8" of Joint: **YES**
 Remarks:

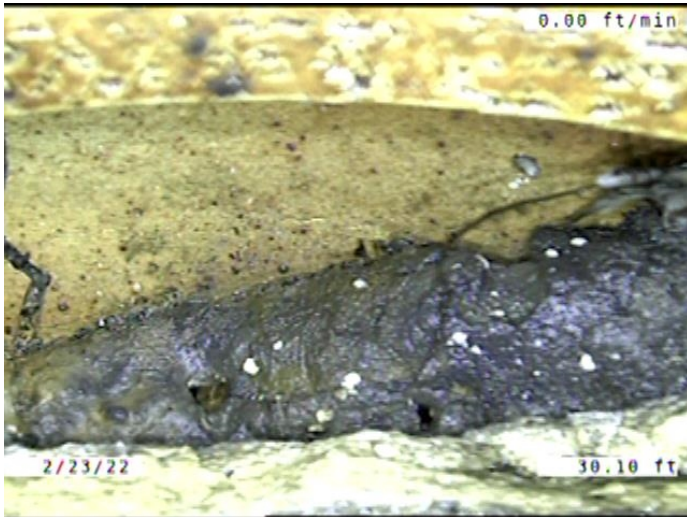
Code: **SMW**
 Description: **Surface Damage Missing Wall**

Distance (ft): **30.1**
 Structural Grade: **5**
 O&M Grade: **0**
 Clock Start/From: **11**
 Clock To: **3**
 1st Value:
 2nd Value:
 Value Percent:
 Continuous Index:
 Within 8" of Joint: **YES**
 Remarks:

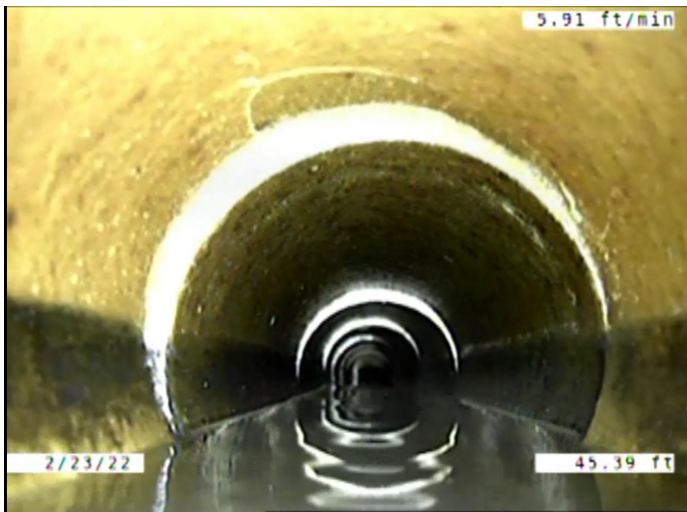
Code: **CM**
 Description: **Crack Multiple**

Distance (ft): **45.4**
 Structural Grade: **3**
 O&M Grade: **0**
 Clock Start/From: **11**
 Clock To: **3**
 1st Value:
 2nd Value:
 Value Percent:
 Continuous Index:
 Within 8" of Joint: **YES**
 Remarks:

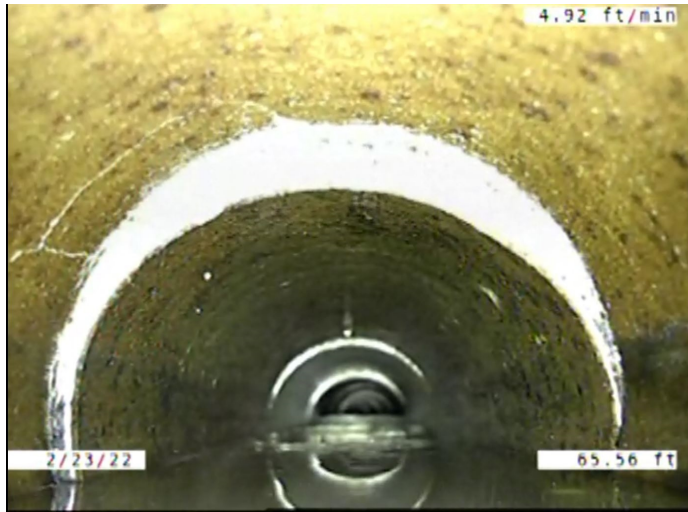
Code: **CM**
Description: **Crack Multiple**

Distance (ft): **65.6**
Structural Grade: **3**
O&M Grade: **0**
Clock Start/From: **10**
Clock To: **12**
1st Value:
2nd Value:
Value Percent:
Continuous Index:
Within 8" of Joint: **YES**
Remarks:

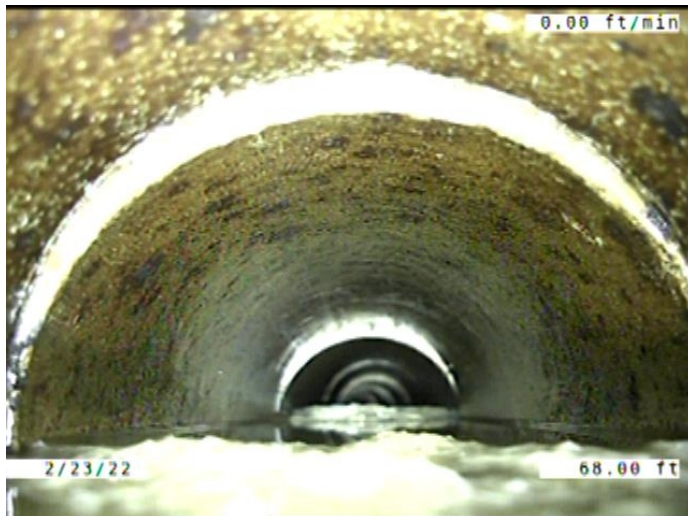
Code: **OBZ**
Description: **Obstruction Other**

Distance (ft): **68.0**
Structural Grade: **0**
O&M Grade: **3**
Clock Start/From: **3**
Clock To: **9**
1st Value:
2nd Value:
Value Percent: **15.000**
Continuous Index:
Within 8" of Joint: **YES**
Remarks: **TP AND RAG LOGS**

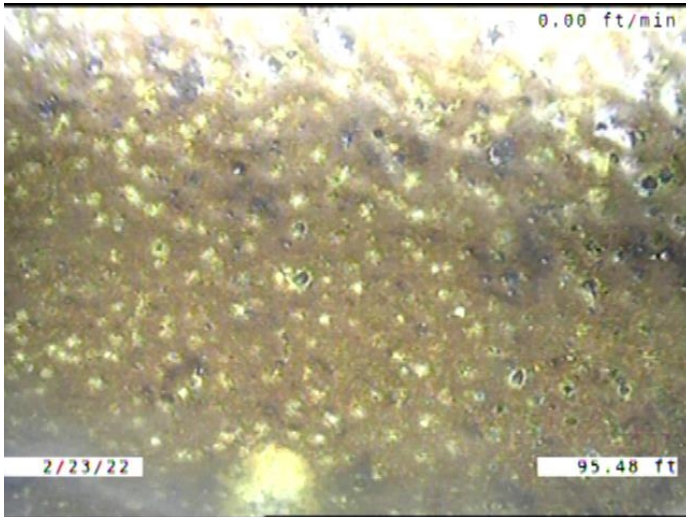
| Code: | MCU |
| Description: | Miscellaneous Camera Underwater |
| Distance (ft): | 95.5 |
| O&M Grade: | 4 |

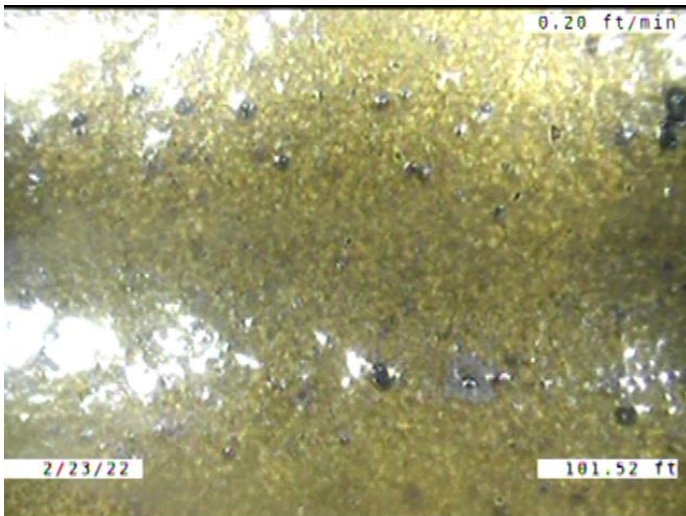
| Code: | MCU |
| Description: | Miscellaneous Camera Underwater |
| Distance (ft): | 101.5 |
| O&M Grade: | 4 |

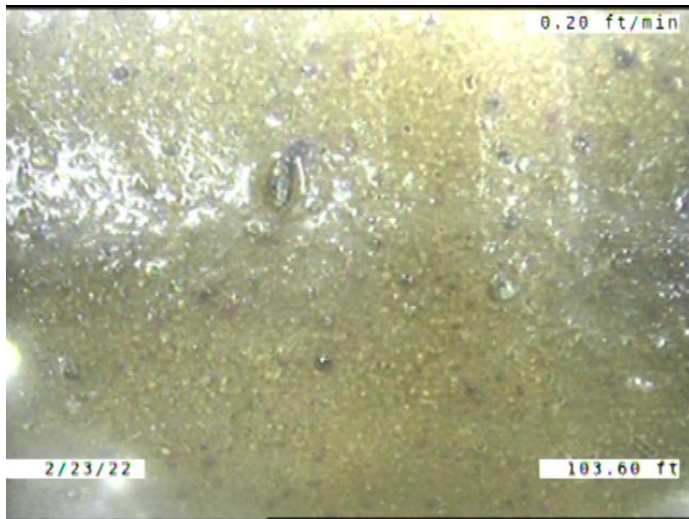
| Code: | MCU |
| Description: | Miscellaneous Camera Underwater |
| Distance (ft): | 103.6 |
| O&M Grade: | 4 |

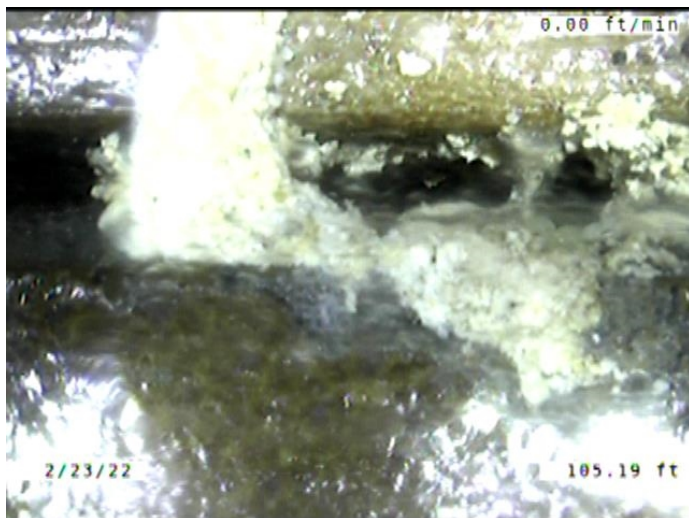
| Code: | DAE |
| Description: | Deposits Attached Encrustation |
| Distance (ft): | 105.2 |
| O&M Grade: | 2 |

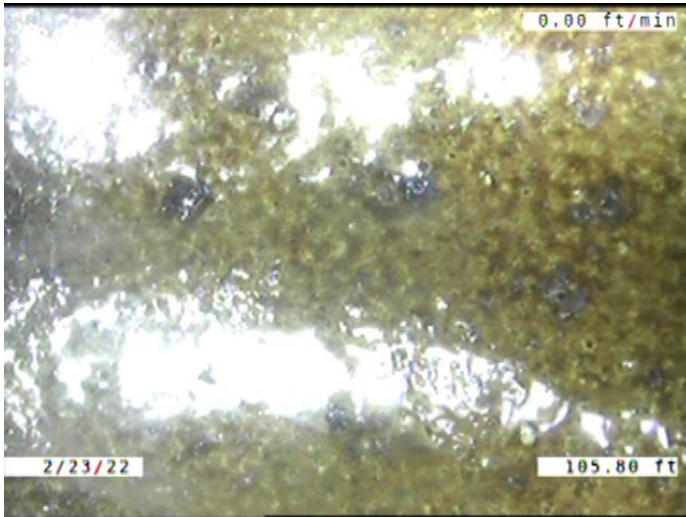
Code: **MCU**
 Description: **Miscellaneous Camera Underwater**

Distance (ft): **105.8**
 Structural Grade: **0**
 O&M Grade: **4**
 Clock Start/From:
 Clock To:
 1st Value:
 2nd Value:
 Value Percent:
 Continuous Index:
 Within 8" of Joint: **NO**
 Remarks:

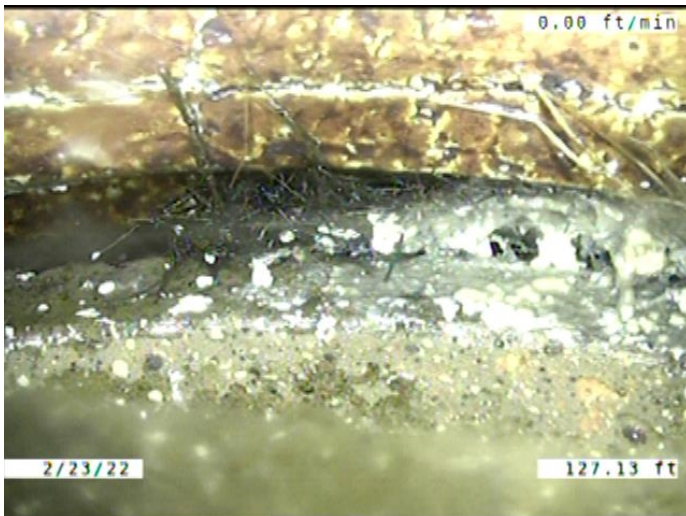
Code: **RFJ**
 Description: **Roots Fine Joint**

Distance (ft): **127.1**
 Structural Grade: **0**
 O&M Grade: **1**
 Clock Start/From: **10**
 Clock To: **2**
 1st Value:
 2nd Value:
 Value Percent:
 Continuous Index:
 Within 8" of Joint: **YES**
 Remarks:

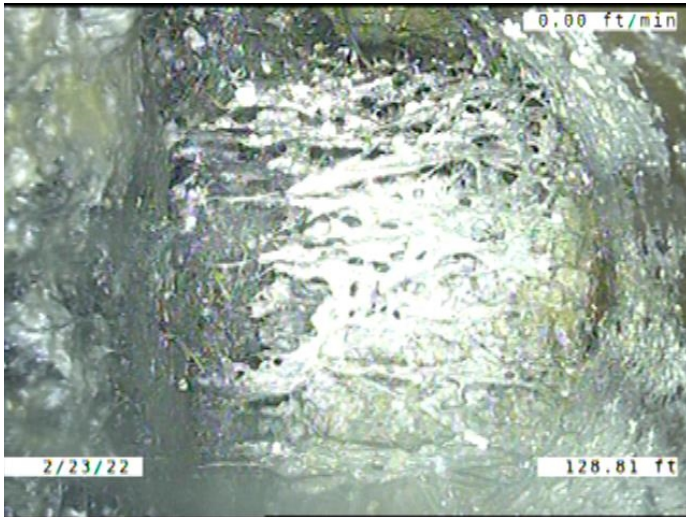
Code: **TF**
 Description: **Tap Factory**

Distance (ft): **128.8**
 Structural Grade: **0**
 O&M Grade: **0**
 Clock Start/From: **9**
 Clock To:
 1st Value: **6.000**
 2nd Value:
 Value Percent:
 Continuous Index:
 Within 8" of Joint: **YES**
 Remarks: **LOOKS TO BE 95% PLUGGED WITH ROOTS**

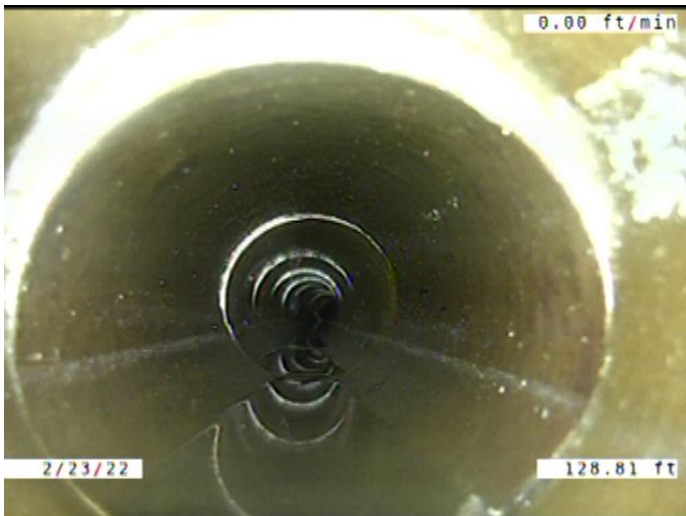
Code: **JOM**
 Description: **Joint Offset Medium**

Distance (ft): **128.8**
 Structural Grade: **3**
 O&M Grade: **0**
 Clock Start/From:
 Clock To:
 1st Value:
 2nd Value:
 Value Percent:
 Continuous Index: **F01**
 Within 8" of Joint: **NO**
 Remarks:

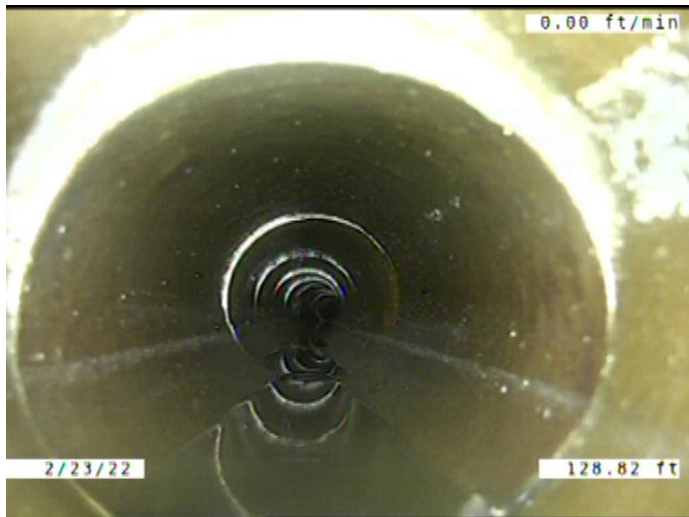
Code: **MWLS**
Description: **Miscellaneous Water Level Sag**

Distance (ft): **128.8**
Structural Grade: **3**
O&M Grade: **0**
Clock Start/From:
Clock To:
1st Value:
2nd Value:
Value Percent: **50.000**
Continuous Index: **F03**
Within 8" of Joint: **NO**
Remarks:

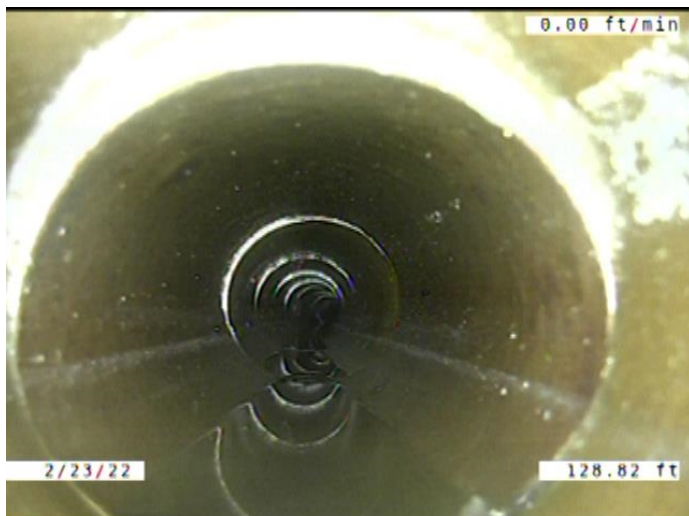
Code: **DAE**
Description: **Deposits Attached Encrustation**

Distance (ft): **128.8**
Structural Grade: **0**
O&M Grade: **2**
Clock Start/From: **11**
Clock To: **1**
1st Value:
2nd Value:
Value Percent: **5.000**
Continuous Index: **F04**
Within 8" of Joint: **YES**
Remarks:

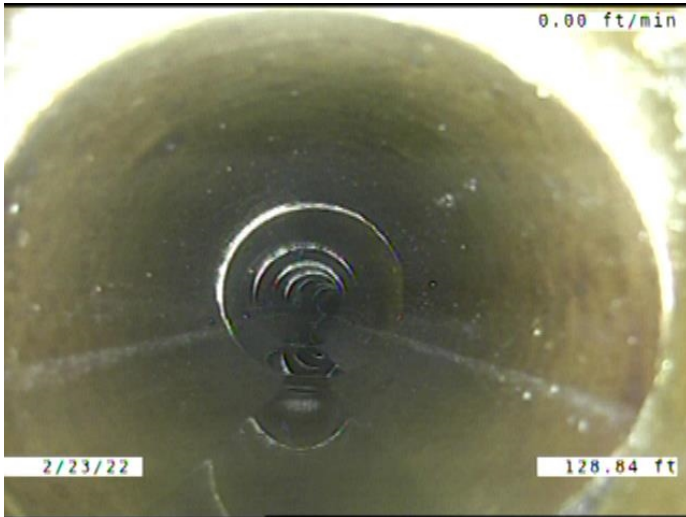
MSA

Miscellaneous Survey Abandoned

**MADE IT TO THE POINT OF OVERLAP.
REVERSAL COMPLETE.**
