## Profile/Photo Observation Report

Date:	<b>04/14/2018</b>	Weather:		Coding:	<b>PACP 6.0</b>
Pipe Length (ft):	<b>218.3</b>	Owner:	<b>NA</b>	Pre Clean:	<b>Not Known</b>
P.O.#:		Surveyor:	<b>Jen Costello</b>	PSR:	<b>P-706-008.7-008.6</b>
Customer:		Clean Date:	<b>01/01/1900</b>	Shape:	<b>C</b>

Street:	<b>GARFIELD ST</b>	Flow Control:	<b>Not Controlled</b>
City:	<b>Hobart, IN</b>	Year Renewed:	
Location:	<b>Light Highway</b>	Tape/Media #:	
Purpose:	<b>Maintenance Related</b>	Dia/Height:	<b>8"</b>
Use:	<b>Sanitary</b>	Material:	<b>VCP</b>
Drain Area:	<b>NA</b>	Lining:	<b>Cured in Place</b>
Category:	<b>NA</b>		
Comment:	<b>roots at 29'.</b>

Location Details:		Direction of Survey:	<b>Downstream</b>
US MH:	<b>M-706-008.6</b>	DS MH:	<b>M-706-008.7</b>
		Total Length Surveyed (ft):	<b>30.4</b>

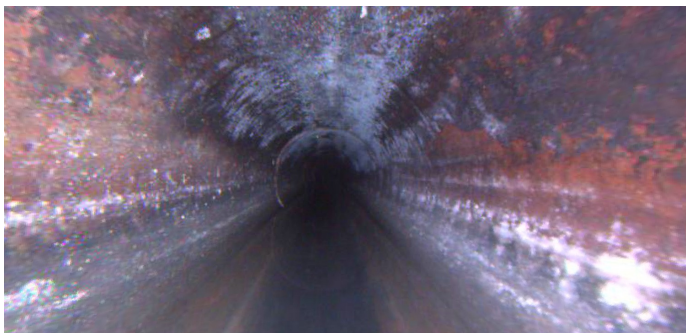
Code: **AMH**  
Description: **Manhole**

Distance (ft): **.0**  
Structural Grade: **0**  
O&M Grade: **0**  
Clock Start/From:  
Clock To:  
1st Value:  
2nd Value:  
Value Percent:  
Continuous Index:  
Within 8" of Joint: **NO**  
Remarks: **M-706-008.6**

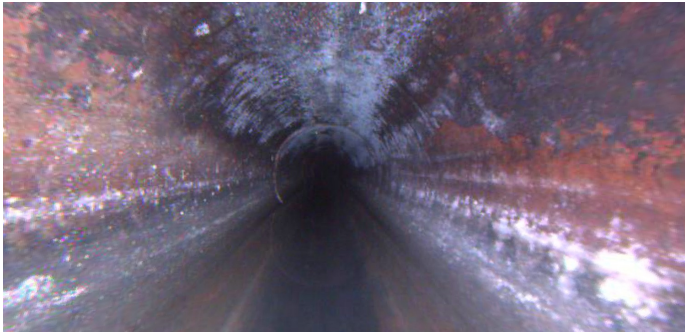
Code:	<b>MWL</b>
Description:	<b>Water Level</b>

Distance (ft):	<b>.0</b>
Structural Grade:	<b>0</b>
O&M Grade:	<b>0</b>
Clock Start/From:	
Clock To:	
1st Value:	
2nd Value:	
Value Percent:	<b>10.000</b>
Continuous Index:	
Within 8" of Joint:	<b>NO</b>
Remarks:

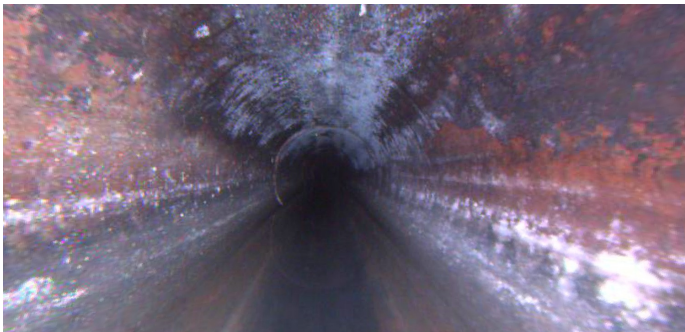
Code:	<b>DAE</b>
Description:	<b>Deposits Attached Encrustation</b>

Distance (ft):	<b>.0</b>
Structural Grade:	<b>0</b>
O&M Grade:	<b>2</b>
Clock Start/From:	<b>8</b>
Clock To:	<b>4</b>
1st Value:	
2nd Value:	
Value Percent:	<b>5.000</b>
Continuous Index:	<b>S01</b>
Within 8" of Joint:	<b>NO</b>
Remarks:

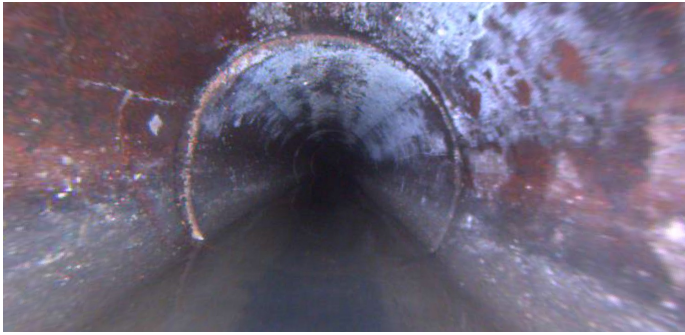
Code: **CL**  
Description: **Crack Longitudinal**

Distance (ft): **2.0**  
Structural Grade: **2**  
O&M Grade: **0**  
Clock Start/From: **10**  
Clock To:  
1st Value:  
2nd Value:  
Value Percent:  
Continuous Index:  
Within 8" of Joint: **YES**  
Remarks:

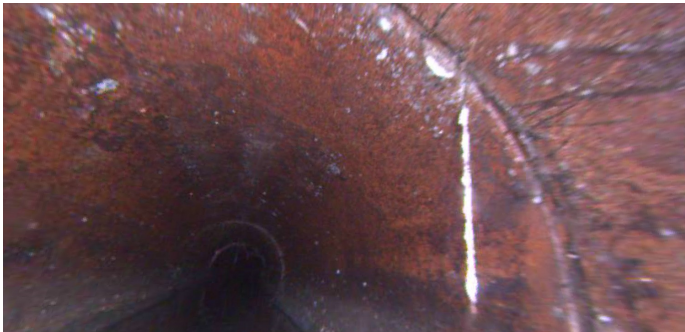
Code: **RFJ**  
Description: **Roots Fine Joint**

Distance (ft): **8.3**  
Structural Grade: **0**  
O&M Grade: **1**  
Clock Start/From: **1**  
Clock To: **3**  
1st Value:  
2nd Value:  
Value Percent:  
Continuous Index:  
Within 8" of Joint: **YES**  
Remarks:

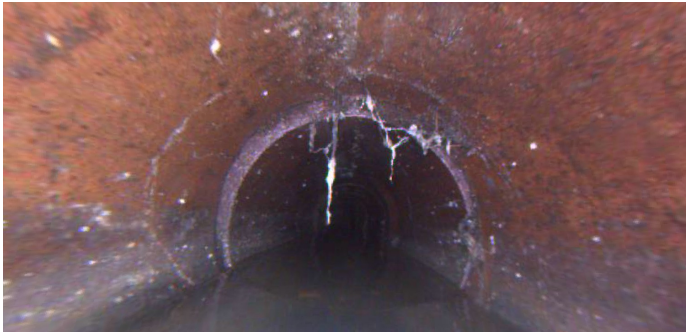
Code: **FM**  
Description: **Fracture Multiple**

Distance (ft): **11.6**  
Structural Grade: **4**  
O&M Grade: **0**  
Clock Start/From: **8**  
Clock To: **4**  
1st Value:  
2nd Value:  
Value Percent:  
Continuous Index:  
Within 8" of Joint: **YES**  
Remarks:

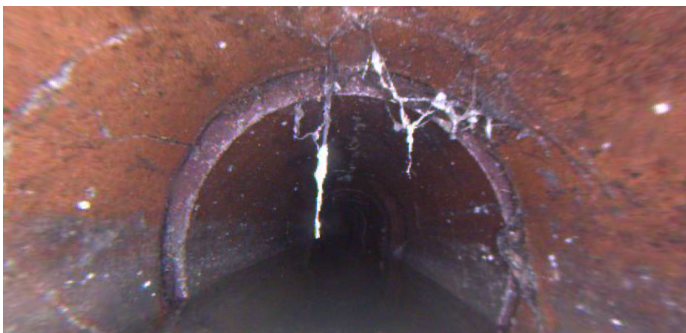
Code: **RFJ**  
Description: **Roots Fine Joint**

Distance (ft): **11.8**  
Structural Grade: **0**  
O&M Grade: **1**  
Clock Start/From: **8**  
Clock To: **4**  
1st Value:  
2nd Value:  
Value Percent:  
Continuous Index:  
Within 8" of Joint: **YES**  
Remarks:

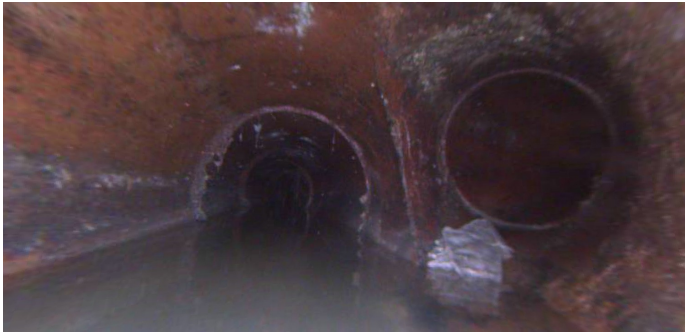
Code: **TF**  
Description: **Tap Factory**

Distance (ft): **13.2**  
Structural Grade: **0**  
O&M Grade: **0**  
Clock Start/From: **3**  
Clock To:  
1st Value: **4.000**  
2nd Value:  
Value Percent:  
Continuous Index:  
Within 8" of Joint:  
Remarks:

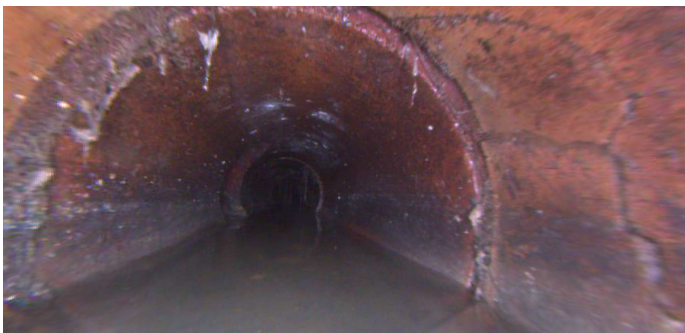
Code: **FM**  
Description: **Fracture Multiple**

Distance (ft): **13.9**  
Structural Grade: **4**  
O&M Grade: **0**  
Clock Start/From: **1**  
Clock To: **4**  
1st Value:  
2nd Value:  
Value Percent:  
Continuous Index:  
Within 8" of Joint: **YES**  
Remarks:

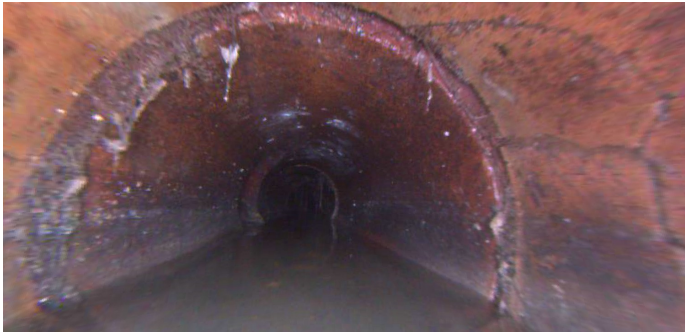
Code: **RFJ**  
Description: **Roots Fine Joint**

Distance (ft): **13.9**  
Structural Grade: **0**  
O&M Grade: **1**  
Clock Start/From: **8**  
Clock To: **4**  
1st Value:  
2nd Value:  
Value Percent:  
Continuous Index:  
Within 8" of Joint: **YES**  
Remarks:

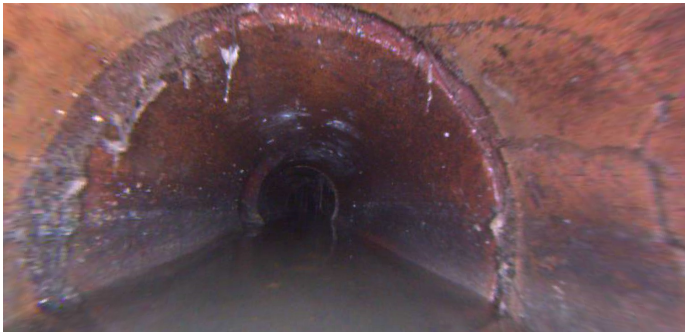
Code: **DAE**  
Description: **Deposits Attached Encrustation**

Distance (ft): **13.9**  
Structural Grade: **0**  
O&M Grade: **2**  
Clock Start/From: **8**  
Clock To: **4**  
1st Value:  
2nd Value:  
Value Percent: **5.000**  
Continuous Index: **F01**  
Within 8" of Joint: **NO**  
Remarks:

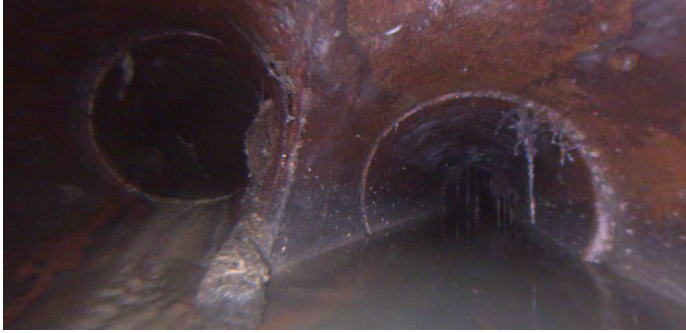
Code: **TFA**  
Description: **Tap Factory Active**

Distance (ft): **15.5**  
Structural Grade: **0**  
O&M Grade: **0**  
Clock Start/From: **9**  
Clock To:  
1st Value: **4.000**  
2nd Value:  
Value Percent:  
Continuous Index:  
Within 8" of Joint:  
Remarks:

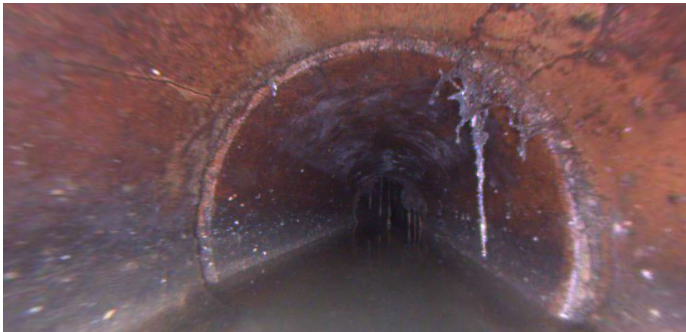
Code: **RFJ**  
Description: **Roots Fine Joint**

Distance (ft): **15.9**  
Structural Grade: **0**  
O&M Grade: **1**  
Clock Start/From: **8**  
Clock To: **4**  
1st Value:  
2nd Value:  
Value Percent:  
Continuous Index:  
Within 8" of Joint: **YES**  
Remarks:

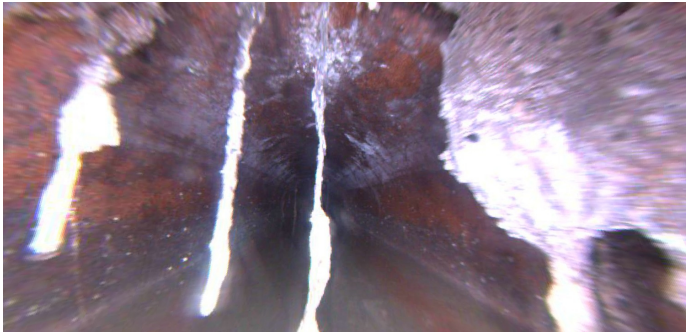
Code: **RMJ**  
Description: **Roots Medium Joint**

Distance (ft): **18.1**  
Structural Grade: **0**  
O&M Grade: **3**  
Clock Start/From: **8**  
Clock To: **4**  
1st Value:  
2nd Value:  
Value Percent: **15.000**  
Continuous Index:  
Within 8" of Joint: **YES**  
Remarks:

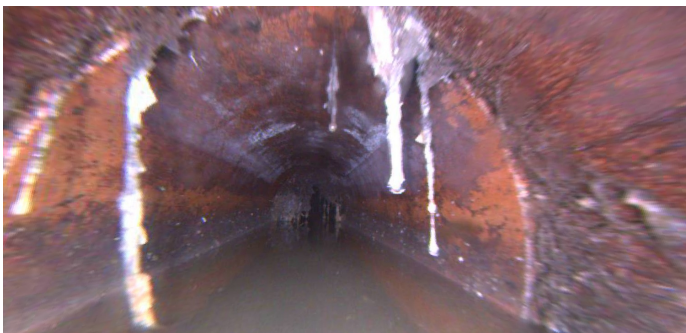
Code: **RFJ**  
Description: **Roots Fine Joint**

Distance (ft): **20.0**  
Structural Grade: **0**  
O&M Grade: **1**  
Clock Start/From: **8**  
Clock To: **4**  
1st Value:  
2nd Value:  
Value Percent:  
Continuous Index:  
Within 8" of Joint: **YES**  
Remarks:

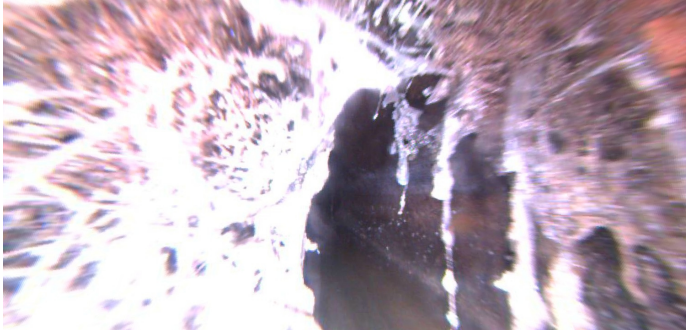
Code: **RBJ**  
Description: **Roots Ball Joint**

Distance (ft): **22.0**  
Structural Grade: **0**  
O&M Grade: **4**  
Clock Start/From: **8**  
Clock To: **4**  
1st Value:  
2nd Value:  
Value Percent: **60.000**  
Continuous Index:  
Within 8" of Joint: **YES**  
Remarks:

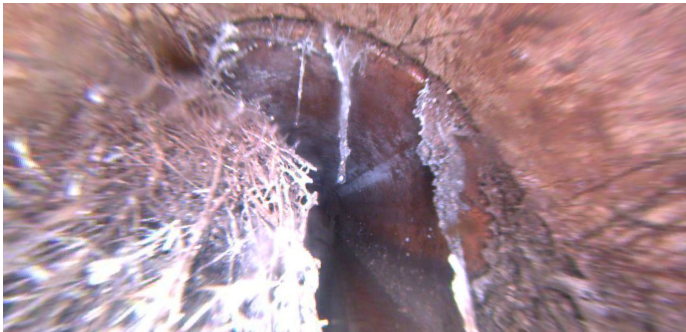
Code: **RBJ**  
Description: **Roots Ball Joint**

Distance (ft): **23.8**  
Structural Grade: **0**  
O&M Grade: **4**  
Clock Start/From: **8**  
Clock To: **4**  
1st Value:  
2nd Value:  
Value Percent: **60.000**  
Continuous Index:  
Within 8" of Joint: **YES**  
Remarks:

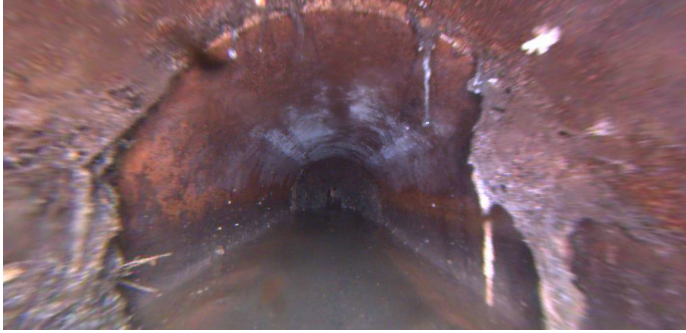
Code: **RMJ**  
Description: **Roots Medium Joint**

Distance (ft): **25.9**  
Structural Grade: **0**  
O&M Grade: **3**  
Clock Start/From: **8**  
Clock To: **4**  
1st Value:  
2nd Value:  
Value Percent: **10.000**  
Continuous Index:  
Within 8" of Joint: **YES**  
Remarks:

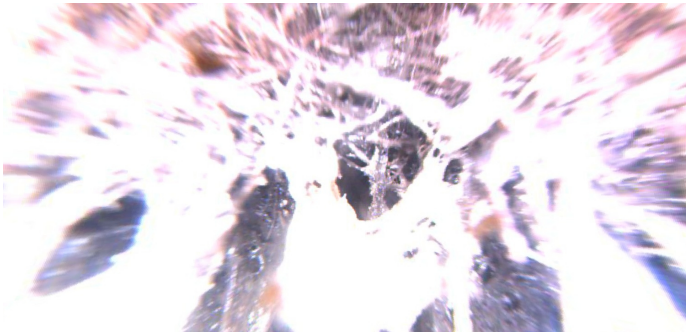
Code: **RBJ**  
Description: **Roots Ball Joint**

Distance (ft): **27.8**  
Structural Grade: **0**  
O&M Grade: **4**  
Clock Start/From: **8**  
Clock To: **4**  
1st Value:  
2nd Value:  
Value Percent: **90.000**  
Continuous Index:  
Within 8" of Joint: **YES**  
Remarks:

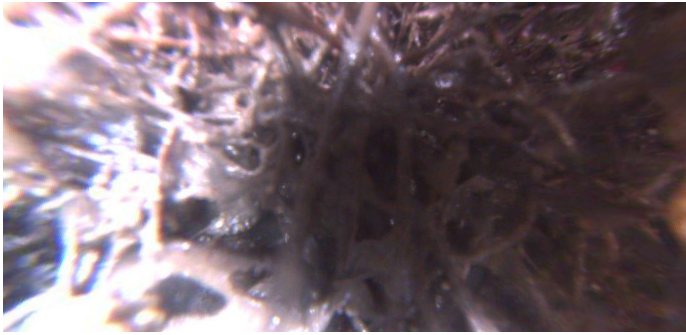
Code: **RBJ**  
Description: **Roots Ball Joint**

Distance (ft): **29.9**  
Structural Grade: **0**  
O&M Grade: **4**  
Clock Start/From: **8**  
Clock To: **4**  
1st Value:  
2nd Value:  
Value Percent: **90.000**  
Continuous Index:  
Within 8" of Joint: **YES**  
Remarks:
