Profile/Photo Observation Report

Date:	04/14/2018	Weather:		Coding:	PACP 6.0
Pipe Length (ft):	218.3	Owner:	NA	Pre Clean:	Not Known
P.O.#:		Surveyor:	Jen Costello	PSR:	P-706-008.7-008.6
Customer:		Clean Date:	01/01/1900	Shape:	C

Street:	Capitol	Flow Control:	Not Controlled
City:	Hobart, IN	Year Renewed:	
Location:	Light Highway	Tape/Media #:	
Purpose:	Maintenance Related	Dia/Height:	8"
Use:	Sanitary	Material:	VCP
Drain Area:	NA	Lining:	Cured in Place
Category:	NA		
Comment:	roots at 29'.

Location Details:		Direction of Survey:	Downstream
US MH:	M-706-008.6	DS MH:	M-706-008.7
		Total Length Surveyed (ft):	30.4

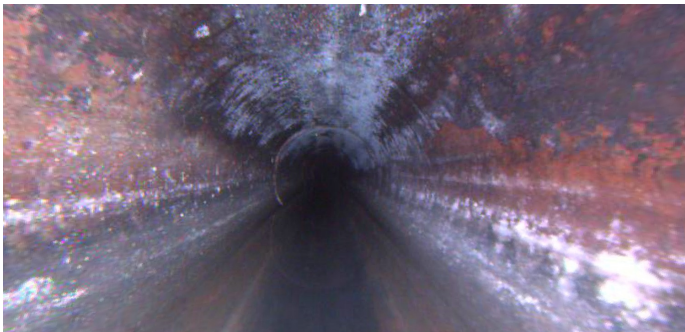
Code:	DAE
Description:	Deposits Attached Encrustation

Distance (ft):	.0
Structural Grade:	0
O&M Grade:	2
Clock Start/From:	8
Clock To:	4
1st Value:	
2nd Value:	
Value Percent:	5.000
Continuous Index:	S01
Within 8" of Joint:	NO
Remarks:

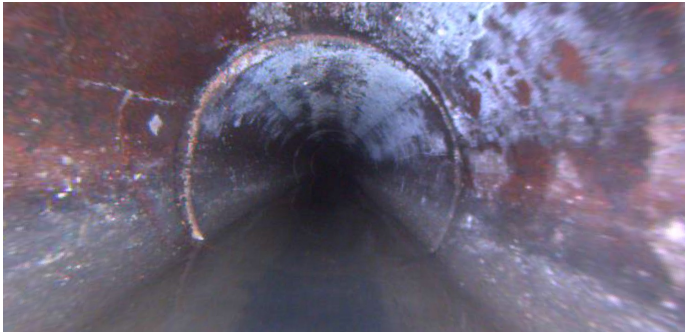
Code: **CL**
Description: **Crack Longitudinal**

Distance (ft): **2.0**
Structural Grade: **2**
O&M Grade: **0**
Clock Start/From: **10**
Clock To:
1st Value:
2nd Value:
Value Percent:
Continuous Index:
Within 8" of Joint: **YES**
Remarks:

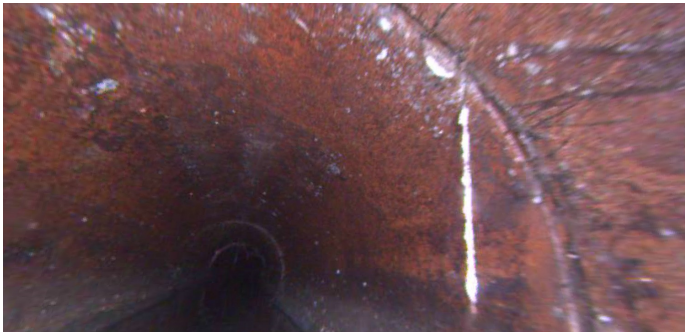
Code: **RFJ**
Description: **Roots Fine Joint**

Distance (ft): **8.3**
Structural Grade: **0**
O&M Grade: **1**
Clock Start/From: **1**
Clock To: **3**
1st Value:
2nd Value:
Value Percent:
Continuous Index:
Within 8" of Joint: **YES**
Remarks:

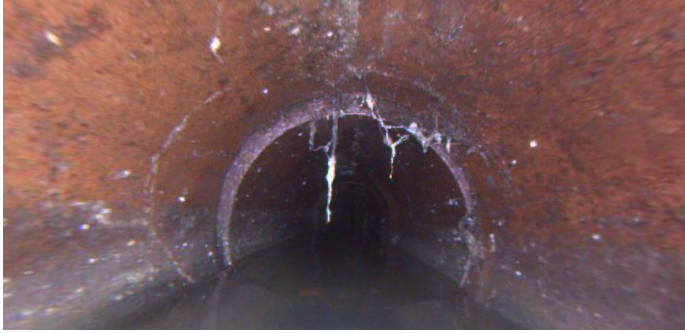
Code: **FM**
Description: **Fracture Multiple**

Distance (ft): **11.6**
Structural Grade: **4**
O&M Grade: **0**
Clock Start/From: **8**
Clock To: **4**
1st Value:
2nd Value:
Value Percent:
Continuous Index:
Within 8" of Joint: **YES**
Remarks:

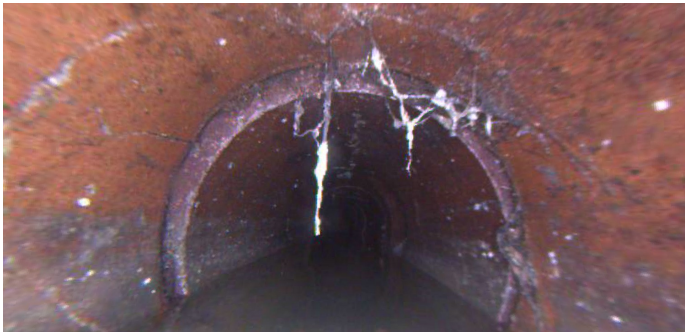
Code: **RFJ**
Description: **Roots Fine Joint**

Distance (ft): **11.8**
Structural Grade: **0**
O&M Grade: **1**
Clock Start/From: **8**
Clock To: **4**
1st Value:
2nd Value:
Value Percent:
Continuous Index:
Within 8" of Joint: **YES**
Remarks:

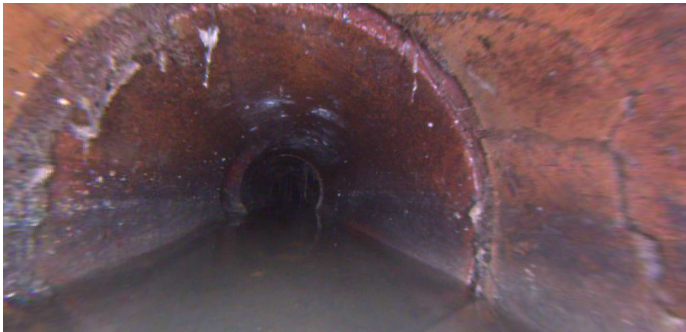
Code: **FM**
Description: **Fracture Multiple**

Distance (ft): **13.9**
Structural Grade: **4**
O&M Grade: **0**
Clock Start/From: **1**
Clock To: **4**
1st Value:
2nd Value:
Value Percent:
Continuous Index:
Within 8" of Joint: **YES**
Remarks:

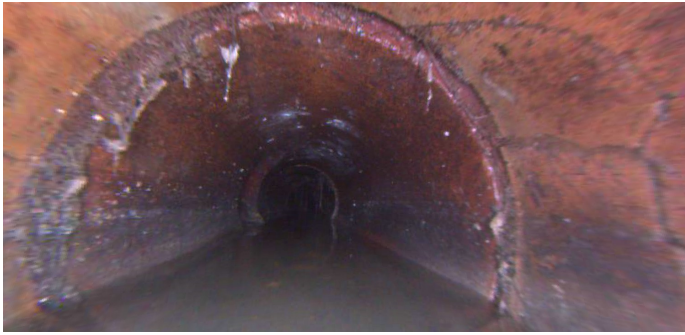
Code: **RFJ**
Description: **Roots Fine Joint**

Distance (ft): **13.9**
Structural Grade: **0**
O&M Grade: **1**
Clock Start/From: **8**
Clock To: **4**
1st Value:
2nd Value:
Value Percent:
Continuous Index:
Within 8" of Joint: **YES**
Remarks:

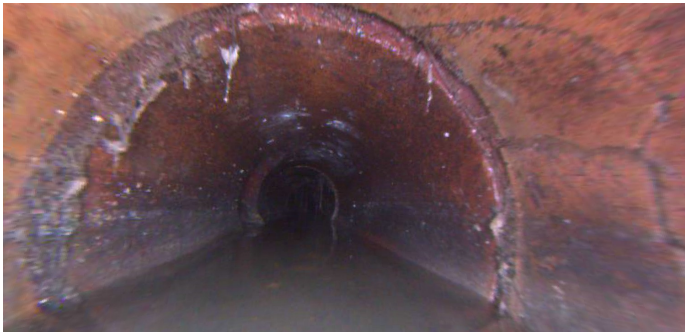
Code: **DAE**
Description: **Deposits Attached Encrustation**

Distance (ft): **13.9**
Structural Grade: **0**
O&M Grade: **2**
Clock Start/From: **8**
Clock To: **4**
1st Value:
2nd Value:
Value Percent: **5.000**
Continuous Index: **F01**
Within 8" of Joint: **NO**
Remarks:

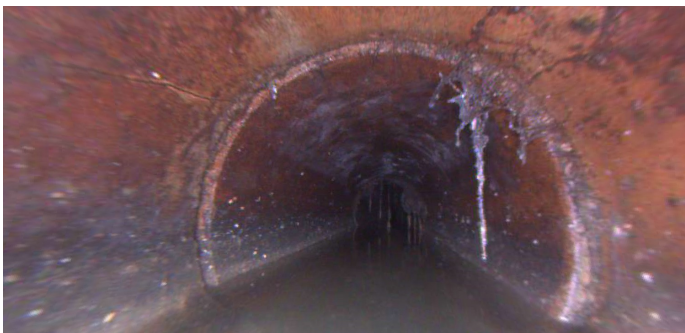
Code: **RFJ**
Description: **Roots Fine Joint**

Distance (ft): **15.9**
Structural Grade: **0**
O&M Grade: **1**
Clock Start/From: **8**
Clock To: **4**
1st Value:
2nd Value:
Value Percent:
Continuous Index:
Within 8" of Joint: **YES**
Remarks:

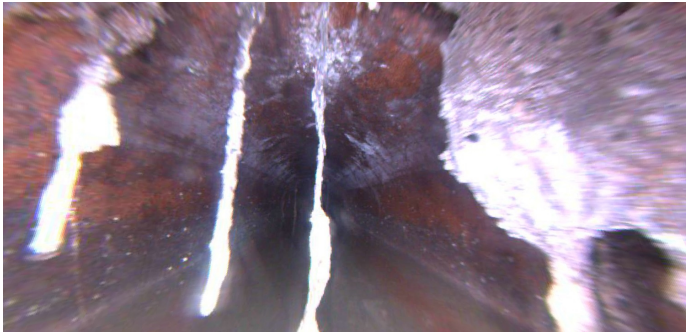
Code: **RMJ**
Description: **Roots Medium Joint**

Distance (ft): **18.1**
Structural Grade: **0**
O&M Grade: **3**
Clock Start/From: **8**
Clock To: **4**
1st Value:
2nd Value:
Value Percent: **15.000**
Continuous Index:
Within 8" of Joint: **YES**
Remarks:

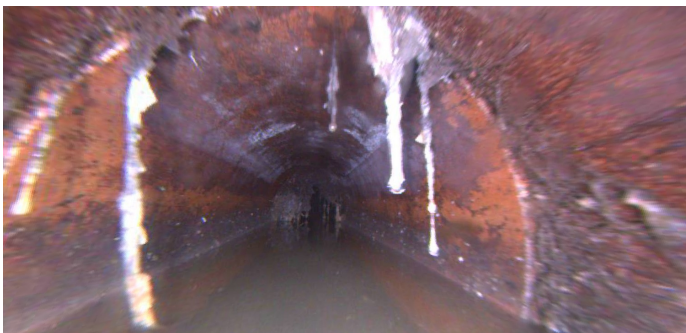
Code: **RFJ**
Description: **Roots Fine Joint**

Distance (ft): **20.0**
Structural Grade: **0**
O&M Grade: **1**
Clock Start/From: **8**
Clock To: **4**
1st Value:
2nd Value:
Value Percent:
Continuous Index:
Within 8" of Joint: **YES**
Remarks:

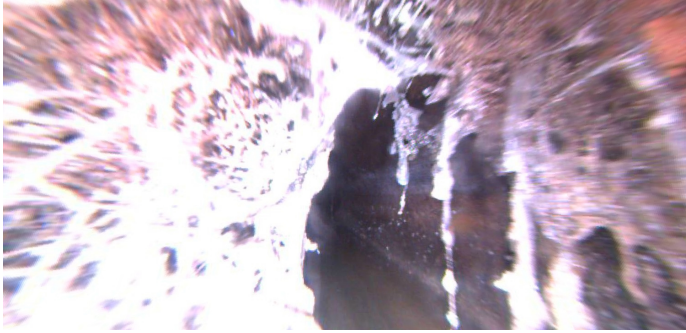
Code: **RBJ**
Description: **Roots Ball Joint**

Distance (ft): **22.0**
Structural Grade: **0**
O&M Grade: **4**
Clock Start/From: **8**
Clock To: **4**
1st Value:
2nd Value:
Value Percent: **60.000**
Continuous Index:
Within 8" of Joint: **YES**
Remarks:

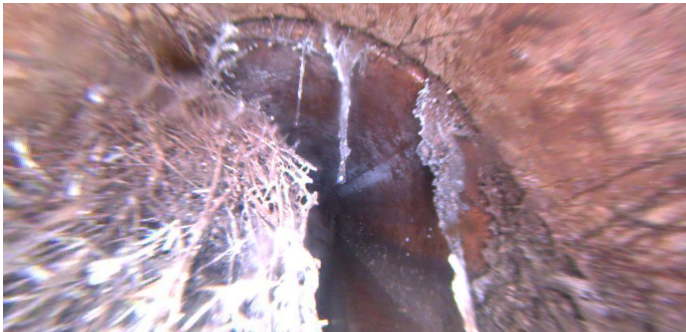
Code: **RBJ**
Description: **Roots Ball Joint**

Distance (ft): **23.8**
Structural Grade: **0**
O&M Grade: **4**
Clock Start/From: **8**
Clock To: **4**
1st Value:
2nd Value:
Value Percent: **60.000**
Continuous Index:
Within 8" of Joint: **YES**
Remarks:

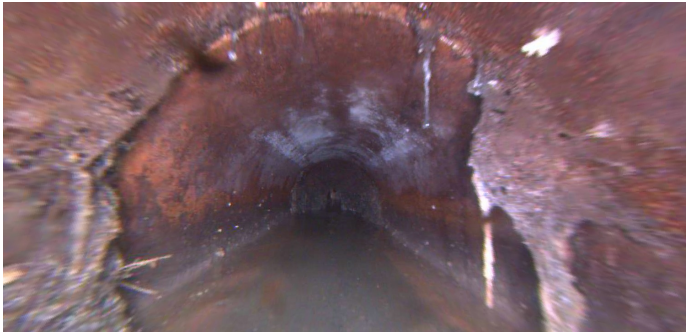
Code: **RMJ**
Description: **Roots Medium Joint**

Distance (ft): **25.9**
Structural Grade: **0**
O&M Grade: **3**
Clock Start/From: **8**
Clock To: **4**
1st Value:
2nd Value:
Value Percent: **10.000**
Continuous Index:
Within 8" of Joint: **YES**
Remarks:

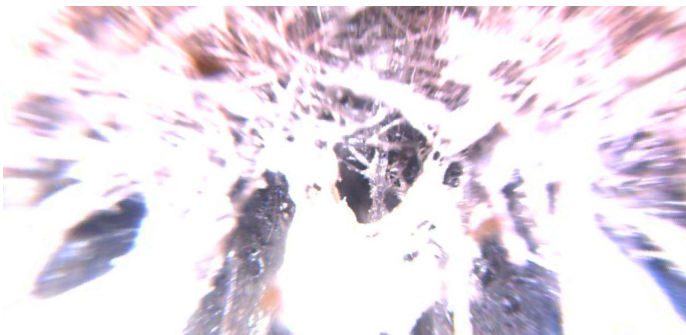
Code: **RBJ**
Description: **Roots Ball Joint**

Distance (ft): **27.8**
Structural Grade: **0**
O&M Grade: **4**
Clock Start/From: **8**
Clock To: **4**
1st Value:
2nd Value:
Value Percent: **90.000**
Continuous Index:
Within 8" of Joint: **YES**
Remarks:

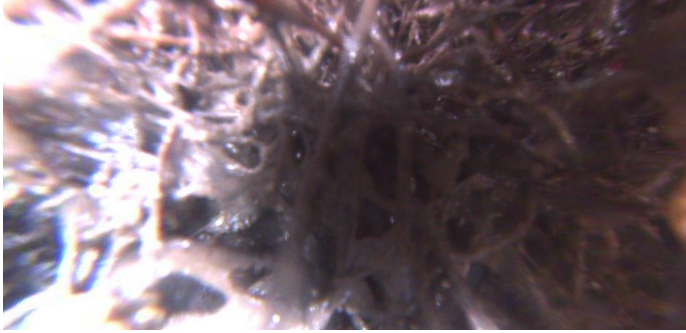
Code: **RBJ**
Description: **Roots Ball Joint**

Distance (ft): **29.9**
Structural Grade: **0**
O&M Grade: **4**
Clock Start/From: **8**
Clock To: **4**
1st Value:
2nd Value:
Value Percent: **90.000**
Continuous Index:
Within 8" of Joint: **YES**
Remarks:
