Profile/Photo Observation Report

Date:	04/14/2018	Weather:		Coding:	PACP 6.0
Pipe Length (ft):	218.3	Owner:	NA	Pre Clean:	Not Known
P.O.#:		Surveyor:	Jen Costello	PSR:	P-706-008.7-008.6
Customer:		Clean Date:	01/01/1900	Shape:	C

Street:	GARFIELD ST	Flow Control:	Not Controlled
City:	Hobart, IN	Year Renewed:	
Location:	Light Highway	Tape/Media #:	
Purpose:	Maintenance Related	Dia/Height:	8"
Use:	Sanitary	Material:	VCP
Drain Area:	NA	Lining:	Cured in Place
Category:	NA		
Comment:	Reverse setup. heavy debris at 37'.flow incorrect		
Location Details:		Direction of Survey:	Upstream
US MH:	M-706-008.6	DS MH:	M-706-008.7
		Total Length Surveyed (ft):	38.3

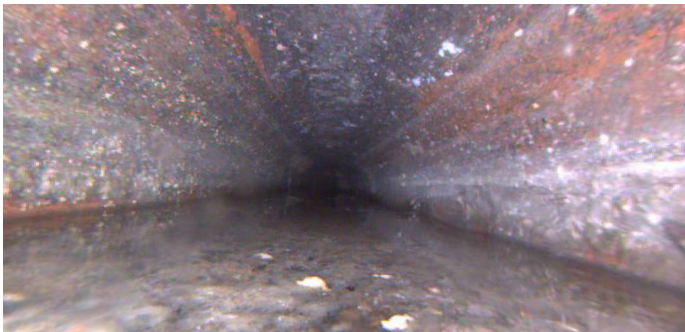
Code:	DAGS
Description:	Deposits Attached Grease

Distance (ft):	.0
Structural Grade:	0
O&M Grade:	2
Clock Start/From:	8
Clock To:	4
1st Value:	
2nd Value:	
Value Percent:	5.000
Continuous Index:	S01
Within 8" of Joint:	NO
Remarks:

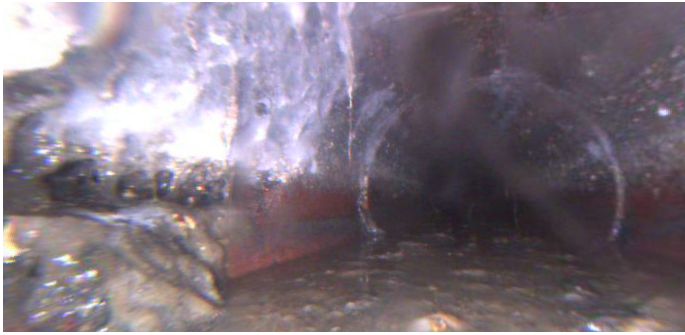
Code: **TFD**
Description: **Tap Factory Defective**

Distance (ft): **5.8**
Structural Grade: **0**
O&M Grade: **2**
Clock Start/From: **3**
Clock To:
1st Value: **4.000**
2nd Value:
Value Percent:
Continuous Index:
Within 8" of Joint:
Remarks: **ROOTS**

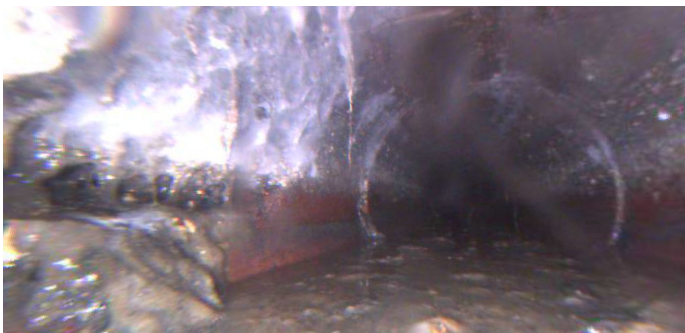
Code: **RFL**
Description: **Roots Fine Lateral**

Distance (ft): **5.8**
Structural Grade: **0**
O&M Grade: **1**
Clock Start/From: **2**
Clock To: **4**
1st Value:
2nd Value:
Value Percent:
Continuous Index:
Within 8" of Joint: **NO**
Remarks:

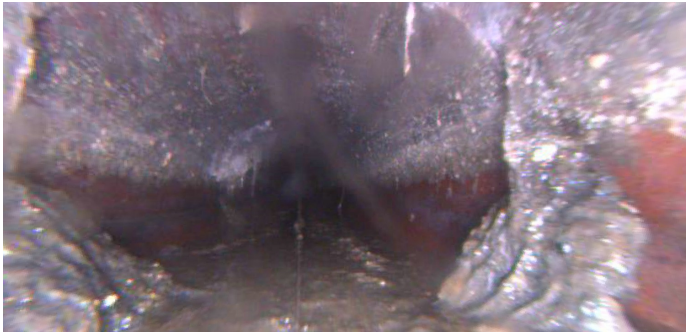
Code: **RMJ**
Description: **Roots Medium Joint**

Distance (ft): **7.1**
Structural Grade: **0**
O&M Grade: **3**
Clock Start/From: **8**
Clock To: **4**
1st Value:
2nd Value:
Value Percent: **10.000**
Continuous Index: **S02**
Within 8" of Joint: **YES**
Remarks:

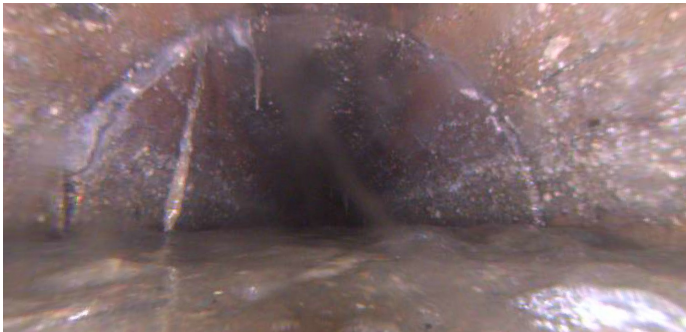
Code: **RFJ**
Description: **Roots Fine Joint**

Distance (ft): **19.0**
Structural Grade: **0**
O&M Grade: **1**
Clock Start/From: **12**
Clock To: **4**
1st Value:
2nd Value:
Value Percent:
Continuous Index:
Within 8" of Joint: **YES**
Remarks:

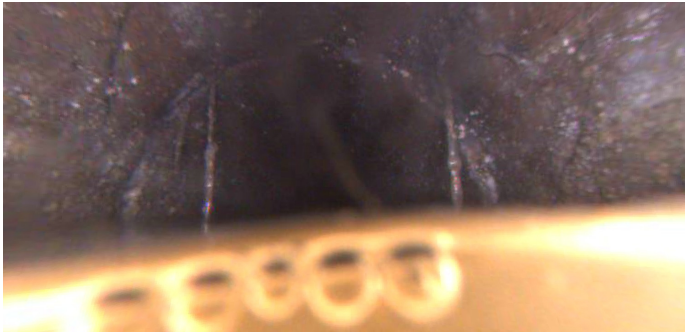
Code: **RFJ**
Description: **Roots Fine Joint**

Distance (ft): **21.1**
Structural Grade: **0**
O&M Grade: **1**
Clock Start/From: **8**
Clock To: **4**
1st Value:
2nd Value:
Value Percent:
Continuous Index:
Within 8" of Joint: **YES**
Remarks:

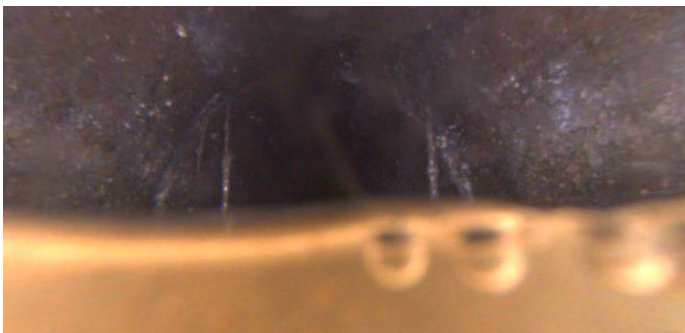
Code: **RMJ**
Description: **Roots Medium Joint**

Distance (ft): **21.2**
Structural Grade: **0**
O&M Grade: **3**
Clock Start/From: **8**
Clock To: **4**
1st Value:
2nd Value:
Value Percent: **10.000**
Continuous Index: **F02**
Within 8" of Joint: **YES**
Remarks:
