Profile/Photo Observation Report

Date:	04/14/2018	Weather:		Coding:	PACP 6.0
Pipe Length (ft):	218.3	Owner:	NA	Pre Clean:	Not Known
P.O.#:		Surveyor:	Jen Costello	PSR:	P-706-008.7-008.6
Customer:		Clean Date:	01/01/1900	Shape:	C

Street:	Capitol	Flow Control:	Not Controlled
City:	Hobart, IN	Year Renewed:	
Location:	Light Highway	Tape/Media #:	
Purpose:	Maintenance Related	Dia/Height:	8"
Use:	Sanitary	Material:	VCP
Drain Area:	NA	Lining:	Cured in Place
Category:	NA		
Comment:	Reverse setup. heavy debris at 37'.flow incorrect		
Location Details:		Direction of Survey:	Upstream
US MH:	M-706-008.6	DS MH:	M-706-008.7
		Total Length Surveyed (ft):	38.3

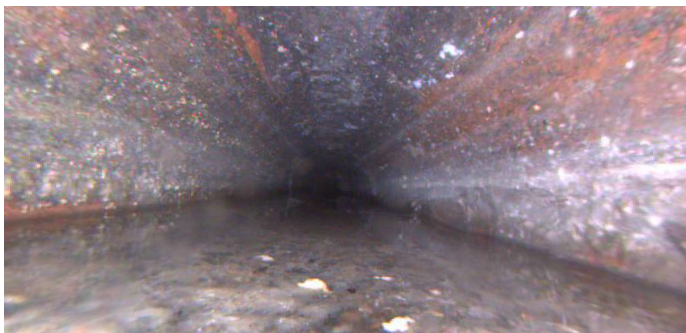
Code: **AMH**
Description: **Manhole**

Distance (ft): **.0**
Structural Grade: **0**
O&M Grade: **0**
Clock Start/From:
Clock To:
1st Value:
2nd Value:
Value Percent:
Continuous Index:
Within 8" of Joint: **NO**
Remarks: **M-706-008.7**

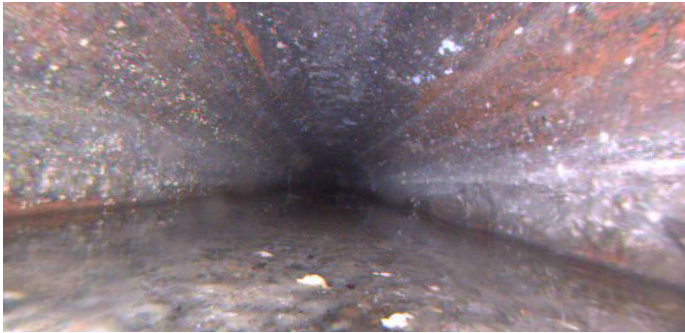
Code:	MWL
Description:	Water Level

Distance (ft):	.0
Structural Grade:	0
O&M Grade:	0
Clock Start/From:	
Clock To:	
1st Value:	
2nd Value:	
Value Percent:	40.000
Continuous Index:	
Within 8" of Joint:	NO
Remarks:

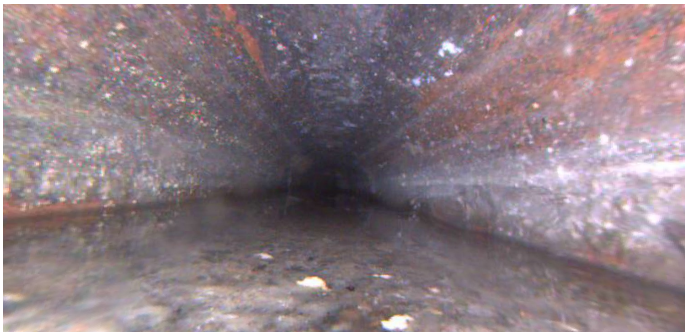
Code:	DAGS
Description:	Deposits Attached Grease

Distance (ft):	.0
Structural Grade:	0
O&M Grade:	2
Clock Start/From:	8
Clock To:	4
1st Value:	
2nd Value:	
Value Percent:	5.000
Continuous Index:	S01
Within 8" of Joint:	NO
Remarks:

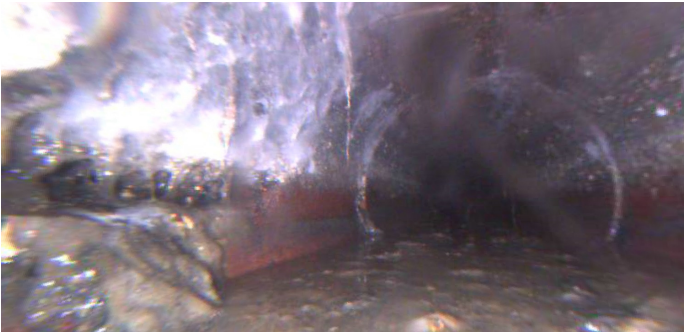
Code: **TFD**
Description: **Tap Factory Defective**

Distance (ft): **5.8**
Structural Grade: **0**
O&M Grade: **2**
Clock Start/From: **3**
Clock To:
1st Value: **4.000**
2nd Value:
Value Percent:
Continuous Index:
Within 8" of Joint:
Remarks: **ROOTS**

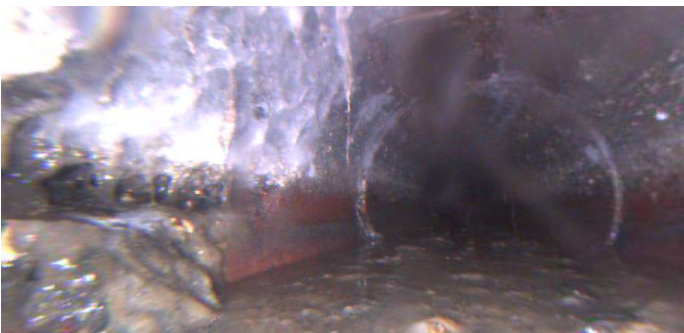
Code: **RFL**
Description: **Roots Fine Lateral**

Distance (ft): **5.8**
Structural Grade: **0**
O&M Grade: **1**
Clock Start/From: **2**
Clock To: **4**
1st Value:
2nd Value:
Value Percent:
Continuous Index:
Within 8" of Joint: **NO**
Remarks:

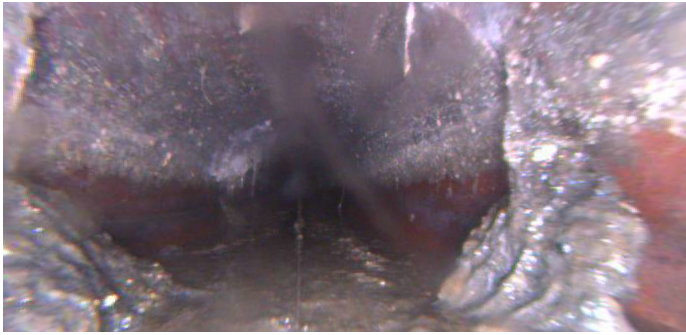
Code: **RMJ**
Description: **Roots Medium Joint**

Distance (ft): **7.1**
Structural Grade: **0**
O&M Grade: **3**
Clock Start/From: **8**
Clock To: **4**
1st Value:
2nd Value:
Value Percent: **10.000**
Continuous Index: **S02**
Within 8" of Joint: **YES**
Remarks:

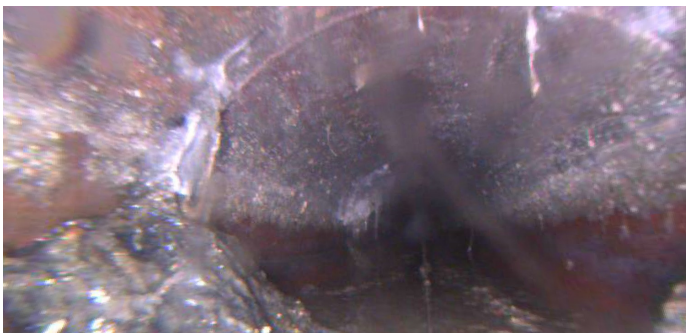
Code: **MGO**
Description: **General Observation**

Distance (ft): **7.1**
Structural Grade: **0**
O&M Grade: **0**
Clock Start/From:
Clock To:
1st Value:
2nd Value:
Value Percent:
Continuous Index:
Within 8" of Joint: **NO**
Remarks: **REAR CAMERA**

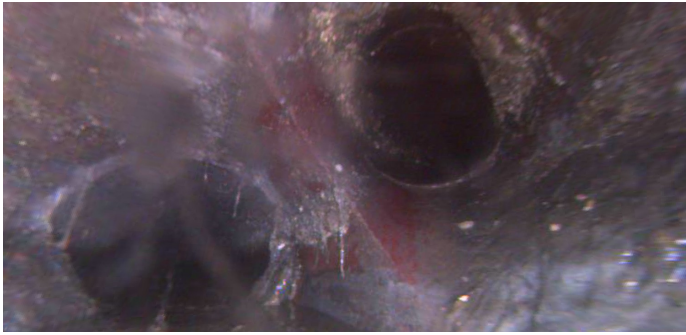
Code: **TF**
Description: **Tap Factory**

Distance (ft): **7.9**
Structural Grade: **0**
O&M Grade: **0**
Clock Start/From: **10**
Clock To:
1st Value: **4.000**
2nd Value:
Value Percent:
Continuous Index:
Within 8" of Joint:
Remarks:

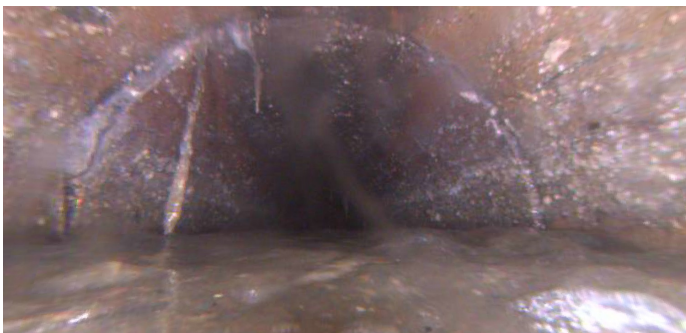
Code: **RFJ**
Description: **Roots Fine Joint**

Distance (ft): **19.0**
Structural Grade: **0**
O&M Grade: **1**
Clock Start/From: **12**
Clock To: **4**
1st Value:
2nd Value:
Value Percent:
Continuous Index:
Within 8" of Joint: **YES**
Remarks:

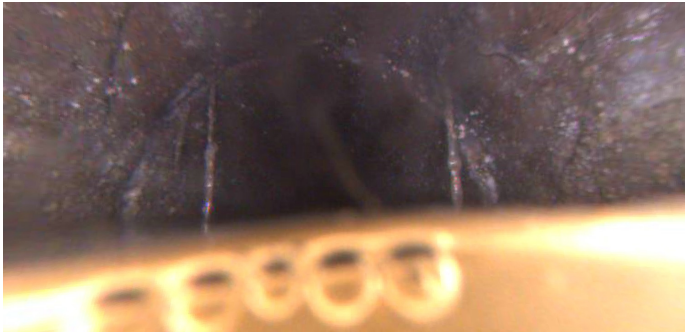
Code: **RFJ**
Description: **Roots Fine Joint**

Distance (ft): **21.1**
Structural Grade: **0**
O&M Grade: **1**
Clock Start/From: **8**
Clock To: **4**
1st Value:
2nd Value:
Value Percent:
Continuous Index:
Within 8" of Joint: **YES**
Remarks:

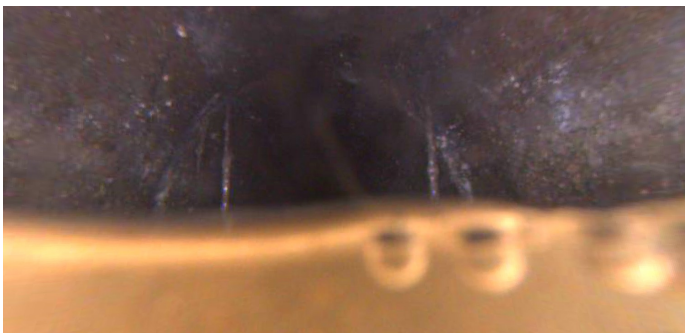
Code: **RMJ**
Description: **Roots Medium Joint**

Distance (ft): **21.2**
Structural Grade: **0**
O&M Grade: **3**
Clock Start/From: **8**
Clock To: **4**
1st Value:
2nd Value:
Value Percent: **10.000**
Continuous Index: **F02**
Within 8" of Joint: **YES**
Remarks:
