Profile/Photo Observation Report

Date:	02/23/2022	Weather:		Coding:	PACP 7.0
Pipe Length (ft):	218.0	Owner:	City of Hobart	Pre Clean:	Heavy Cleaning
P.O.#:	YES502259	Surveyor:	S. Bucklin	PSR:	P-706-008.7-008.6
Customer:	City of Hobart, IN (Red	Clean Date:	02/18/2022	Shape:	C

Street:	South Garfield Street	Flow Control:	Not Controlled
City:	Hobart, IN	Year Renewed:	
Location:	Local rural streets with light traffic, t	Tape/Media #:	
Purpose:	Routine Assessment	Dia/Height:	8"
Use:	Sanitary Sewage Pipe	Material:	VCP
Drain Area:		Lining:	None
Category:	NA		
Comment:			
Location Details:		Direction of Survey:	Downstream
US MH:	M-706-008.6	DS MH:	M-706-008.7
		Total Length Surveyed (ft):	217.6

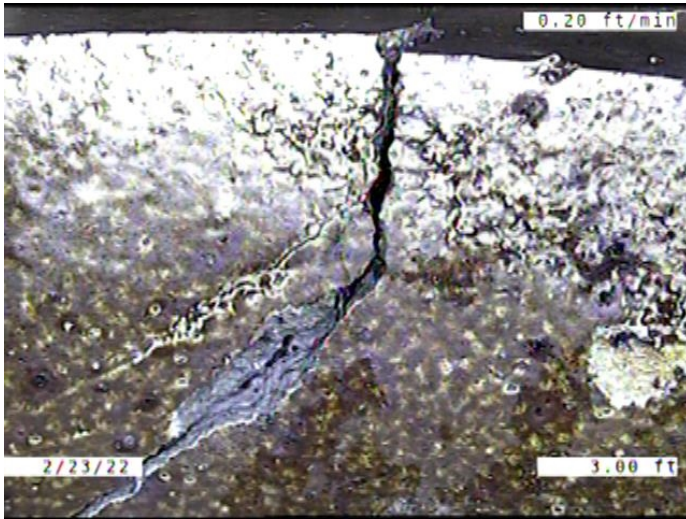
Code: **B**
 Description: **Broken**

Distance (ft): **3.0**
 Structural Grade: **4**
 O&M Grade: **0**
 Clock Start/From: **8**
 Clock To: **3**
 1st Value:
 2nd Value:
 Value Percent:
 Continuous Index:
 Within 8" of Joint: **YES**
 Remarks:

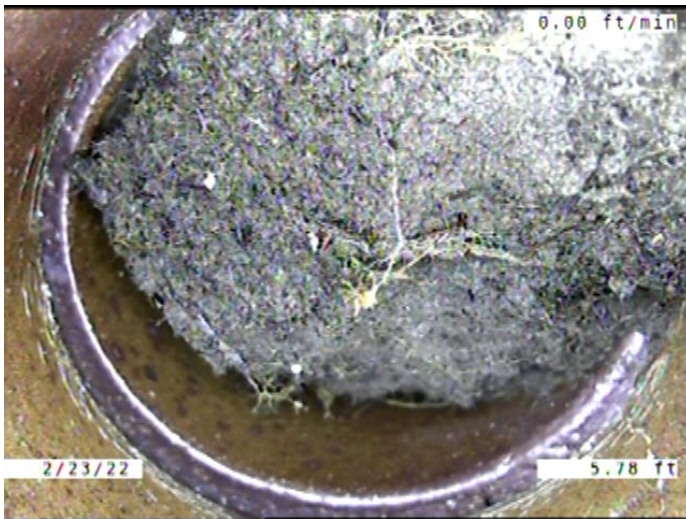
Code: **TF**
 Description: **Tap Factory**

Distance (ft): **5.8**
 Structural Grade: **0**
 O&M Grade: **0**
 Clock Start/From: **2**
 Clock To:
 1st Value: **4.000**
 2nd Value:
 Value Percent:
 Continuous Index:
 Within 8" of Joint: **YES**
 Remarks: **LOOKS TO BE 95% PLUGGED WITH ROOTS.**

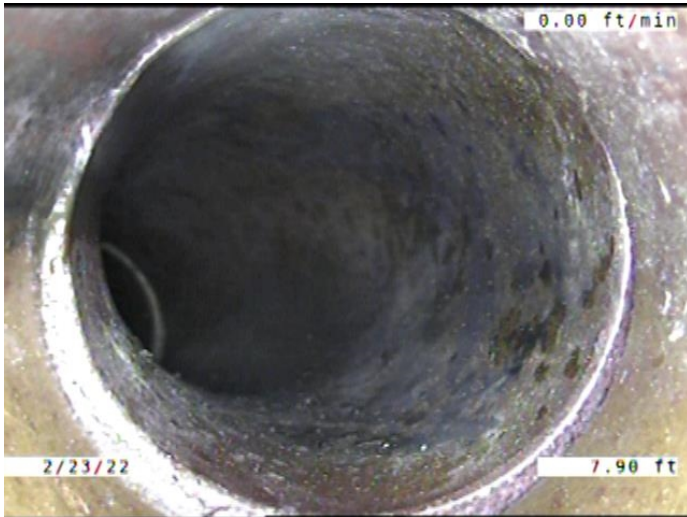
Code: **TF**
Description: **Tap Factory**

Distance (ft): **7.9**
Structural Grade: **0**
O&M Grade: **0**
Clock Start/From: **10**
Clock To:
1st Value: **4.000**
2nd Value:
Value Percent:
Continuous Index:
Within 8" of Joint: **YES**
Remarks: **CONSTANTLY RUNNING WATER**

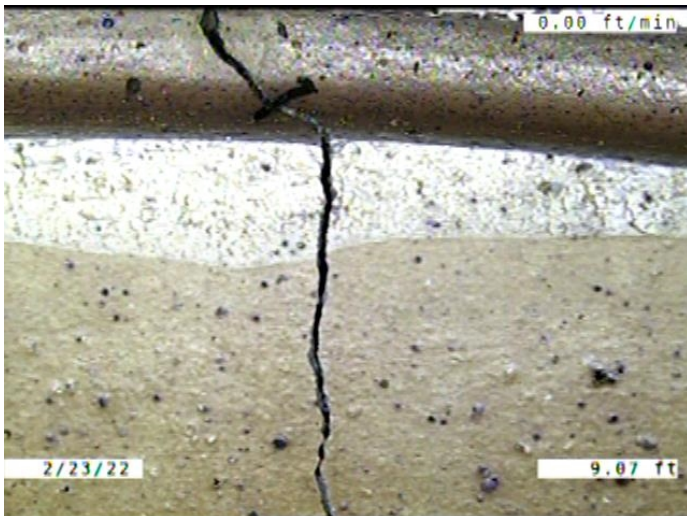
Code: **FM**
Description: **Fracture Multiple**

Distance (ft): **9.1**
Structural Grade: **4**
O&M Grade: **0**
Clock Start/From: **8**
Clock To: **4**
1st Value:
2nd Value:
Value Percent:
Continuous Index:
Within 8" of Joint: **YES**
Remarks:

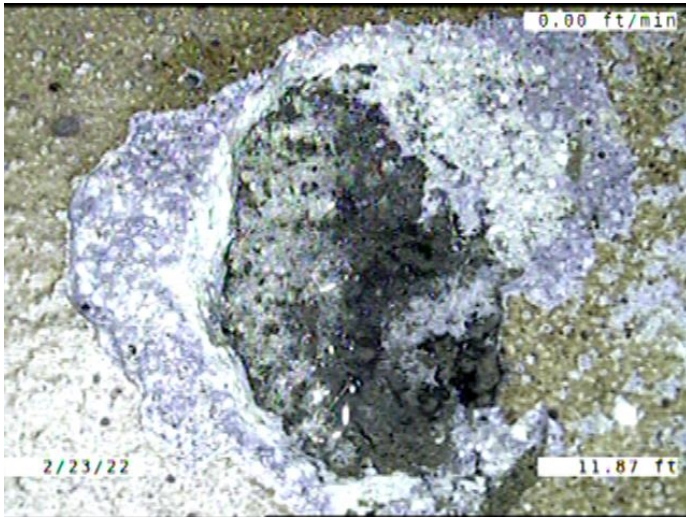
Code: **H**
Description: **Hole**

Distance (ft): **11.9**
Structural Grade: **4**
O&M Grade: **0**
Clock Start/From: **7**
Clock To:
1st Value:
2nd Value:
Value Percent:
Continuous Index:
Within 8" of Joint: **NO**
Remarks:

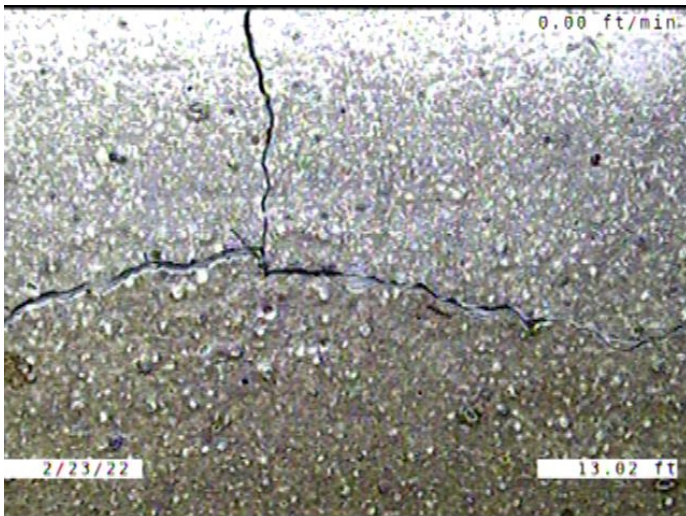
Code: **FM**
Description: **Fracture Multiple**

Distance (ft): **13.0**
Structural Grade: **4**
O&M Grade: **0**
Clock Start/From: **7**
Clock To: **6**
1st Value:
2nd Value:
Value Percent:
Continuous Index: **S01**
Within 8" of Joint: **YES**
Remarks:

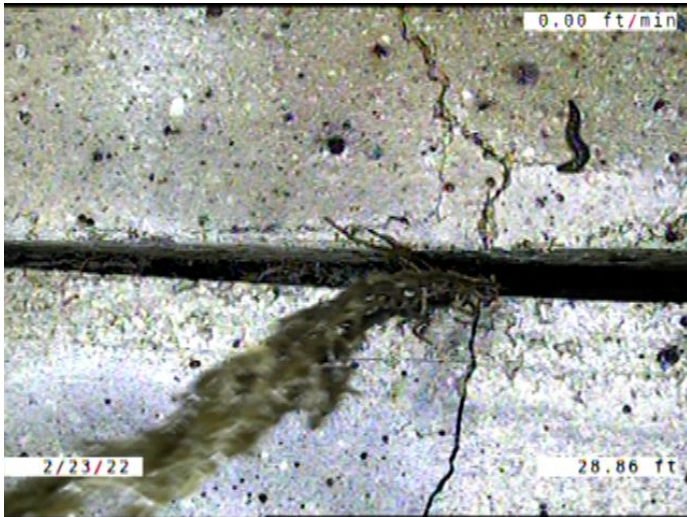
Code: **RFJ**
Description: **Roots Fine Joint**

Distance (ft): **28.9**
Structural Grade: **0**
O&M Grade: **1**
Clock Start/From: **11**
Clock To: **12**
1st Value:
2nd Value:
Value Percent:
Continuous Index:
Within 8" of Joint: **YES**
Remarks:

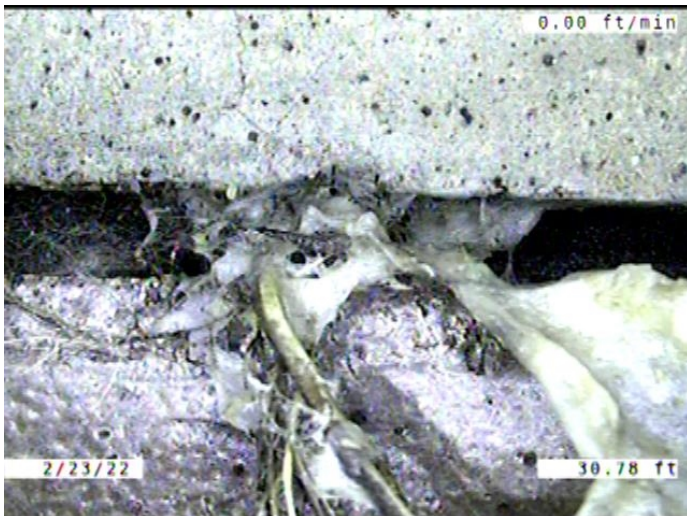
Code: **RMJ**
Description: **Roots Medium Joint**

Distance (ft): **30.8**
Structural Grade: **0**
O&M Grade: **3**
Clock Start/From: **8**
Clock To: **4**
1st Value:
2nd Value:
Value Percent: **5.000**
Continuous Index: **S02**
Within 8" of Joint: **YES**
Remarks:

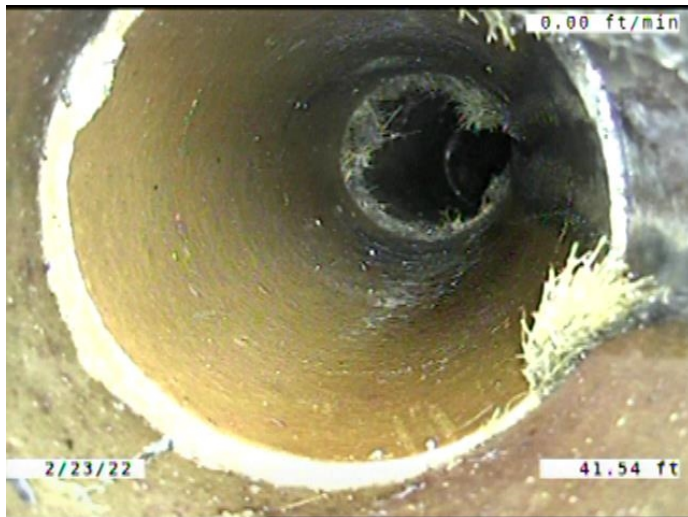
Code:	TF
Description:	Tap Factory
Distance (ft):	41.5
Structural Grade:	0
O&M Grade:	0
Clock Start/From:	2
Clock To:	
1st Value:	4.000
2nd Value:	
Value Percent:	
Continuous Index:	
Within 8" of Joint:	YES
Remarks:	ROOTS GROWING FROM THE JOINTS

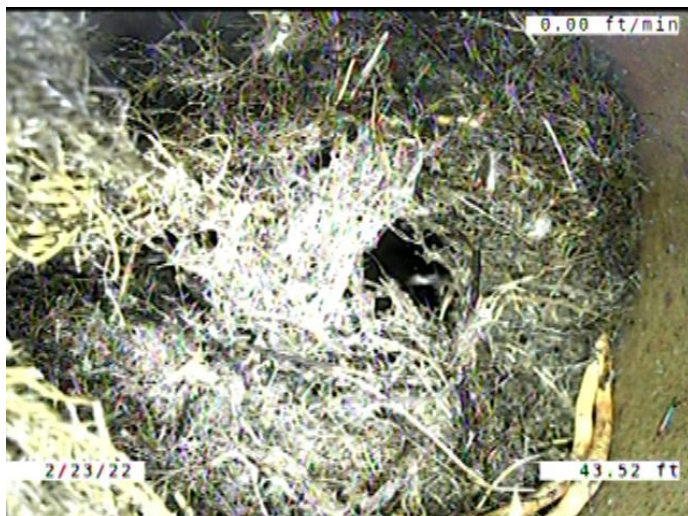
Code:	TF
Description:	Tap Factory
Distance (ft):	43.5
Structural Grade:	0
O&M Grade:	0
Clock Start/From:	10
Clock To:	
1st Value:	4.000
2nd Value:	
Value Percent:	
Continuous Index:	
Within 8" of Joint:	YES
Remarks:	LOOKS 80% PLUGGED WITH ROOTS. ROOTS GROWING OUT OF THE SERV

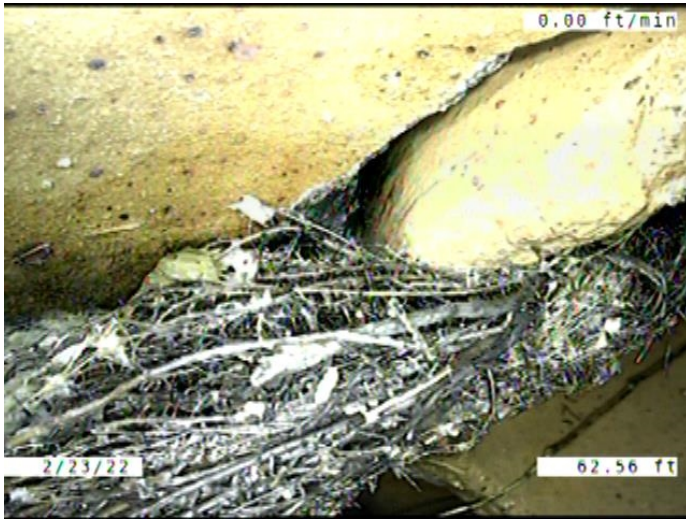
Code: **IRC**
 Description: **Infiltration Runner Connection**

Distance (ft): **62.6**
 Structural Grade: **0**
 O&M Grade: **4**
 Clock Start/From: **9**
 Clock To:
 1st Value:
 2nd Value:
 Value Percent:
 Continuous Index:
 Within 8" of Joint: **NO**
 Remarks:

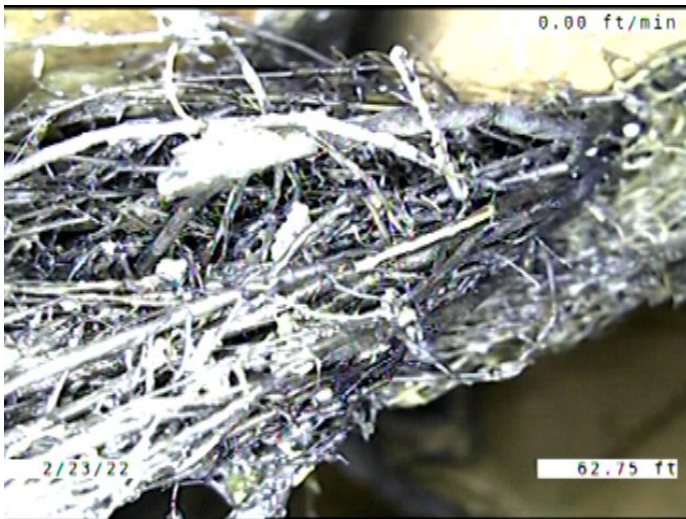
Code: **RMC**
 Description: **Roots Medium Connection**

Distance (ft): **62.7**
 Structural Grade: **0**
 O&M Grade: **3**
 Clock Start/From: **9**
 Clock To: **12**
 1st Value:
 2nd Value:
 Value Percent: **5.000**
 Continuous Index:
 Within 8" of Joint: **NO**
 Remarks:

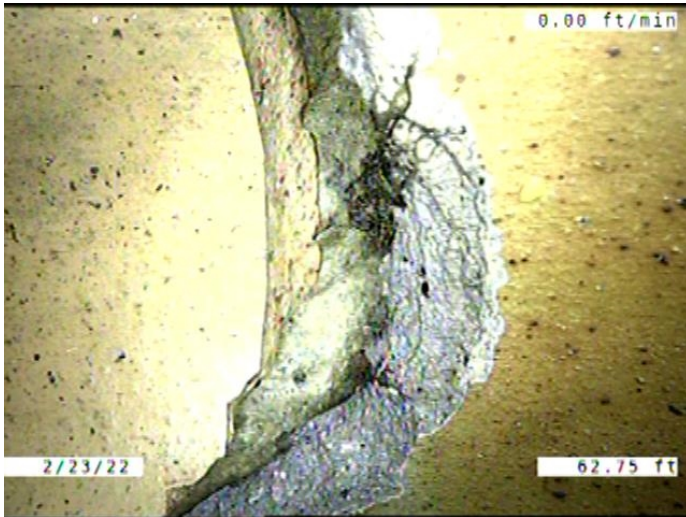
Code: **SSS**
 Description: **Surface Damage Surface Spalling**

Distance (ft): **62.7**
 Structural Grade: **2**
 O&M Grade: **0**
 Clock Start/From: **9**
 Clock To: **12**
 1st Value:
 2nd Value:
 Value Percent:
 Continuous Index:
 Within 8" of Joint: **YES**
 Remarks:

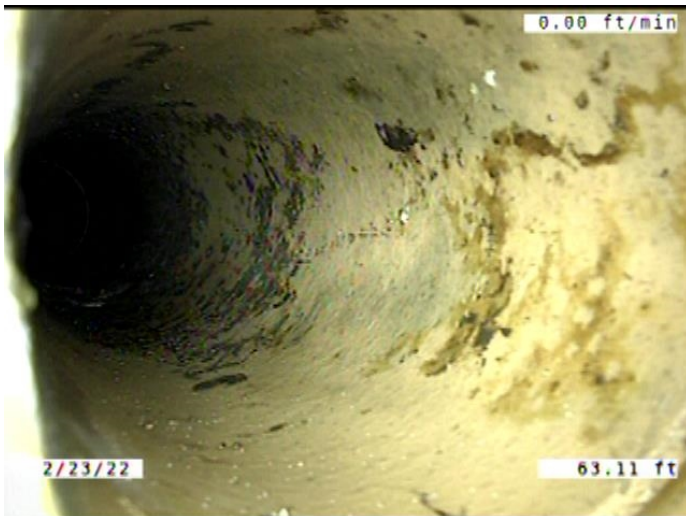
Code: **TBI**
 Description: **Tap Break-in Intruding**

Distance (ft): **63.1**
 Structural Grade: **0**
 O&M Grade: **2**
 Clock Start/From: **10**
 Clock To:
 1st Value: **6.000**
 2nd Value: **1.000**
 Value Percent:
 Continuous Index:
 Within 8" of Joint: **NO**
 Remarks:

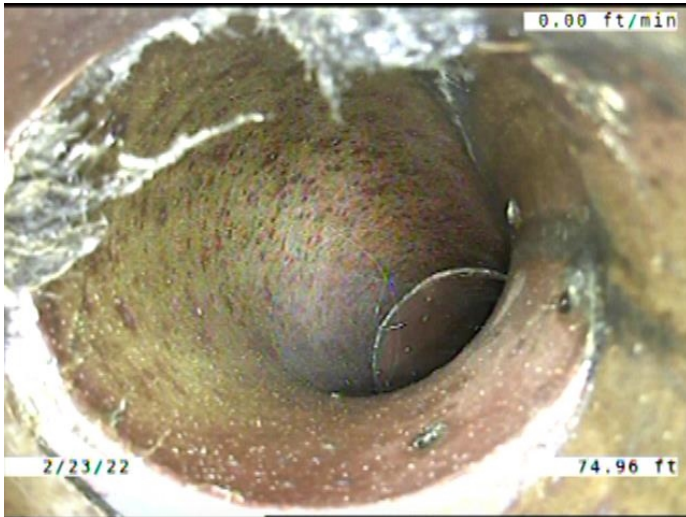
Code: **TF**
 Description: **Tap Factory**

Distance (ft): **75.0**
 Structural Grade: **0**
 O&M Grade: **0**
 Clock Start/From: **2**
 Clock To:
 1st Value: **6.000**
 2nd Value:
 Value Percent:
 Continuous Index:
 Within 8" of Joint: **YES**
 Remarks: **ROOTS GROWING FROM THE JOINTS**

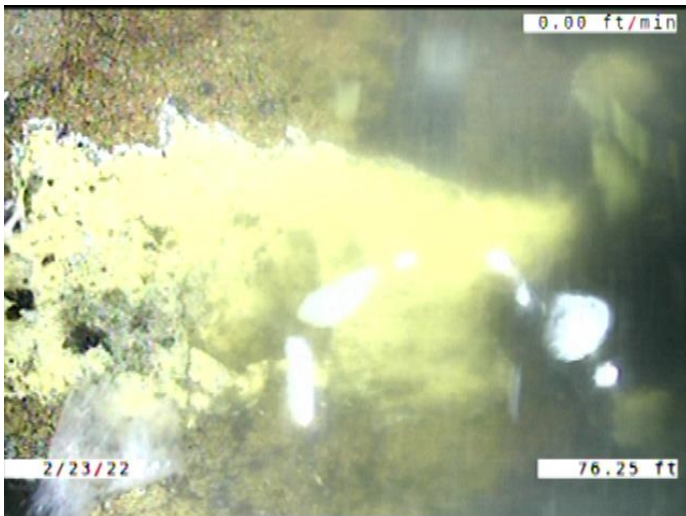
Code: **SSS**
 Description: **Surface Damage Surface Spalling**

Distance (ft): **76.3**
 Structural Grade: **2**
 O&M Grade: **0**
 Clock Start/From: **4**
 Clock To: **7**
 1st Value:
 2nd Value:
 Value Percent:
 Continuous Index:
 Within 8" of Joint: **YES**
 Remarks:

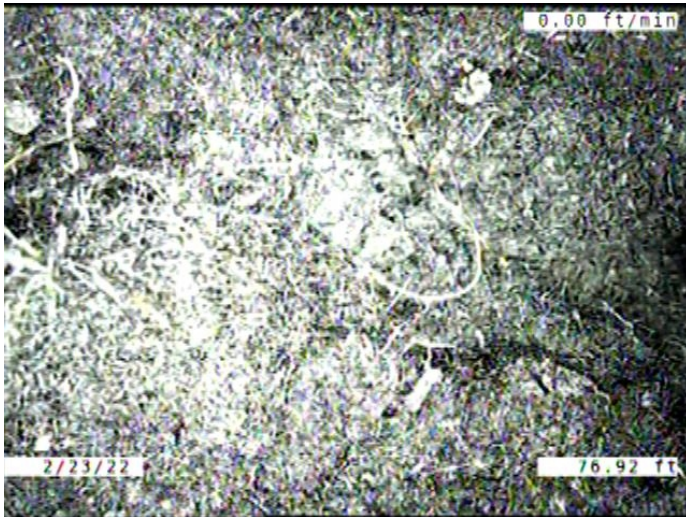
Code: **TF**
Description: **Tap Factory**

Distance (ft): **76.9**
Structural Grade: **0**
O&M Grade: **0**
Clock Start/From: **10**
Clock To:
1st Value: **6.000**
2nd Value:
Value Percent:
Continuous Index:
Within 8" of Joint: **YES**
Remarks: **LOOKS TO BE 95% PLUGGED WITH ROOTS**

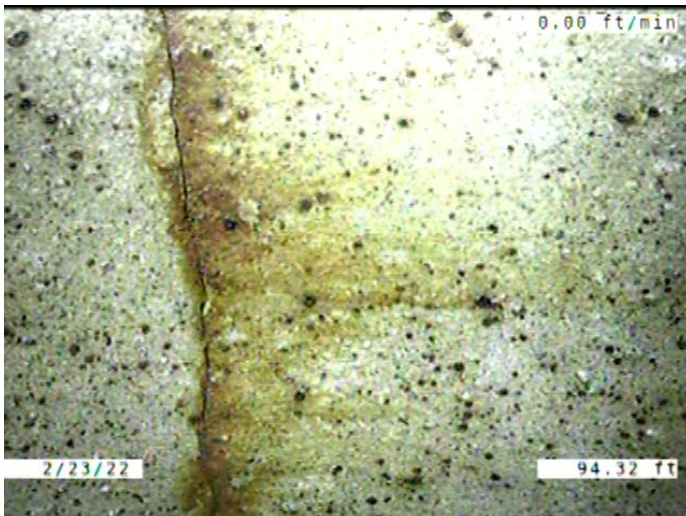
Code: **ISB**
Description: **Infiltration Stain Barrel**

Distance (ft): **94.3**
Structural Grade: **0**
O&M Grade: **1**
Clock Start/From: **1**
Clock To: **2**
1st Value:
2nd Value:
Value Percent:
Continuous Index:
Within 8" of Joint: **NO**
Remarks:

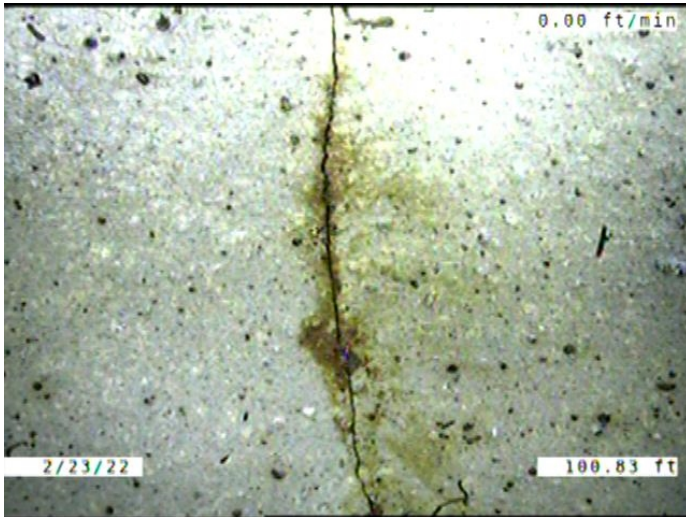
Code: **ISB**
 Description: **Infiltration Stain Barrel**

Distance (ft): **100.8**
 Structural Grade: **0**
 O&M Grade: **1**
 Clock Start/From: **12**
 Clock To:
 1st Value:
 2nd Value:
 Value Percent:
 Continuous Index:
 Within 8" of Joint: **NO**
 Remarks:

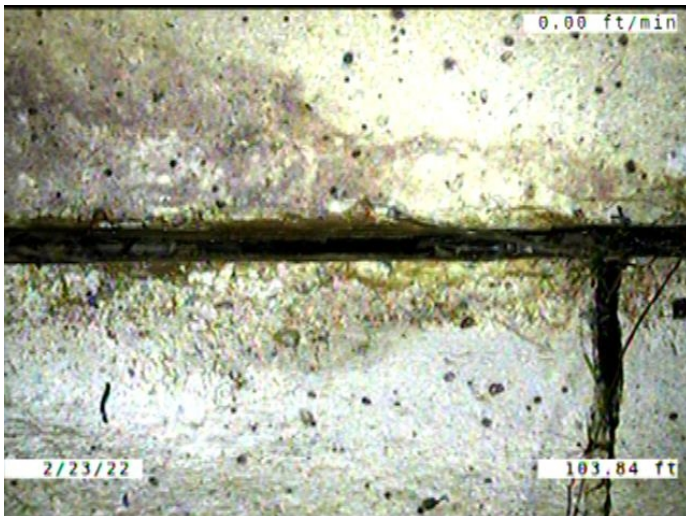
Code: **ISJ**
 Description: **Infiltration Stain Joint**

Distance (ft): **103.8**
 Structural Grade: **0**
 O&M Grade: **1**
 Clock Start/From: **9**
 Clock To: **12**
 1st Value:
 2nd Value:
 Value Percent:
 Continuous Index:
 Within 8" of Joint: **YES**
 Remarks:

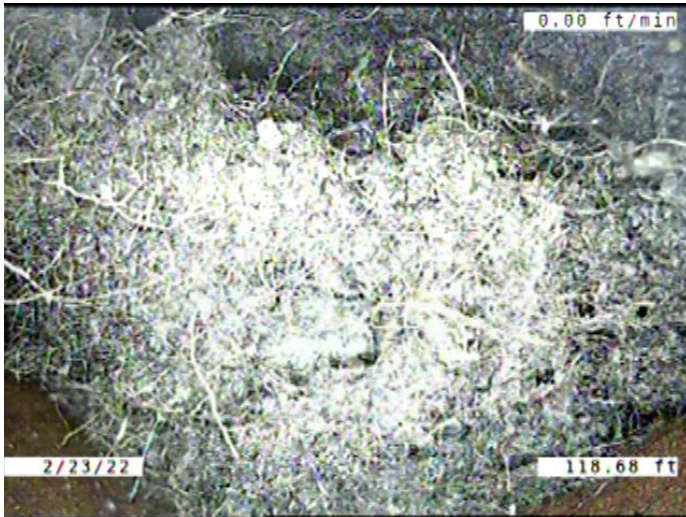
Code: **TF**
Description: **Tap Factory**

Distance (ft): **118.7**
Structural Grade: **0**
O&M Grade: **0**
Clock Start/From: **2**
Clock To:
1st Value: **6.000**
2nd Value:
Value Percent:
Continuous Index:
Within 8" of Joint: **YES**
Remarks: **LOOKS TO BE 95% PLUGGED WITH ROOTS**

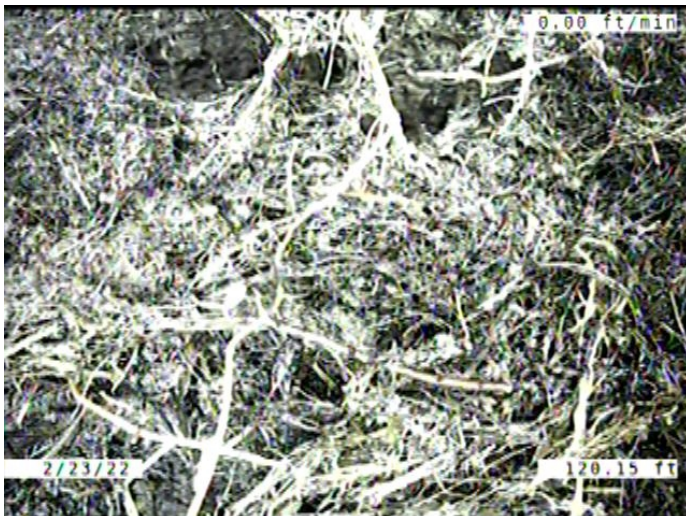
Code: **TF**
Description: **Tap Factory**

Distance (ft): **120.1**
Structural Grade: **0**
O&M Grade: **0**
Clock Start/From: **10**
Clock To:
1st Value: **6.000**
2nd Value:
Value Percent:
Continuous Index:
Within 8" of Joint: **YES**
Remarks: **LOOKS TO BE 95% PLUGGED WITH ROOTS**

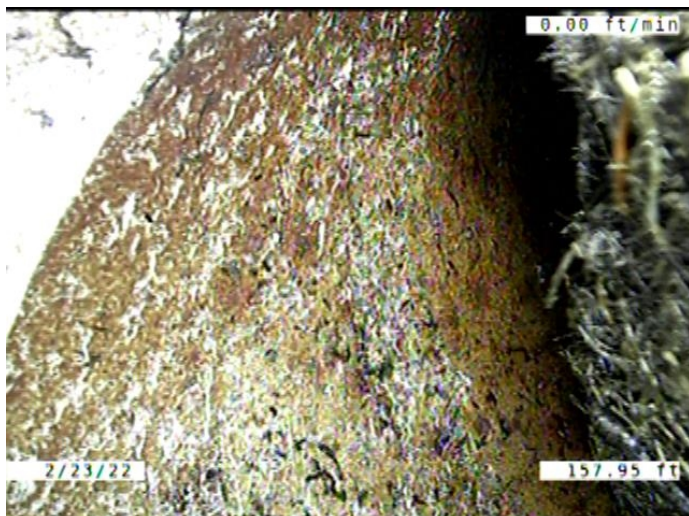
Code: **TF**
 Description: **Tap Factory**

Distance (ft): **157.9**
 Structural Grade: **0**
 O&M Grade: **0**
 Clock Start/From: **2**
 Clock To:
 1st Value: **6.000**
 2nd Value:
 Value Percent:
 Continuous Index:
 Within 8" of Joint: **YES**
 Remarks: **LOOKS TO BE 95% PLUGGED WITH ROOTS**

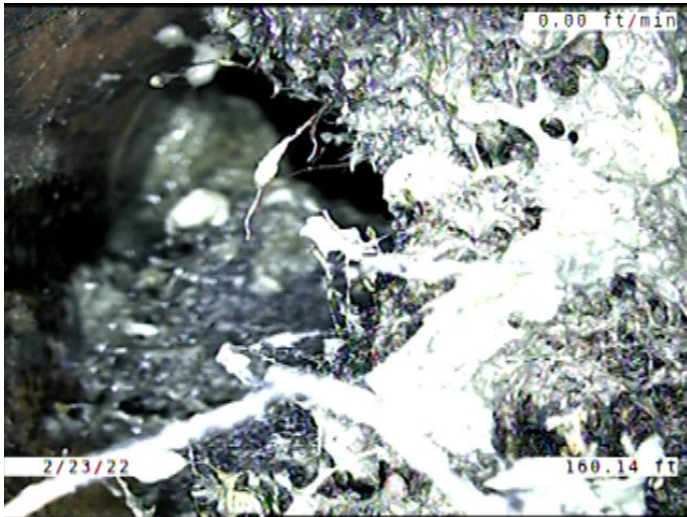
Code: **TF**
 Description: **Tap Factory**

Distance (ft): **160.1**
 Structural Grade: **0**
 O&M Grade: **0**
 Clock Start/From: **10**
 Clock To:
 1st Value: **6.000**

2nd Value:
 Value Percent:
 Continuous Index:
 Within 8" of Joint: **YES**
 Remarks: **LOOKS TO BE 75% PLUGGED WITH ROOTS**

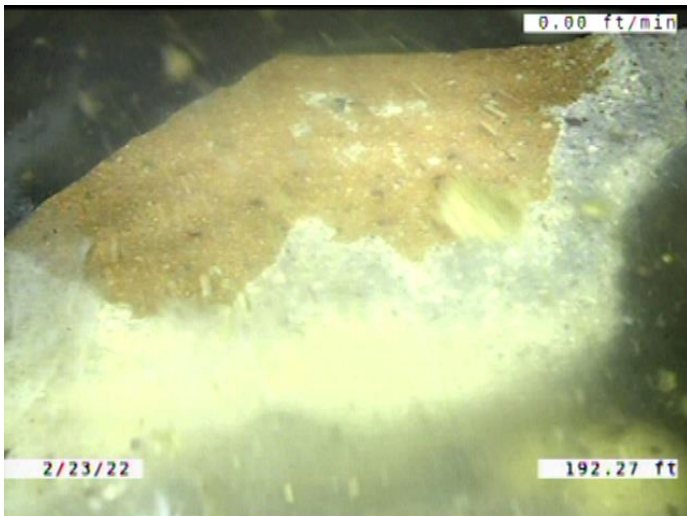
Code: **OBM**
 Description: **Obstruction Pipe Material in Invert**

Distance (ft): **192.3**
 Structural Grade: **0**
 O&M Grade: **2**
 Clock Start/From: **5**
 Clock To: **7**

1st Value:
 2nd Value:
 Value Percent: **5.000**
 Continuous Index:
 Within 8" of Joint: **YES**
 Remarks:

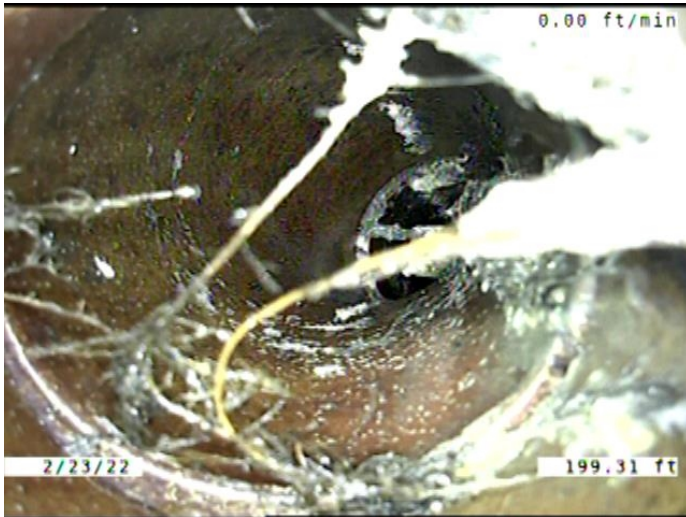
Code:	TF
Description:	Tap Factory
Distance (ft):	199.3
Structural Grade:	0
O&M Grade:	0
Clock Start/From:	2
Clock To:	
1st Value:	6.000
2nd Value:	
Value Percent:	
Continuous Index:	
Within 8" of Joint:	YES
Remarks:	ROOTS GROWING FROM THE JOINTS

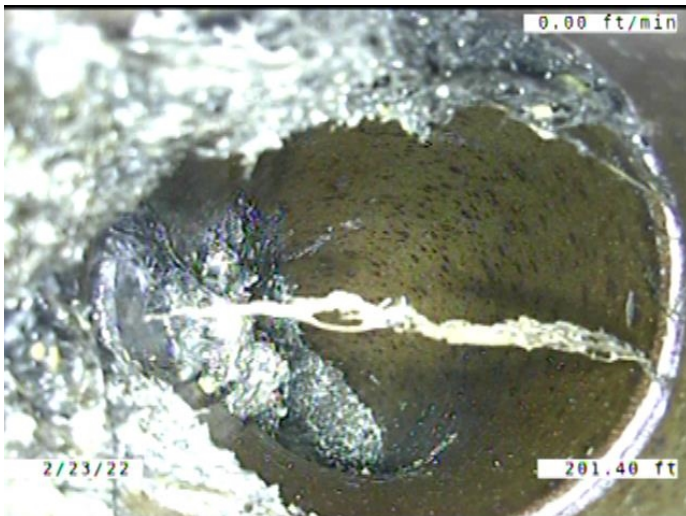
Code:	TF
Description:	Tap Factory
Distance (ft):	201.4
Structural Grade:	0
O&M Grade:	0
Clock Start/From:	10
Clock To:	
1st Value:	6.000
2nd Value:	
Value Percent:	
Continuous Index:	
Within 8" of Joint:	YES
Remarks:	ROOTS GROWING FROM THE JOINTS

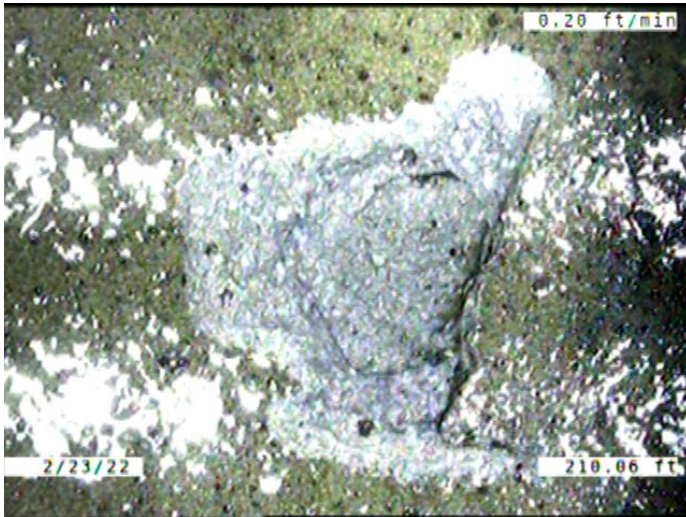
Code: **SSS**
 Description: **Surface Damage Surface Spalling**

Distance (ft): **210.1**
 Structural Grade: **2**
 O&M Grade: **0**
 Clock Start/From: **8**
 Clock To:
 1st Value:
 2nd Value:
 Value Percent:
 Continuous Index:
 Within 8" of Joint: **NO**
 Remarks:

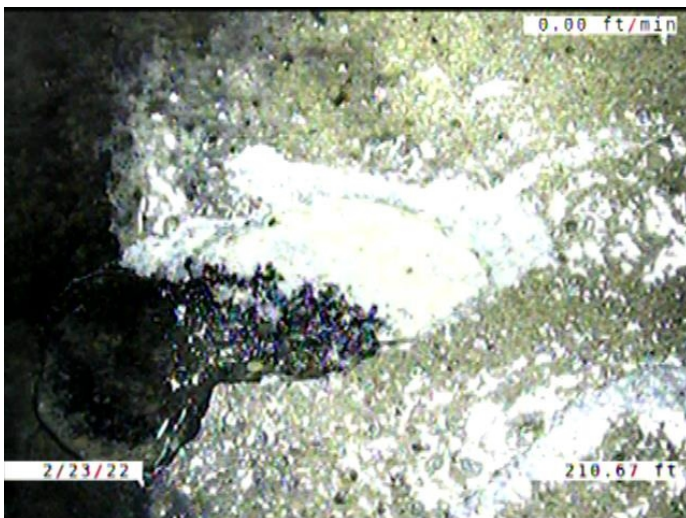
Code: **SSS**
 Description: **Surface Damage Surface Spalling**

Distance (ft): **210.7**
 Structural Grade: **2**
 O&M Grade: **0**
 Clock Start/From: **5**
 Clock To:
 1st Value:
 2nd Value:
 Value Percent:
 Continuous Index:
 Within 8" of Joint: **YES**
 Remarks:

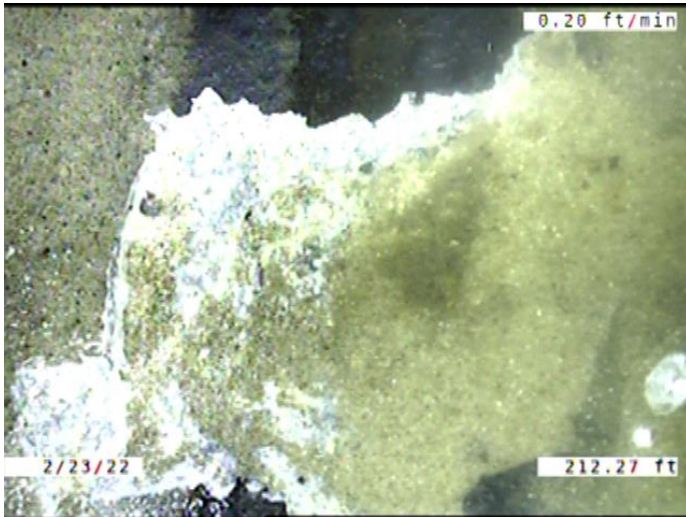
Code: **SSS**
Description: **Surface Damage Surface Spalling**

Distance (ft): **212.3**
Structural Grade: **2**
O&M Grade: **0**
Clock Start/From: **7**
Clock To:
1st Value:
2nd Value:
Value Percent:
Continuous Index:
Within 8" of Joint: **YES**
Remarks:

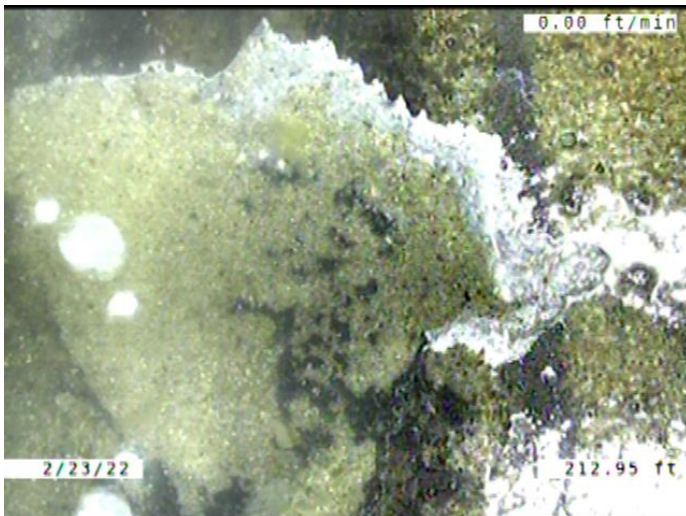
Code: **SSS**
Description: **Surface Damage Surface Spalling**

Distance (ft): **212.9**
Structural Grade: **2**
O&M Grade: **0**
Clock Start/From: **5**
Clock To: **7**
1st Value:
2nd Value:
Value Percent:
Continuous Index:
Within 8" of Joint: **YES**
Remarks:

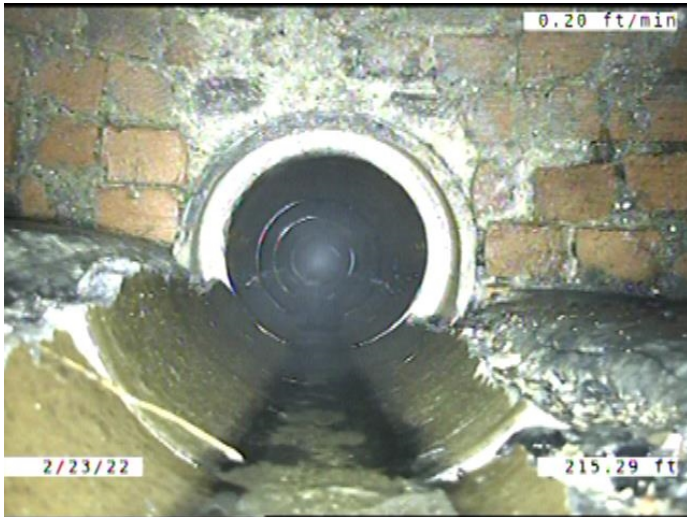
Code: **FM**
 Description: **Fracture Multiple**

Distance (ft): **215.3**
 Structural Grade: **4**
 O&M Grade: **0**
 Clock Start/From: **7**
 Clock To: **6**
 1st Value:
 2nd Value:
 Value Percent:
 Continuous Index: **F01**
 Within 8" of Joint: **YES**
 Remarks:

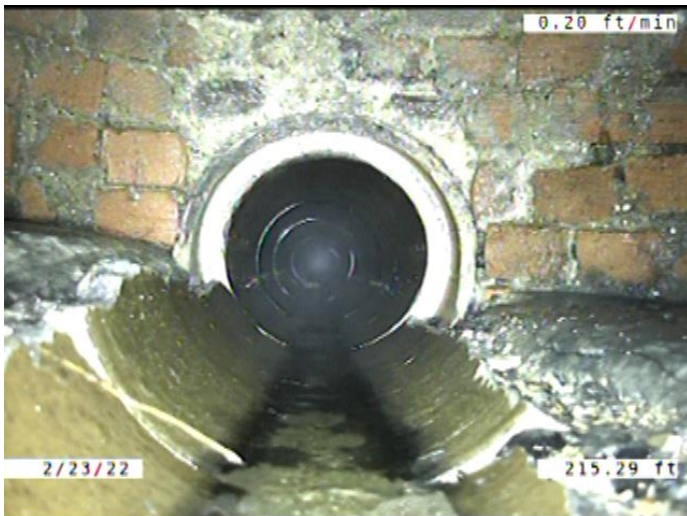
Code: **RMJ**
 Description: **Roots Medium Joint**

Distance (ft): **215.3**
 Structural Grade: **0**
 O&M Grade: **3**
 Clock Start/From: **8**
 Clock To: **4**
 1st Value:
 2nd Value:
 Value Percent: **5.000**
 Continuous Index: **F02**
 Within 8" of Joint: **YES**
 Remarks:
