Profile/Photo Observation Report

Profile/Photo Observation Report								
Date:	10/21/2021	Weather: Owner:	Hobart	IN	Coding: Pre Clean:	PACP 6.0 Not Known		
Pipe Length (ft):			Hobart, IN M. Pielacha					
P.O.#:	938_1	Surveyor:		acna	PSR:	P-706-008.7-002		
Customer:	Hobart, IN	Clean Date:			Shape:	С		
Street: Garfield Street			Flow Con	trol:				
City:	ity: Hobart, IN		Year Renewed:					
Location:	Light Highway		Tape/Media #:		938			
Purpose:	Purpose: Reversal		Dia/Height:		8"			
Use:	se: Sanitary		Material:		VCP			
Drain Area:			Lining:					
Category:	NA							
Comment:								
Location Details:			Direction of Survey:		Downstream			
US MH:	M-706-8.7	DS MH:	M-706-2		Total Length Surveyed (ft)	: 68.5		
O&M Index:	2.00	O&M Quick:		2900	O&M Rating:	18.00		
Structural Index	0.00	 Structural Q	uick:	0000	Structural Rating:	0.00		
Overall Index:	2.00	Overall Quic	:k:	2900	Overall Rating:	18.00

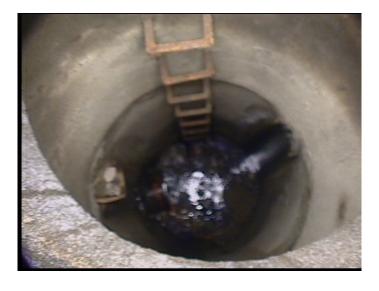
Code:	АМН
Description:	Manhole
Distance (ft):	.0
Structural Grade:	0
O&M Grade:	0
Clock Start/From:	
Clock To:	
1st Value:	
2nd Value:	
Value Percent:	
Continuous Index:	
Within 8" of Joint:	NO
Remarks:	M-706-8.7

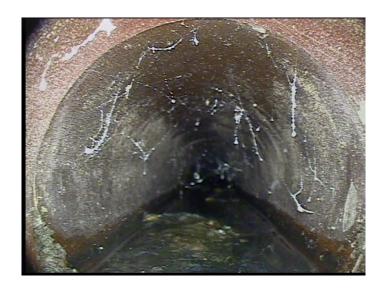
Code: MWL
Description: Water Level

Distance (ft): .0
Structural Grade: 0
O&M Grade: 0

Value Percent: 10.000

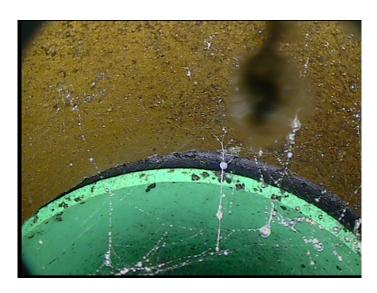
Code: MMC

Description: Material Change

Distance (ft): 17.9
Structural Grade: 0
O&M Grade: 0

Within 8" of Joint: NO Remarks: pvc

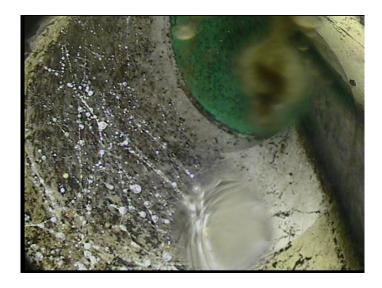
Code: TF

Description: **Tap Factory**

Distance (ft): 22.5 Structural Grade: 0 O&M Grade: 0 Clock Start/From: 2

1st Value: 4.000

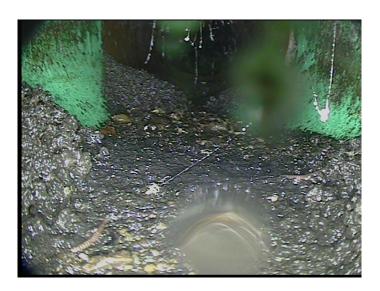
DSF Code:

Description: **Deposits Settled Fine**

Distance (ft): 23.2 Structural Grade: 0 O&M Grade: 2 Clock Start/From: 4 Clock To: 8 1st Value:

2nd Value: Value Percent: 10.000 Continuous Index: **S01** Within 8" of Joint: YES

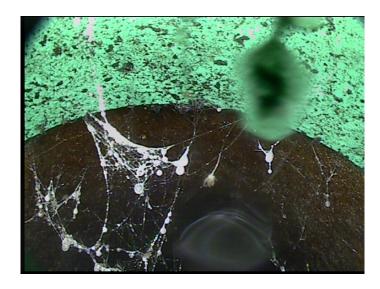
Code: MMC

Description: Material Change

Distance (ft): 24.2
Structural Grade: 0
O&M Grade: 0

Within 8" of Joint: NO Remarks: vcp
