Profile/Photo Observation Report

Date:	10/21/2021	Weather:		Coding:	PACP 6.0
Pipe Length (ft):		Owner:	Hobart, IN	Pre Clean:	Not Known
P.O.#:	937_1	Surveyor:	M. Pielacha	PSR:	P-706-008.7-002
Customer:	Hobart, IN	Clean Date:		Shape:	C

Street:	Garfield Street	Flow Control:	
City:	Hobart, IN	Year Renewed:	
Location:	Light Highway	Tape/Media #:	937
Purpose:	Routine Assessment	Dia/Height:	10"
Use:	Sanitary	Material:	VCP
Drain Area:		Lining:	
Category:	NA		
Comment:

Location Details:		Direction of Survey:	Upstream
US MH:	M-706-8.7	DS MH:	M-706-2
		Total Length Surveyed (ft):	157.7

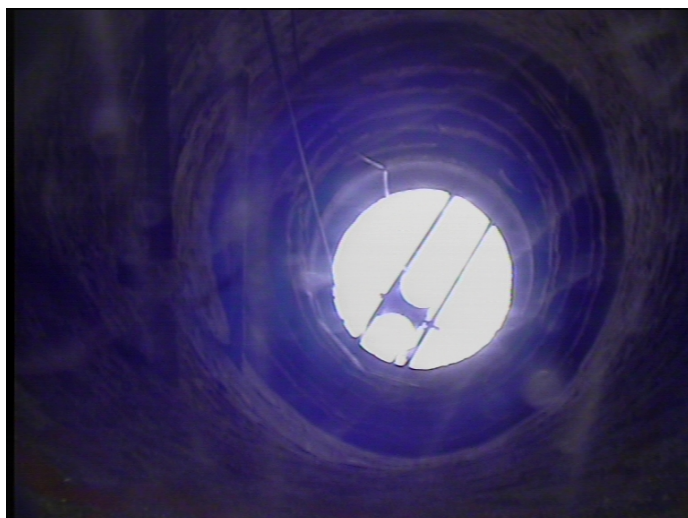
Code: **AMH**
 Description: **Manhole**

Distance (ft): **.0**
 Structural Grade: **0**
 O&M Grade: **0**
 Clock Start/From:
 Clock To:
 1st Value:
 2nd Value:
 Value Percent:
 Continuous Index:
 Within 8" of Joint: **NO**
 Remarks: **M-706-2**

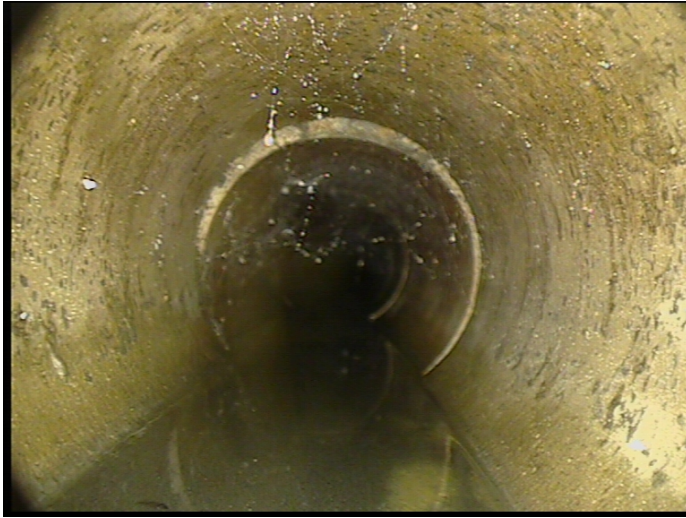
Code:	MWL
Description:	Water Level
Distance (ft):	.0
Structural Grade:	0
O&M Grade:	0
Clock Start/From:	
Clock To:	
1st Value:	
2nd Value:	
Value Percent:	5.000
Continuous Index:	
Within 8" of Joint:	NO
Remarks:

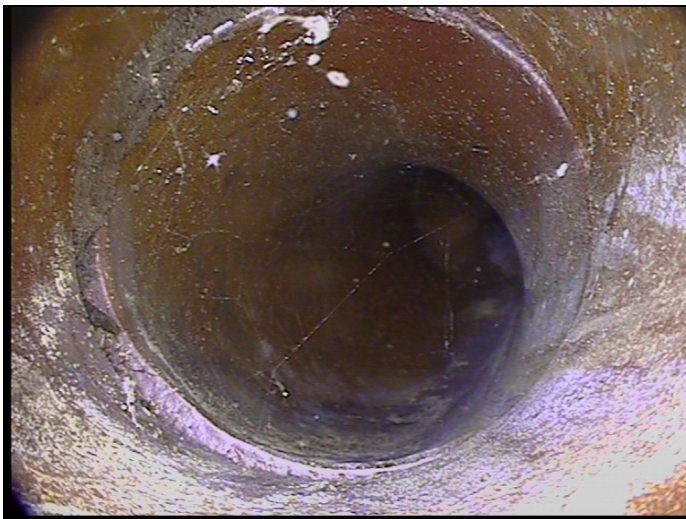
Code:	TF
Description:	Tap Factory
Distance (ft):	27.8
Structural Grade:	0
O&M Grade:	0
Clock Start/From:	2
Clock To:	
1st Value:	4.000
2nd Value:	
Value Percent:	
Continuous Index:	
Within 8" of Joint:	NO
Remarks:

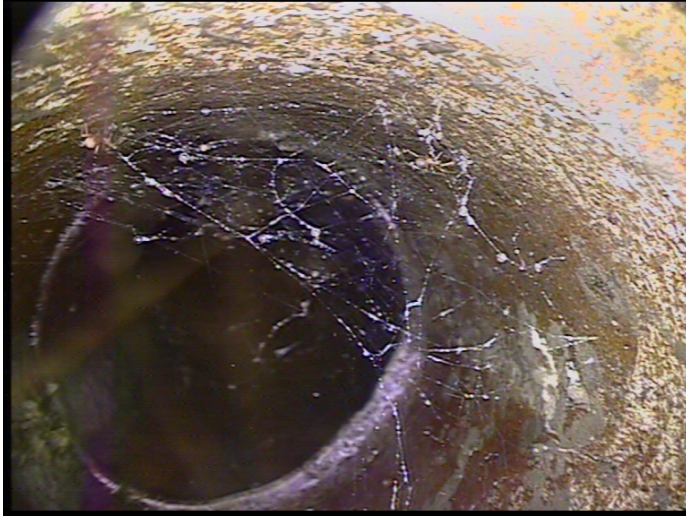
Code:	TF
Description:	Tap Factory
Distance (ft):	29.4
Structural Grade:	0
O&M Grade:	0
Clock Start/From:	10
Clock To:	
1st Value:	4.000
2nd Value:	
Value Percent:	
Continuous Index:	
Within 8" of Joint:	NO
Remarks:

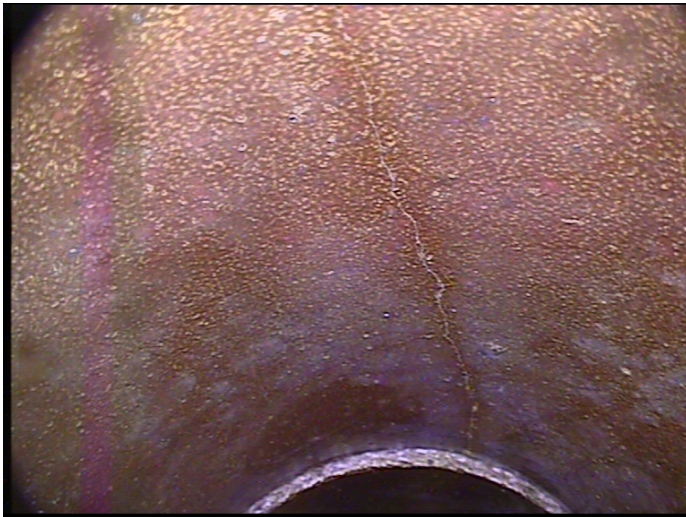
Code:	CL
Description:	Crack Longitudinal
Distance (ft):	66.7
Structural Grade:	2
O&M Grade:	0
Clock Start/From:	12
Clock To:	
1st Value:	
2nd Value:	
Value Percent:	
Continuous Index:	
Within 8" of Joint:	YES
Remarks:

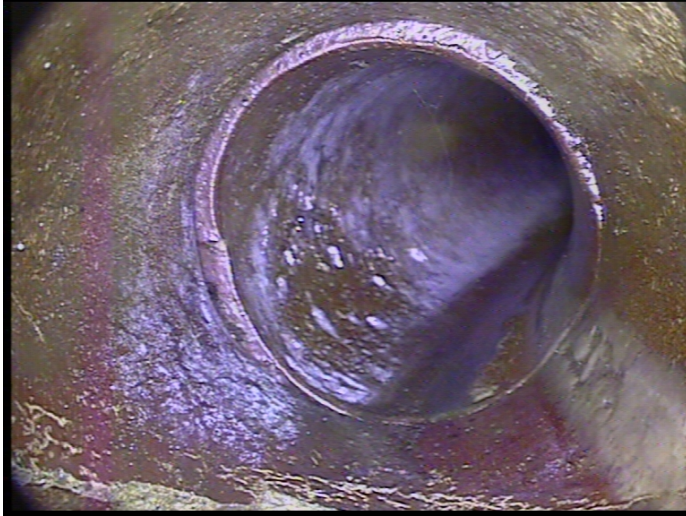
Code: **TF**
Description: **Tap Factory**

Distance (ft): **68.7**
Structural Grade: **0**
O&M Grade: **0**
Clock Start/From: **3**
Clock To:
1st Value: **4.000**
2nd Value:
Value Percent:
Continuous Index:
Within 8" of Joint: **NO**
Remarks:

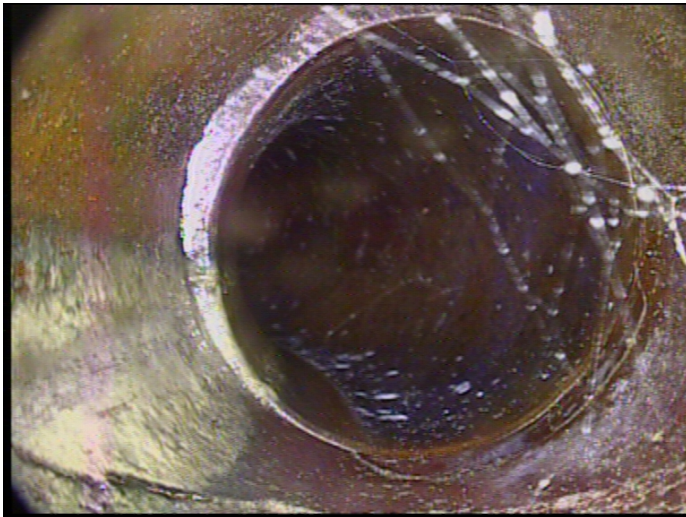
Code: **TF**
Description: **Tap Factory**

Distance (ft): **71.0**
Structural Grade: **0**
O&M Grade: **0**
Clock Start/From: **10**
Clock To:
1st Value: **4.000**
2nd Value:
Value Percent:
Continuous Index:
Within 8" of Joint: **NO**
Remarks:

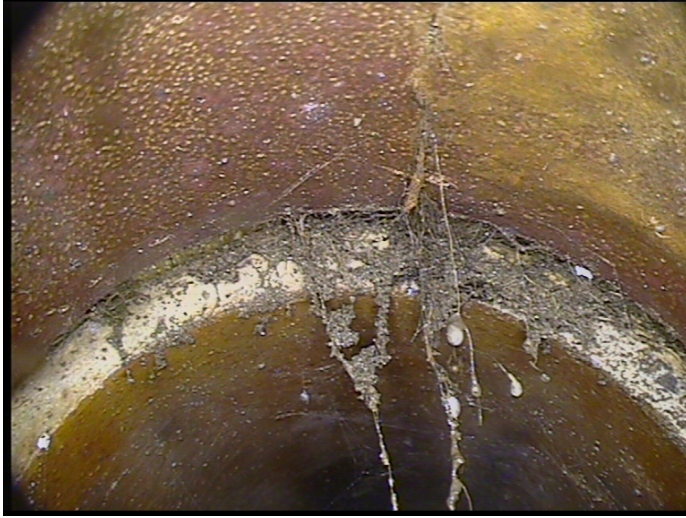
Code: **RFJ**
Description: **Roots Fine Joint**

Distance (ft): **73.2**
Structural Grade: **0**
O&M Grade: **1**
Clock Start/From: **11**
Clock To: **1**
1st Value:
2nd Value:
Value Percent:
Continuous Index:
Within 8" of Joint: **YES**
Remarks:

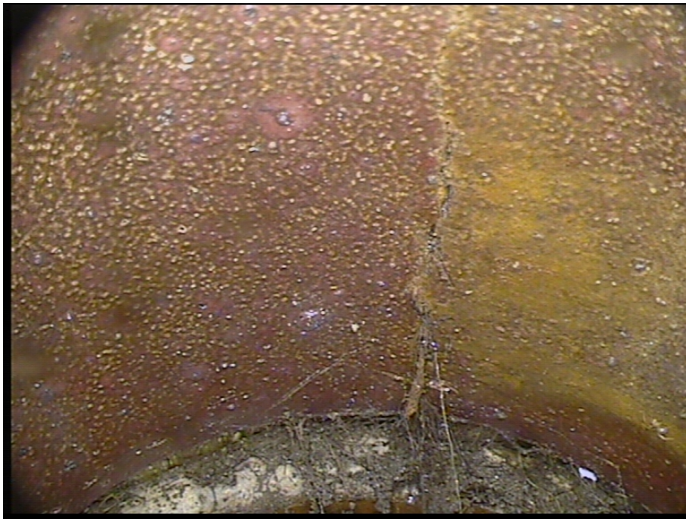
Code: **CL**
Description: **Crack Longitudinal**

Distance (ft): **73.2**
Structural Grade: **2**
O&M Grade: **0**
Clock Start/From: **12**
Clock To:
1st Value:
2nd Value:
Value Percent:
Continuous Index:
Within 8" of Joint: **YES**
Remarks:

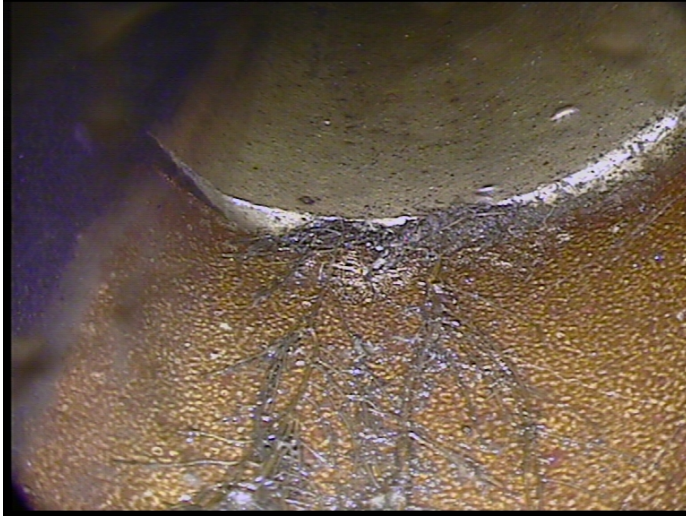
Code: **RFJ**
Description: **Roots Fine Joint**

Distance (ft): **77.3**
Structural Grade: **0**
O&M Grade: **1**
Clock Start/From: **3**
Clock To: **5**
1st Value:
2nd Value:
Value Percent:
Continuous Index: **S01**
Within 8" of Joint: **YES**
Remarks:

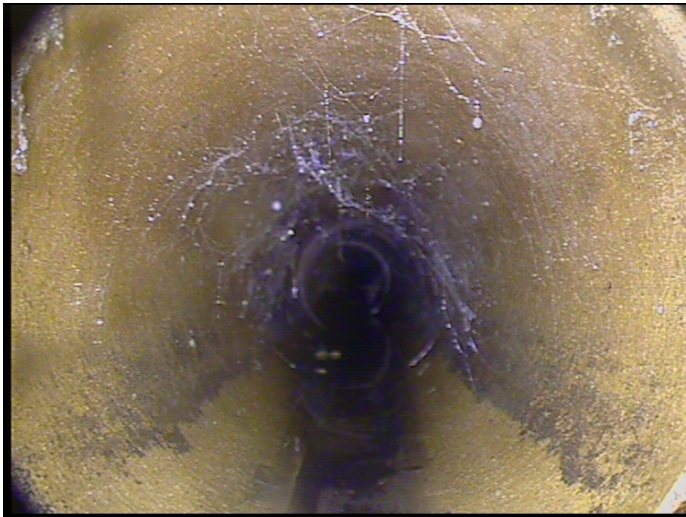
Code: **RFJ**
Description: **Roots Fine Joint**

Distance (ft): **100.7**
Structural Grade: **0**
O&M Grade: **1**
Clock Start/From: **3**
Clock To: **5**
1st Value:
2nd Value:
Value Percent:
Continuous Index: **F01**
Within 8" of Joint: **YES**
Remarks:

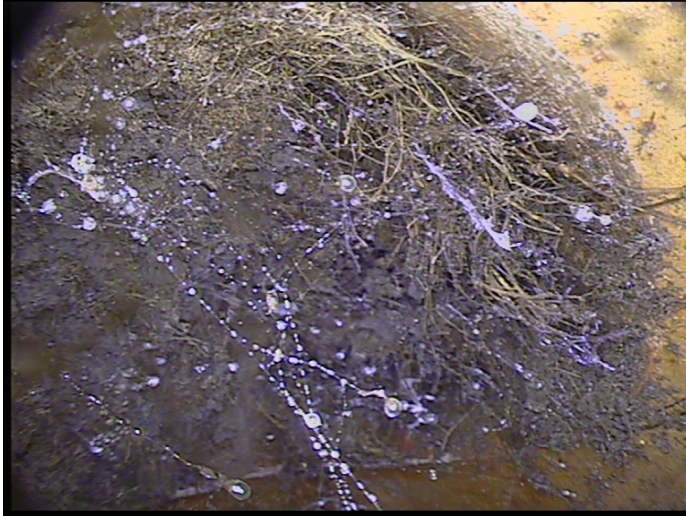
Code:	TFD
Description:	Tap Factory Defective
Distance (ft):	104.0
Structural Grade:	0
O&M Grade:	2
Clock Start/From:	3
Clock To:	
1st Value:	4.000
2nd Value:	
Value Percent:	
Continuous Index:	
Within 8" of Joint:	NO
Remarks:	roots

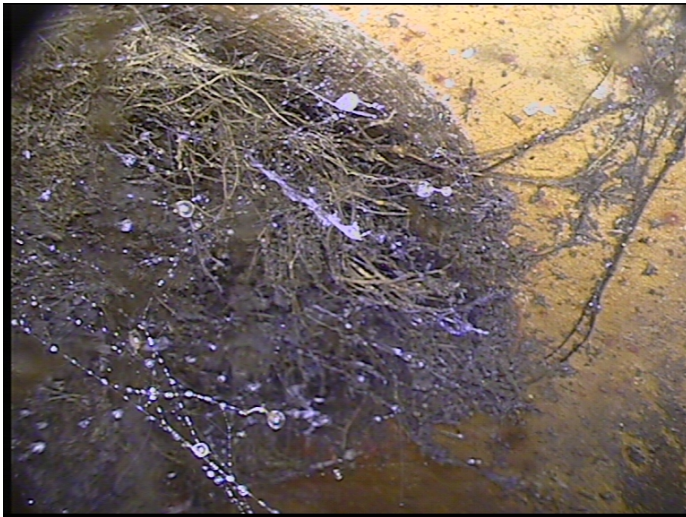
Code:	RFL
Description:	Roots Fine Lateral
Distance (ft):	104.0
Structural Grade:	0
O&M Grade:	1
Clock Start/From:	3
Clock To:	
1st Value:	
2nd Value:	
Value Percent:	
Continuous Index:	
Within 8" of Joint:	NO
Remarks:

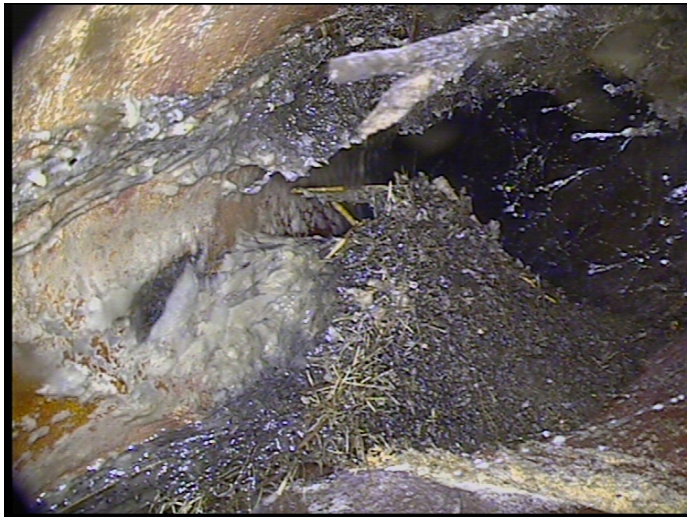
Code: **TFD**
Description: **Tap Factory Defective**

Distance (ft): **106.6**
Structural Grade: **0**
O&M Grade: **2**
Clock Start/From: **10**
Clock To:
1st Value: **4.000**
2nd Value:
Value Percent:
Continuous Index:
Within 8" of Joint: **NO**
Remarks: **roots**

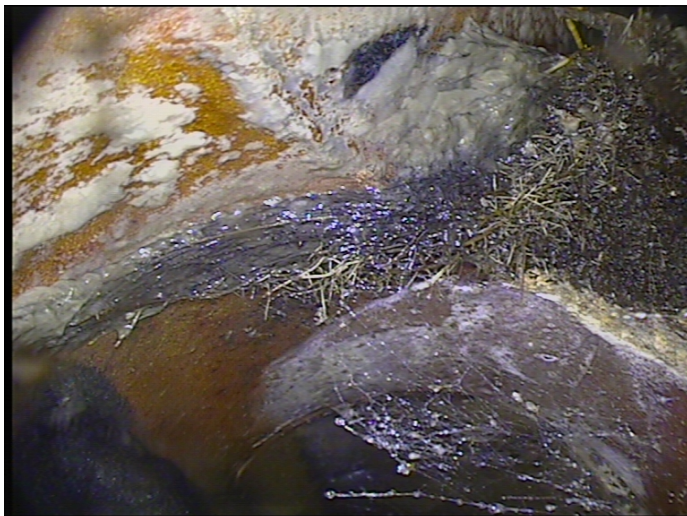
Code: **RFL**
Description: **Roots Fine Lateral**

Distance (ft): **106.6**
Structural Grade: **0**
O&M Grade: **1**
Clock Start/From: **9**
Clock To:
1st Value:
2nd Value:
Value Percent:
Continuous Index:
Within 8" of Joint: **NO**
Remarks:

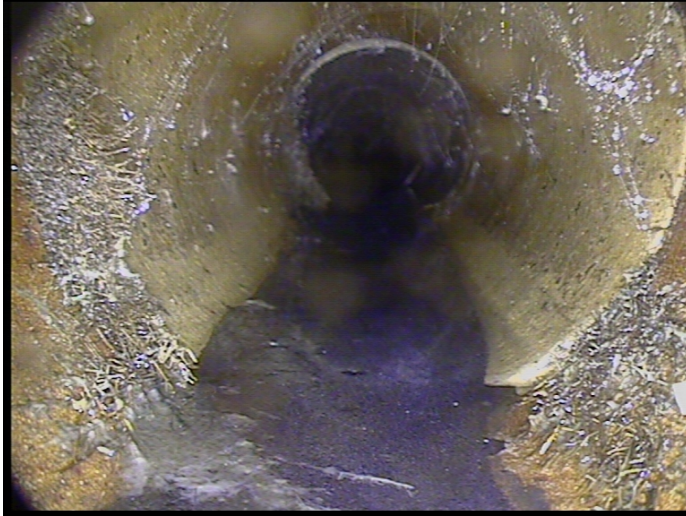
Code: **RMJ**
Description: **Roots Medium Joint**

Distance (ft): **110.8**
Structural Grade: **0**
O&M Grade: **3**
Clock Start/From: **7**
Clock To: **5**
1st Value:
2nd Value:
Value Percent: **5.000**
Continuous Index: **S02**
Within 8" of Joint: **YES**
Remarks:

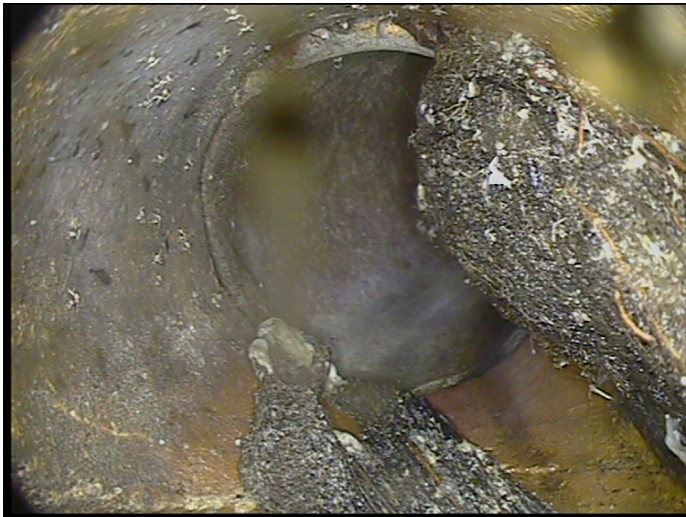
Code: **TFD**
Description: **Tap Factory Defective**

Distance (ft): **152.0**
Structural Grade: **0**
O&M Grade: **2**
Clock Start/From: **2**
Clock To:
1st Value: **4.000**
2nd Value:
Value Percent:
Continuous Index:
Within 8" of Joint: **NO**
Remarks: **roots**

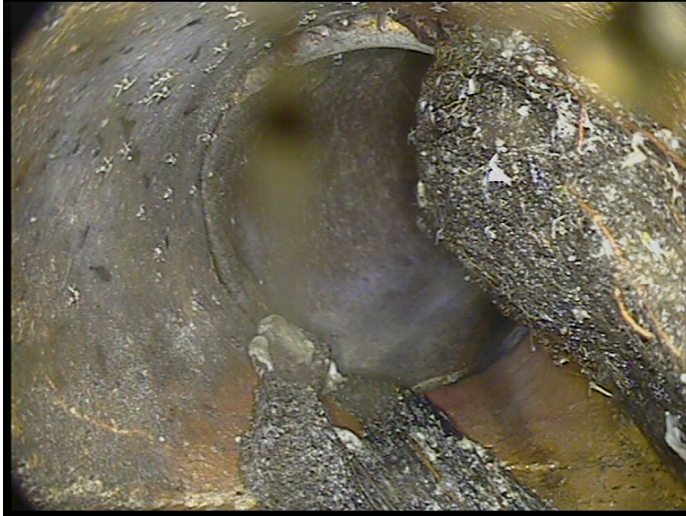
Code: **RML**
Description: **Roots Medium Lateral**

Distance (ft): **152.0**
Structural Grade: **0**
O&M Grade: **3**
Clock Start/From: **3**
Clock To: **4**
1st Value:
2nd Value:
Value Percent: **5.000**
Continuous Index:
Within 8" of Joint: **NO**
Remarks:

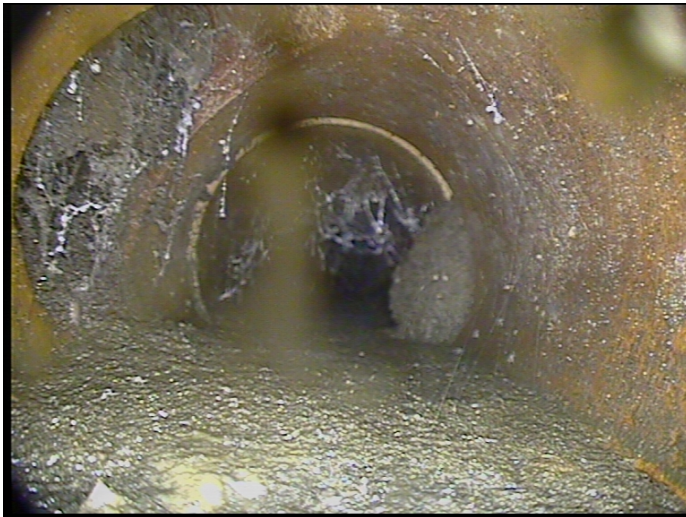
Code: **DSF**
Description: **Deposits Settled Fine**

Distance (ft): **152.6**
Structural Grade: **0**
O&M Grade: **3**
Clock Start/From: **4**
Clock To: **8**
1st Value:
2nd Value:
Value Percent: **20.000**
Continuous Index: **S03**
Within 8" of Joint: **YES**
Remarks:

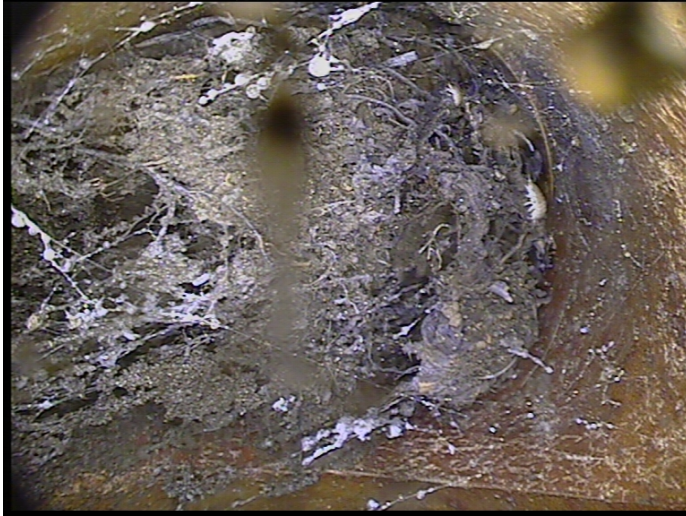
Code:	TFD
Description:	Tap Factory Defective
Distance (ft):	153.5
Structural Grade:	0
O&M Grade:	2
Clock Start/From:	9
Clock To:	
1st Value:	4.000
2nd Value:	
Value Percent:	
Continuous Index:	
Within 8" of Joint:	NO
Remarks:	roots

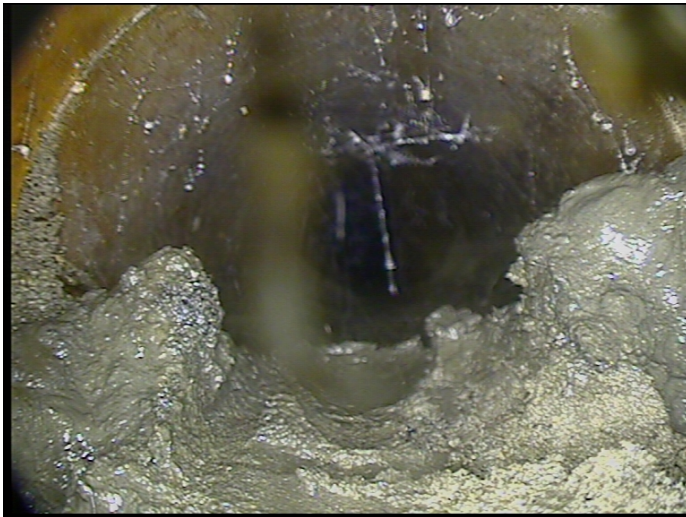
Code:	RMJ
Description:	Roots Medium Joint
Distance (ft):	157.1
Structural Grade:	0
O&M Grade:	3
Clock Start/From:	7
Clock To:	5
1st Value:	
2nd Value:	
Value Percent:	5.000
Continuous Index:	F02
Within 8" of Joint:	YES
Remarks:

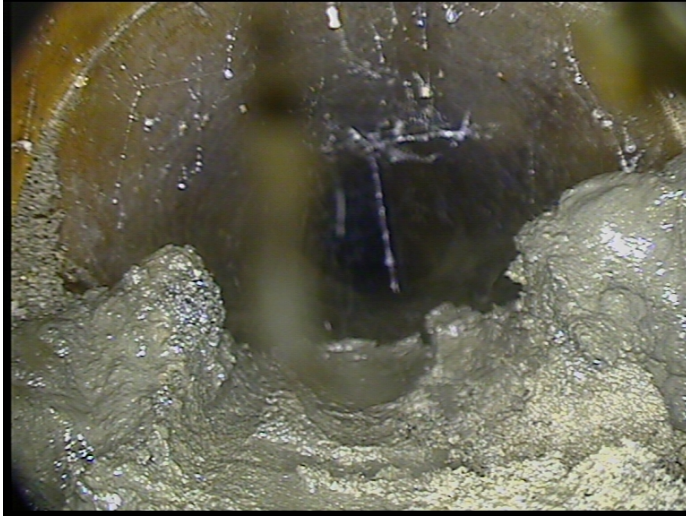
Code: **DSF**
Description: **Deposits Settled Fine**

Distance (ft): **157.1**
Structural Grade: **0**
O&M Grade: **3**
Clock Start/From: **4**
Clock To: **8**
1st Value:
2nd Value:
Value Percent: **20.000**
Continuous Index: **F03**
Within 8" of Joint: **NO**
Remarks:

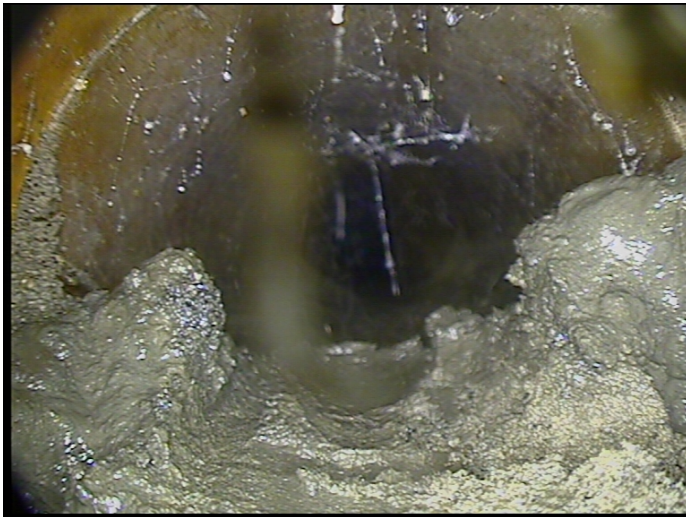
Code: **MSA**
Description: **Abandoned Survey**

Distance (ft): **157.1**
Structural Grade: **0**
O&M Grade: **0**
Clock Start/From:
Clock To:
1st Value:
2nd Value:
Value Percent:
Continuous Index:
Within 8" of Joint: **NO**
Remarks: **deep sediment**
