Date: Pipe Length (ft)	10/21/2021):	Weather: Owner:	Hobart, IN	Coding: Pre Clean:	PACP 6.0 Not Known
P.O.#:	945_1	Surveyor:	M. Pielacha	PSR:	P-706-008.9-001
Customer:	Hobart, IN	Clean Date:		Shape:	С
Street:	10th Street		Flow Control:		
City:	Hobart, IN		Year Renewed:		
Location:	Light Highway		Tape/Media #:	945	
Purpose:	Routine Assessment		Dia/Height:	6"	
Use:	Sanitary		Material:	VCP	
Drain Area:			Lining:		
Category:	NA				
Comment:					
Location Detail	s:		Direction of Survey	/: Downstream	
US MH:	M-706-8.9	DS MH:	M-706-8.9	Total Length Surveyed (ft): 5.2
)&M Index:	4.00	O&M Quick:	4100	O&M Rating:	4.00
tructural Index:	0.00	– Structural Qı	uick· 0000	Structural Rating:	0.00

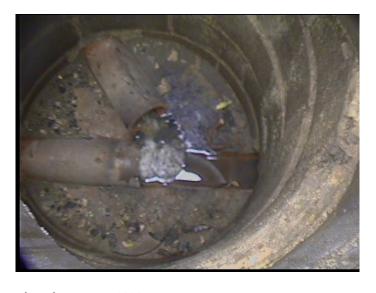
Code: Description:	AMH Manhole		
Distance (ft):	.0		
Structural Grade:	0		
O&M Grade:	0		
Clock Start/From:			
Clock To:			
1st Value:			
2nd Value:			
Value Percent:			
Continuous Index:			
Within 8" of Joint:	NO		
Remarks:	M-706-8.9

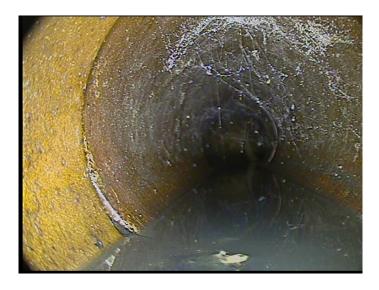
Code: MWL

Description: Water Level

Distance (ft): .0
Structural Grade: 0
O&M Grade: 0

Value Percent: 5.000

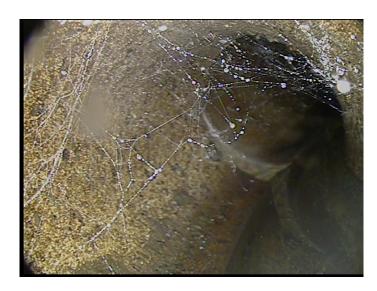
Code: LR

Description: Alignment Right

Distance (ft): 3.4
Structural Grade: 0

O&M Grade: 4

Value Percent: 40.000

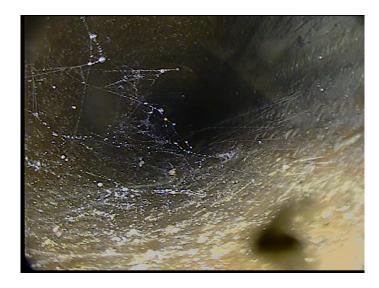
Code: MSA

Description: Abandoned Survey

Distance (ft): 5.2
Structural Grade: 0
O&M Grade: 0

Remarks: Can not make bend
