Profile/Photo Observation Report

Street:	Lincoln Street	Flow Control:	
City:	Hobart, IN	Year Renewed:	
Location:	Light Highway	Tape/Media #:	794
Purpose:	Reversal	Dia/Height:	8"
Use:	Sanitary	Material:	PVC
Drain Area:		Lining:	
Category:	NA		
Comment:

Location Details:	Direction of Survey:	Downstream
US MH: M-706-9.1	DS MH: M-706-24	Total Length Surveyed (ft): 96.9

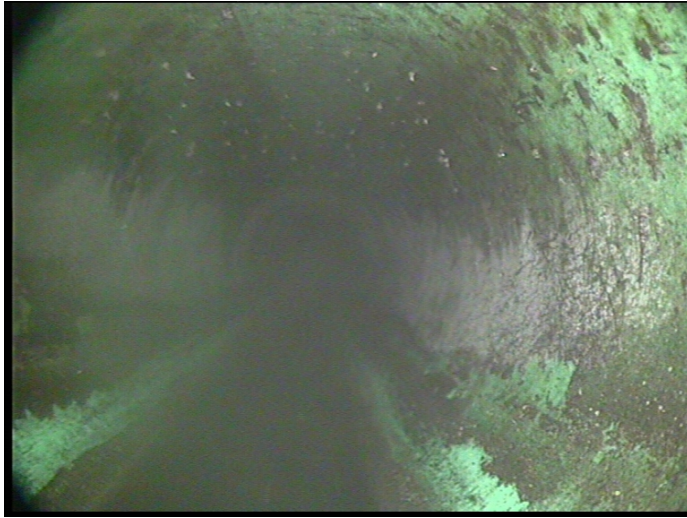
Code:	MWL
Description:	Water Level
Distance (ft):	.0
Structural Grade:	0
O&M Grade:	0
Clock Start/From:	
Clock To:	
1st Value:	
2nd Value:	
Value Percent:	5.000
Continuous Index:	
Within 8" of Joint:	NO
Remarks:

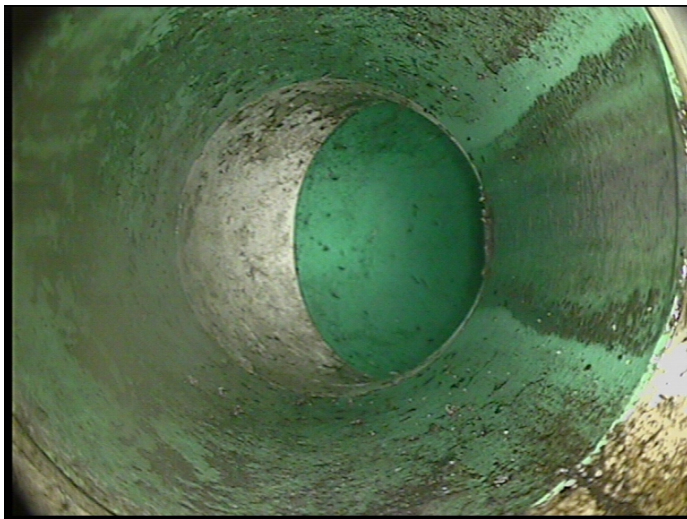
Code:	TF
Description:	Tap Factory
Distance (ft):	40.0
Structural Grade:	0
O&M Grade:	0
Clock Start/From:	2
Clock To:	
1st Value:	4.000
2nd Value:	
Value Percent:	
Continuous Index:	
Within 8" of Joint:	NO
Remarks:

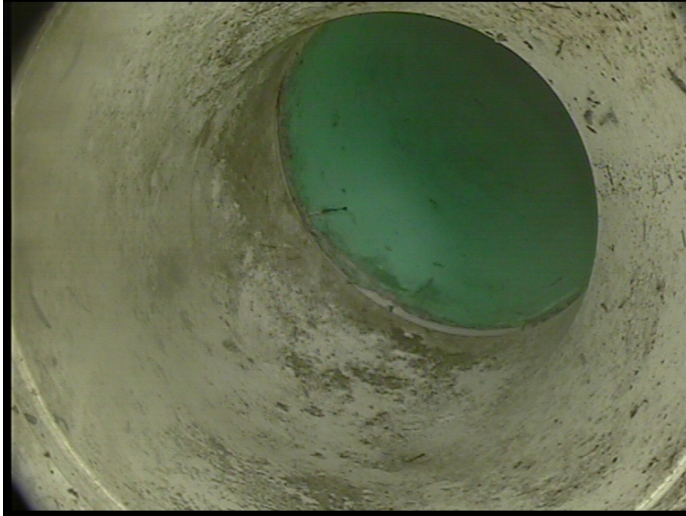
Code: **TF**
Description: **Tap Factory**

Distance (ft): **69.3**
Structural Grade: **0**
O&M Grade: **0**
Clock Start/From: **2**
Clock To:
1st Value: **4.000**
2nd Value:
Value Percent:
Continuous Index:
Within 8" of Joint: **NO**
Remarks:

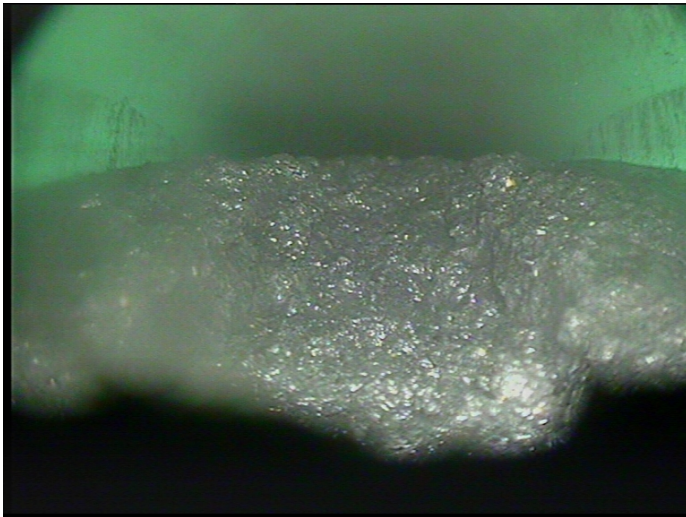
Code: **DSF**
Description: **Deposits Settled Fine**

Distance (ft): **83.2**
Structural Grade: **0**
O&M Grade: **4**
Clock Start/From: **4**
Clock To: **8**
1st Value:
2nd Value:
Value Percent: **25.000**
Continuous Index: **S01**
Within 8" of Joint: **YES**
Remarks:

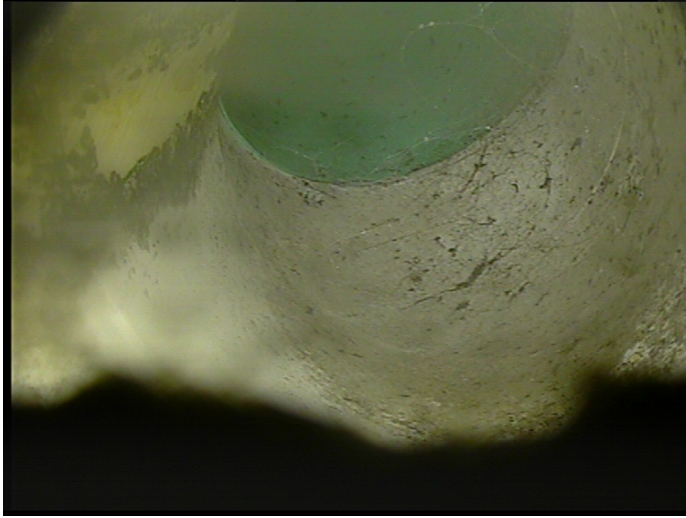
Code:	TF
Description:	Tap Factory
Distance (ft):	92.2
Structural Grade:	0
O&M Grade:	0
Clock Start/From:	10
Clock To:	
1st Value:	4.000
2nd Value:	
Value Percent:	
Continuous Index:	
Within 8" of Joint:	NO
Remarks:

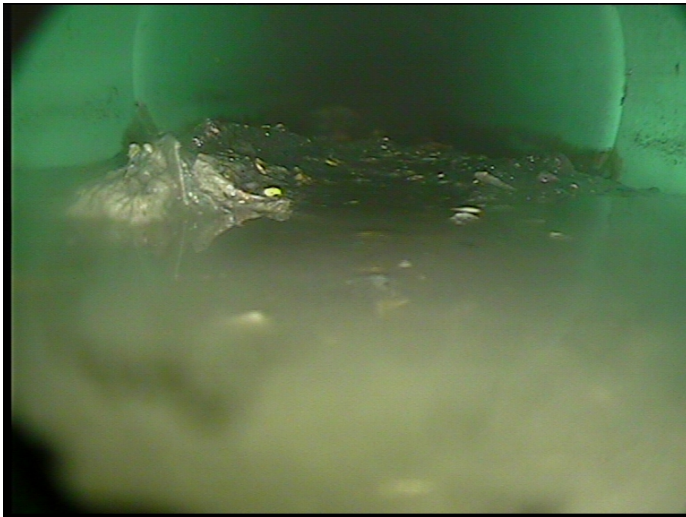
Code:	DSF
Description:	Deposits Settled Fine
Distance (ft):	96.9
Structural Grade:	0
O&M Grade:	4
Clock Start/From:	4
Clock To:	8
1st Value:	
2nd Value:	
Value Percent:	25.000
Continuous Index:	F01
Within 8" of Joint:	NO
Remarks:

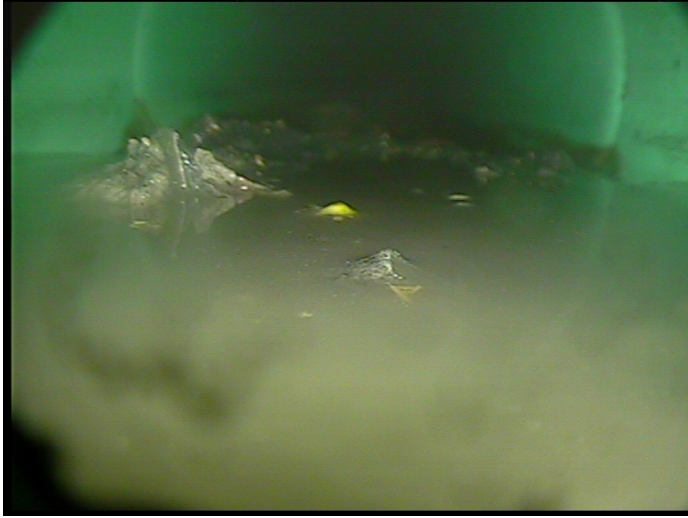
Code:	MSA
Description:	Abandoned Survey
Distance (ft):	96.9
Structural Grade:	0
O&M Grade:	0
Clock Start/From:	
Clock To:	
1st Value:	
2nd Value:	
Value Percent:	
Continuous Index:	
Within 8" of Joint:	NO
Remarks:	deep sediment
