Profile/Photo Observation Report

Date:	05/01/2018	Weather:		Coding:	PACP 6.0
Pipe Length (ft):		Owner:	City of Hobart	Pre Clean:	Not Known
P.O.#:	276	Surveyor:	B. Helbling	PSR:	P-706-010.1-010
Customer:	City of Hobart	Clean Date:		Shape:	C

Street:	State Street	Flow Control:	Not Controlled
City:	Hobart, IN	Year Renewed:	
Location:	Sidewalk	Tape/Media #:	DEP276
Purpose:	Routine Assessment	Dia/Height:	12"
Use:	Sanitary	Material:	VCP
Drain Area:		Lining:	
Category:	NA		
Comment:	5-21-2018

Location Details:		Direction of Survey:	Downstream
US MH:	M-706-010	DS MH:	M-706-010.1
		Total Length Surveyed (ft):	63.8

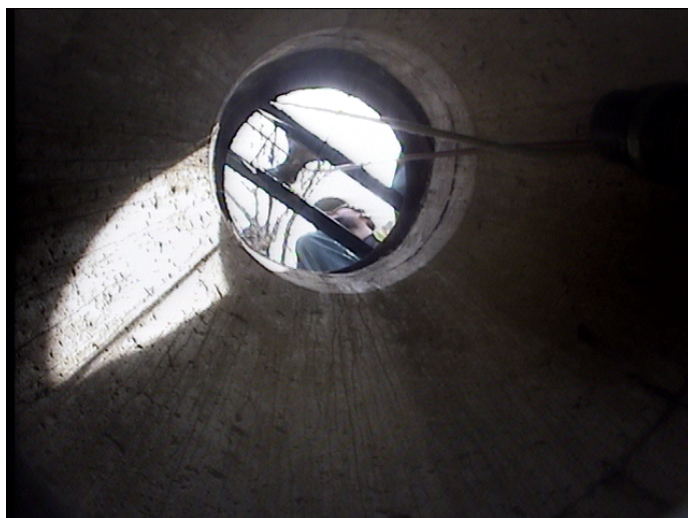
Code: **AMH**
Description: **Manhole**

Distance (ft): **.0**
Structural Grade: **0**
O&M Grade: **0**
Clock Start/From:
Clock To:
1st Value:
2nd Value:
Value Percent:
Continuous Index:
Within 8" of Joint: **NO**
Remarks: **M-706-010.1**

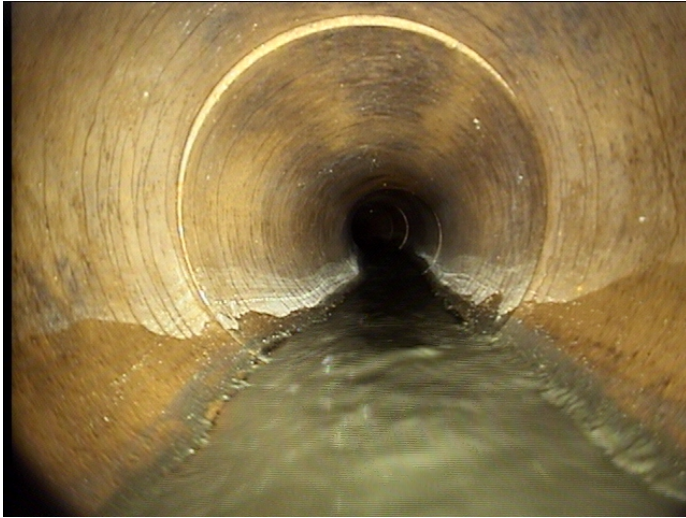
Code: **MWL**
Description: **Water Level**

Distance (ft): **.0**
Structural Grade: **0**
O&M Grade: **0**
Clock Start/From:
Clock To:
1st Value:
2nd Value:
Value Percent: **5.000**
Continuous Index:
Within 8" of Joint: **NO**
Remarks:

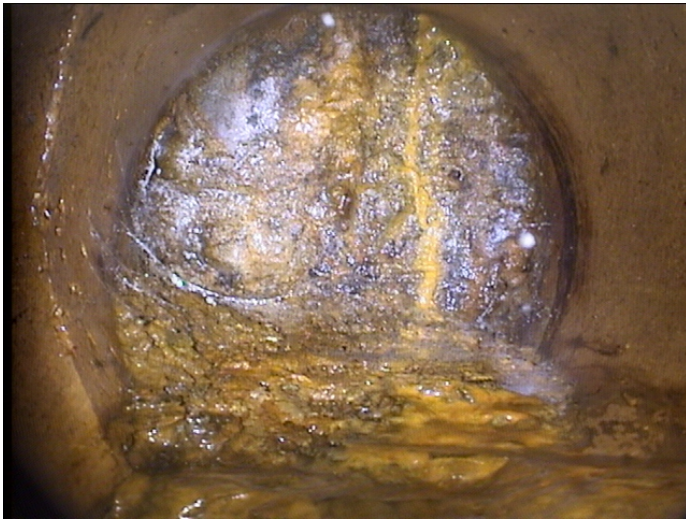
Code: **TFC**
Description: **Tap Factory Capped**

Distance (ft): **12.0**
Structural Grade: **0**
O&M Grade: **0**
Clock Start/From: **9**
Clock To:
1st Value: **6.000**
2nd Value:
Value Percent:
Continuous Index:
Within 8" of Joint: **NO**
Remarks:

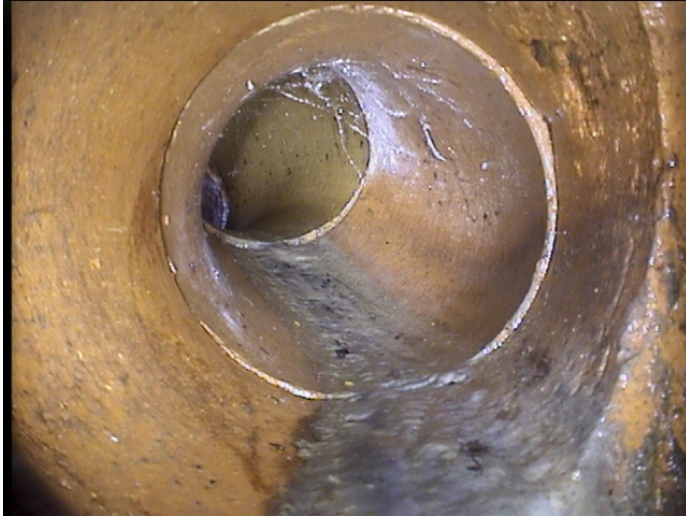
Code: **TF**
Description: **Tap Factory**

Distance (ft): **19.6**
Structural Grade: **0**
O&M Grade: **0**
Clock Start/From: **2**
Clock To:
1st Value: **6.000**
2nd Value:
Value Percent:
Continuous Index:
Within 8" of Joint: **NO**
Remarks:

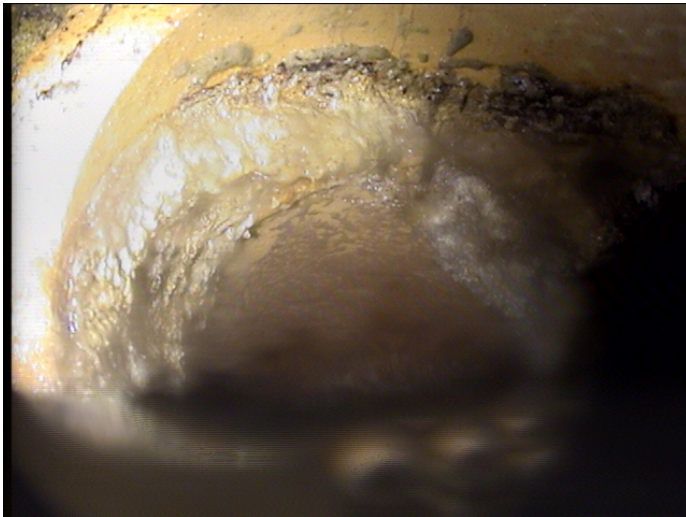
Code: **TB**
Description: **Tap Break-in**

Distance (ft): **61.6**
Structural Grade: **0**
O&M Grade: **0**
Clock Start/From: **10**
Clock To:
1st Value: **6.000**
2nd Value:
Value Percent:
Continuous Index:
Within 8" of Joint: **NO**
Remarks:
