## Profile/Photo Observation Report

Date:	<b>05/01/2018</b>	Weather:		Coding:	<b>PACP 6.0</b>
Pipe Length (ft):		Owner:	<b>City of Hobart</b>	Pre Clean:	<b>Not Known</b>
P.O.#:	<b>277</b>	Surveyor:	<b>B. Helbling</b>	PSR:	<b>P-706-010.1-010</b>
Customer:	<b>City of Hobart</b>	Clean Date:		Shape:	<b>C</b>

Location Details:		Direction of Survey:	<b>Upstream</b>
US MH:	<b>M-706-010.1</b>	DS MH:	<b>M-706-010</b>
		Total Length Surveyed (ft):	<b>135.1</b>

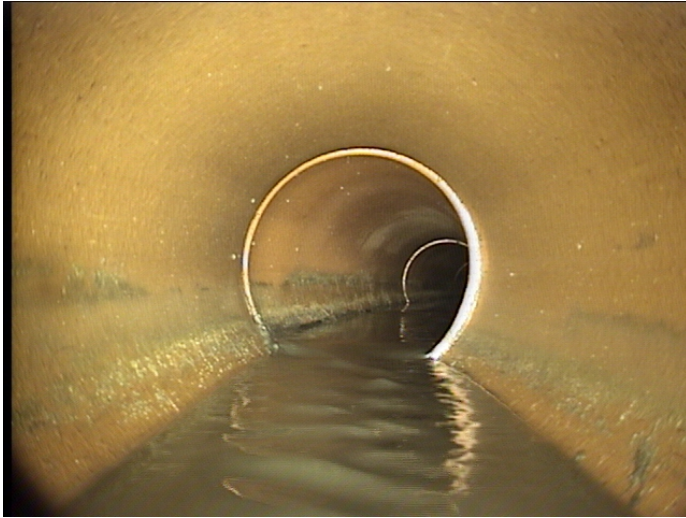
Code:	AMH
Description:	Manhole
Distance (ft):	.0
Structural Grade:	0
O&M Grade:	0
Clock Start/From:	
Clock To:	
1st Value:	
2nd Value:	
Value Percent:	
Continuous Index:	
Within 8" of Joint:	NO
Remarks:	M-706-010

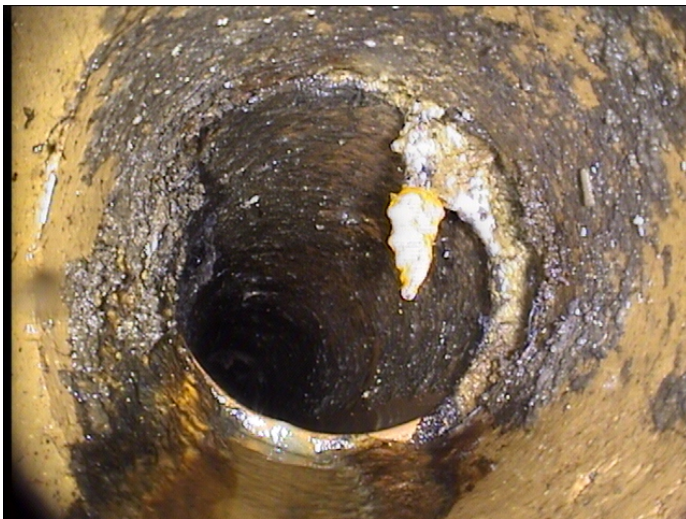
Code:	<b>MWL</b>
Description:	<b>Water Level</b>
Distance (ft):	<b>.0</b>
Structural Grade:	<b>0</b>
O&M Grade:	<b>0</b>
Clock Start/From:	
Clock To:	
1st Value:	
2nd Value:	
Value Percent:	<b>10.000</b>
Continuous Index:	
Within 8" of Joint:	<b>NO</b>
Remarks:

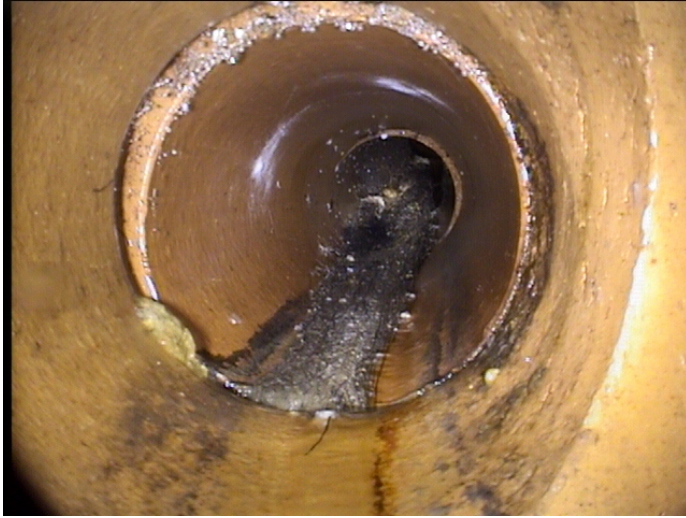
Code:	<b>TF</b>
Description:	<b>Tap Factory</b>
Distance (ft):	<b>66.9</b>
Structural Grade:	<b>0</b>
O&M Grade:	<b>0</b>
Clock Start/From:	<b>2</b>
Clock To:	
1st Value:	<b>4.000</b>
2nd Value:	
Value Percent:	
Continuous Index:	
Within 8" of Joint:	<b>NO</b>
Remarks:

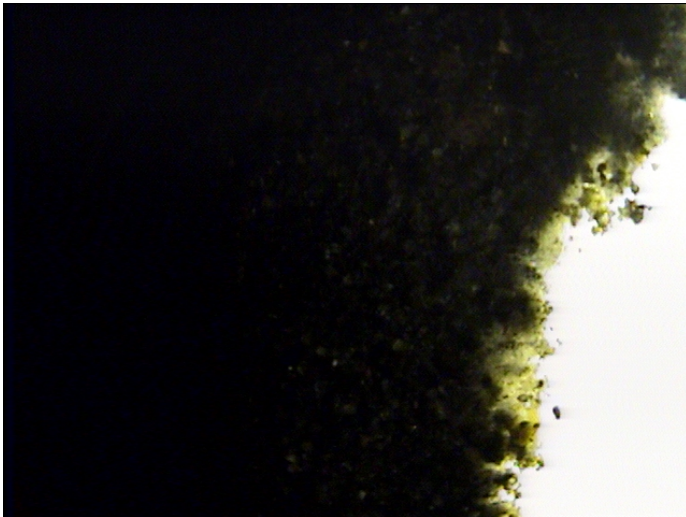
Code: **TFD**  
Description: **Tap Factory Defective**

Distance (ft): **105.3**  
Structural Grade: **0**  
O&M Grade: **2**  
Clock Start/From: **10**  
Clock To:  
1st Value: **4.000**  
2nd Value:  
Value Percent:  
Continuous Index:  
Within 8" of Joint: **NO**  
Remarks: **Defective**

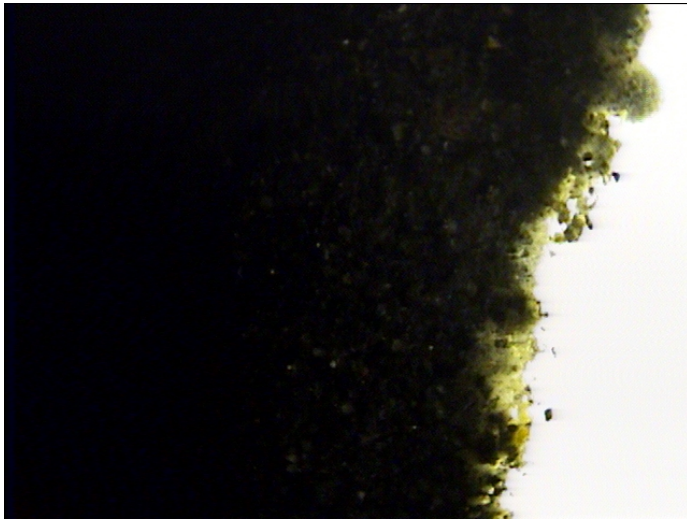
Code: **DSF**  
Description: **Deposits Settled Fine**

Distance (ft): **135.1**  
Structural Grade: **0**  
O&M Grade: **4**  
Clock Start/From: **4**  
Clock To: **8**  
1st Value:  
2nd Value:  
Value Percent: **30.000**  
Continuous Index:  
Within 8" of Joint: **NO**  
Remarks:

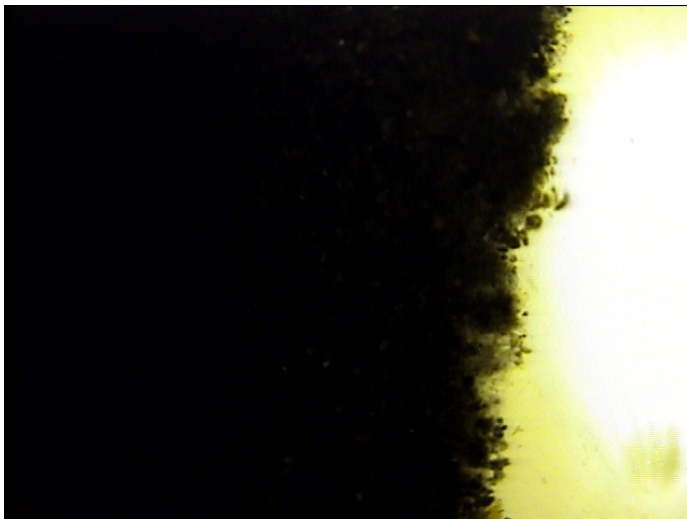
Code: **MSA**  
Description: **Abandoned Survey**

Distance (ft): **135.1**  
Structural Grade: **0**  
O&M Grade: **0**  
Clock Start/From:  
Clock To:  
1st Value:  
2nd Value:  
Value Percent:  
Continuous Index:  
Within 8" of Joint: **NO**  
Remarks: **Heavy sediment and flow over camera. Sag likely.**
