Profile/Photo Observation Report

Date:	04/20/2018	Weather:		Coding:	PACP 6.0
Pipe Length (ft):	228.4	Owner:	NA	Pre Clean:	Not Known
P.O.#:		Surveyor:	Byrd Fitzgerald	PSR:	P-706-010.2-010.1
Customer:		Clean Date:	01/01/1900	Shape:	C

Location Details:		Direction of Survey:	Downstream
US MH:	M-706-010.1	DS MH:	M-706-010.2
		Total Length Surveyed (ft):	116.3

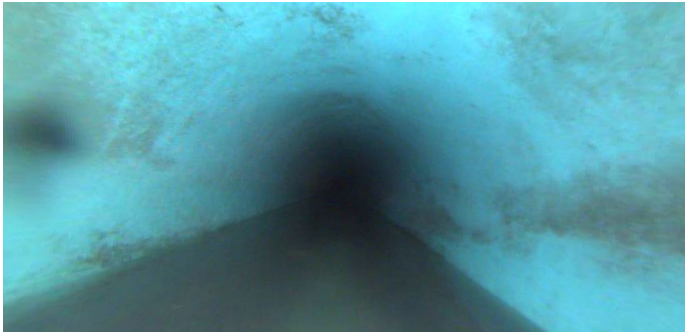
Code:	MWL
Description:	Water Level

Distance (ft):	.0
Structural Grade:	0
O&M Grade:	0
Clock Start/From:	
Clock To:	
1st Value:	
2nd Value:	
Value Percent:	5.000
Continuous Index:	
Within 8" of Joint:	NO
Remarks:

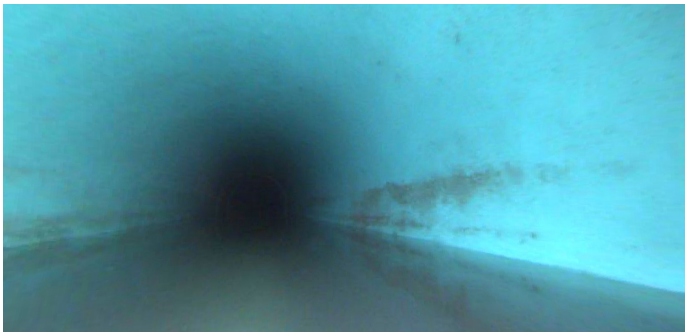
Code:	MWL
Description:	Water Level

Distance (ft):	6.6
Structural Grade:	0
O&M Grade:	0
Clock Start/From:	
Clock To:	
1st Value:	
2nd Value:	
Value Percent:	25.000
Continuous Index:	
Within 8" of Joint:	NO
Remarks:

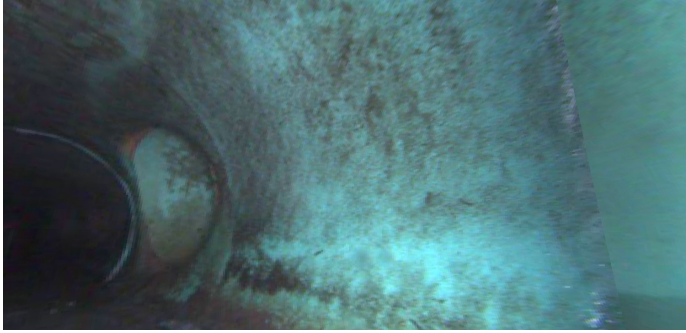
Code: **TF**
Description: **Tap Factory**

Distance (ft): **15.2**
Structural Grade: **0**
O&M Grade: **0**
Clock Start/From: **9**
Clock To:
1st Value: **4.000**
2nd Value:
Value Percent:
Continuous Index:
Within 8" of Joint: **YES**
Remarks:

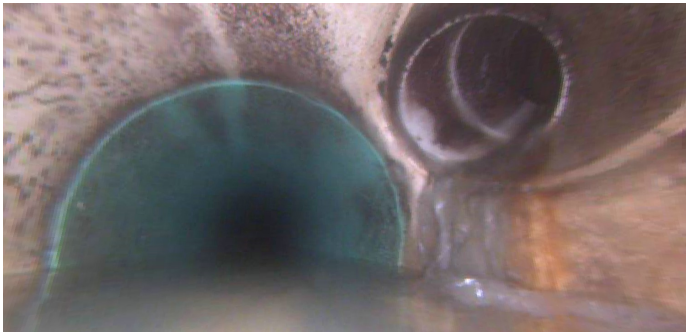
Code: **TF**
Description: **Tap Factory**

Distance (ft): **25.8**
Structural Grade: **0**
O&M Grade: **0**
Clock Start/From: **2**
Clock To:
1st Value: **4.000**
2nd Value:
Value Percent:
Continuous Index:
Within 8" of Joint: **YES**
Remarks:

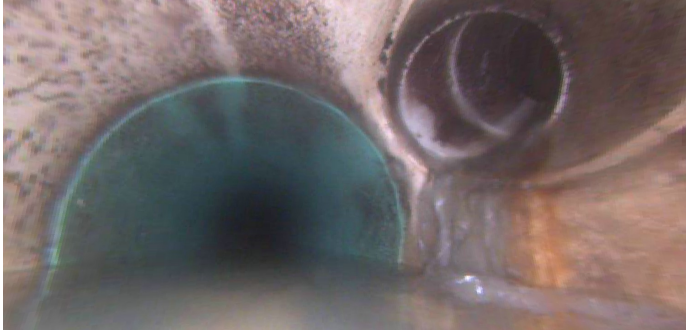
Code: **DAGS**
Description: **Deposits Attached Grease**

Distance (ft): **25.8**
Structural Grade: **0**
O&M Grade: **2**
Clock Start/From: **4**
Clock To:
1st Value:
2nd Value:
Value Percent: **5.000**
Continuous Index:
Within 8" of Joint: **NO**
Remarks:

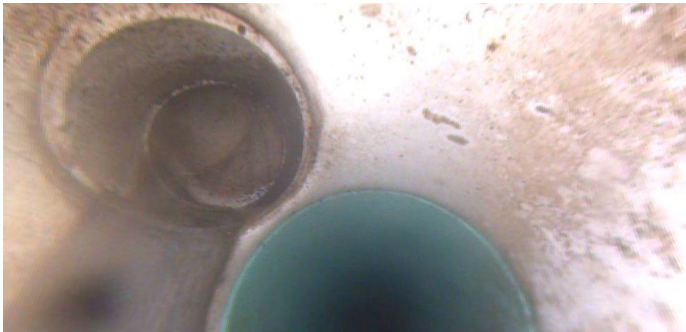
Code: **TF**
Description: **Tap Factory**

Distance (ft): **93.3**
Structural Grade: **0**
O&M Grade: **0**
Clock Start/From: **11**
Clock To:
1st Value: **4.000**
2nd Value:
Value Percent:
Continuous Index:
Within 8" of Joint: **YES**
Remarks:

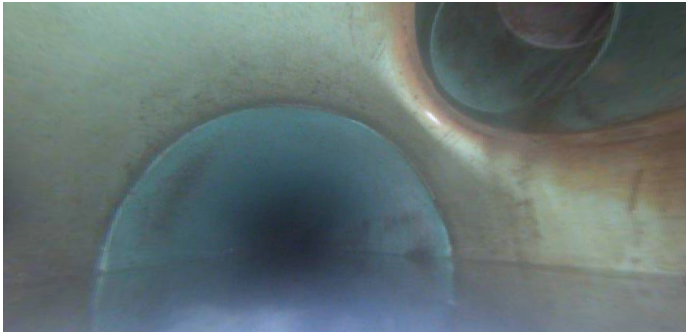
Code: **TF**
Description: **Tap Factory**

Distance (ft): **114.5**
Structural Grade: **0**
O&M Grade: **0**
Clock Start/From: **1**
Clock To:
1st Value: **4.000**
2nd Value:
Value Percent:
Continuous Index:
Within 8" of Joint: **YES**
Remarks:

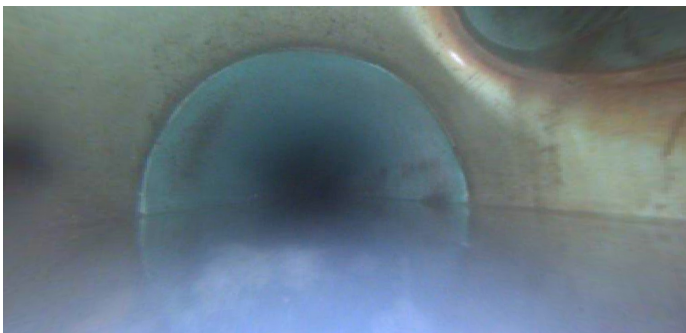
Code: **MWL**
Description: **Water Level**

Distance (ft): **114.5**
Structural Grade: **0**
O&M Grade: **0**
Clock Start/From:
Clock To:
1st Value:
2nd Value:
Value Percent: **40.000**
Continuous Index:
Within 8" of Joint: **NO**
Remarks:

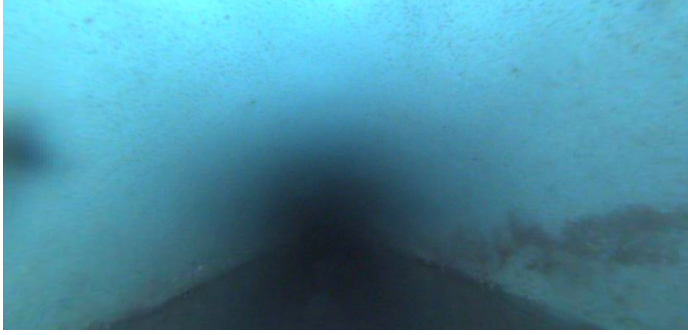
Code:	MSA
Description:	Abandoned Survey
Distance (ft):	116.3
Structural Grade:	0
O&M Grade:	0
Clock Start/From:	
Clock To:	
1st Value:	
2nd Value:	
Value Percent:	
Continuous Index:	
Within 8" of Joint:	NO
Remarks:	debris under water
