Profile/Photo Observation Report

Date:	04/20/2018	Weather:		Coding:	PACP 6.0
Pipe Length (ft):	228.4	Owner:	NA	Pre Clean:	Not Known
P.O.#:		Surveyor:	Jen Costello	PSR:	P-706-010.2-010.1
Customer:		Clean Date:	01/01/1900	Shape:	C

Location Details:		Direction of Survey:	Upstream
US MH:	M-706-010.1	DS MH:	M-706-010.2
		Total Length Surveyed (ft):	22.8

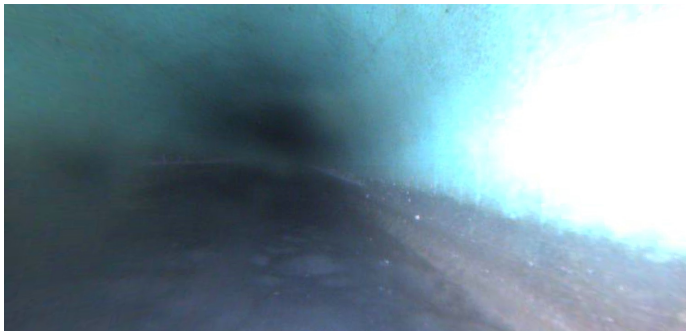
Code: **AMH**
Description: **Manhole**

Distance (ft): **.0**
Structural Grade: **0**
O&M Grade: **0**
Clock Start/From:
Clock To:
1st Value:
2nd Value:
Value Percent:
Continuous Index:
Within 8" of Joint: **NO**
Remarks: **M-706-010.2**

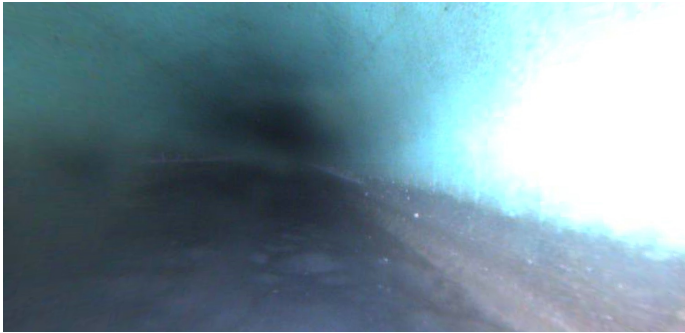
Code:	MWL
Description:	Water Level

Distance (ft):	.0
Structural Grade:	0
O&M Grade:	0
Clock Start/From:	
Clock To:	
1st Value:	
2nd Value:	
Value Percent:	10.000
Continuous Index:	
Within 8" of Joint:	NO
Remarks:

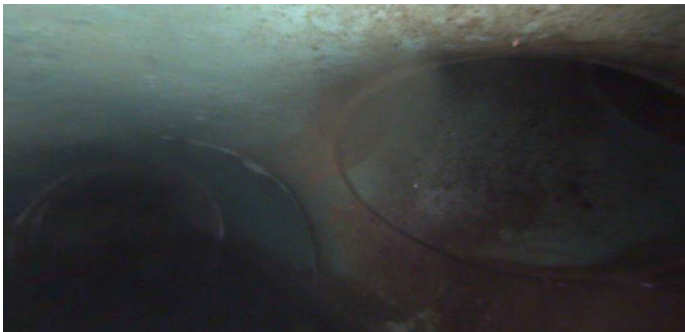
Code:	TF
Description:	Tap Factory

Distance (ft):	12.7
Structural Grade:	0
O&M Grade:	0
Clock Start/From:	3
Clock To:	
1st Value:	4.000
2nd Value:	
Value Percent:	
Continuous Index:	
Within 8" of Joint:	
Remarks:

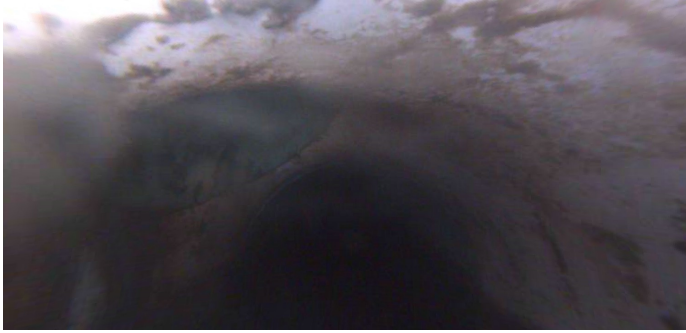
Code: **TF**
Description: **Tap Factory**

Distance (ft): **14.8**
Structural Grade: **0**
O&M Grade: **0**
Clock Start/From: **10**
Clock To:
1st Value: **4.000**
2nd Value:
Value Percent:
Continuous Index:
Within 8" of Joint:
Remarks:

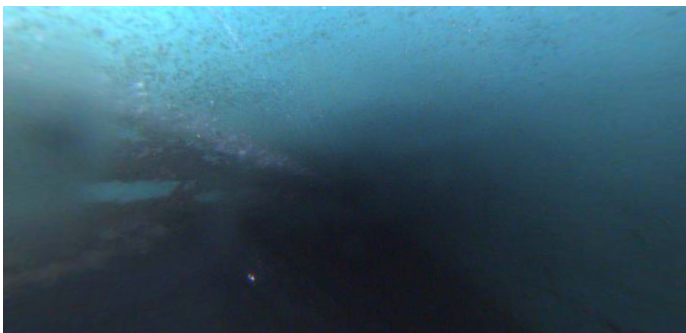
Code: **MSA**
Description: **Abandoned Survey**

Distance (ft): **22.8**
Structural Grade: **0**
O&M Grade: **0**
Clock Start/From:
Clock To:
1st Value:
2nd Value:
Value Percent:
Continuous Index:
Within 8" of Joint: **NO**
Remarks: **debris under water**
