## Profile/Photo Observation Report

Date:	<b>04/20/2018</b>	Weather:		Coding:	<b>PACP 6.0</b>
Pipe Length (ft):	<b>228.4</b>	Owner:	<b>NA</b>	Pre Clean:	<b>Not Known</b>
P.O.#:		Surveyor:	<b>Byrd Fitzgerald</b>	PSR:	<b>P-706-010.2-010.1</b>
Customer:		Clean Date:	<b>01/01/1900</b>	Shape:	<b>C</b>

Street:	<b>STATE ST</b>	Flow Control:	<b>Not Controlled</b>
City:	<b>Hobart, IN</b>	Year Renewed:	
Location:	<b>Easement/Right of Way</b>	Tape/Media #:	
Purpose:	<b>Maintenance Related</b>	Dia/Height:	<b>12"</b>
Use:	<b>Sanitary</b>	Material:	<b>PVC</b>
Drain Area:	<b>NA</b>	Lining:	<b>Cured in Place</b>
Category:	<b>NA</b>		
Comment:	<b>heavy silt at 115'.</b>

Location Details:		Direction of Survey:	<b>Downstream</b>
US MH:	<b>M-706-010.1</b>	DS MH:	<b>M-706-010.2</b>
		Total Length Surveyed (ft):	<b>116.3</b>

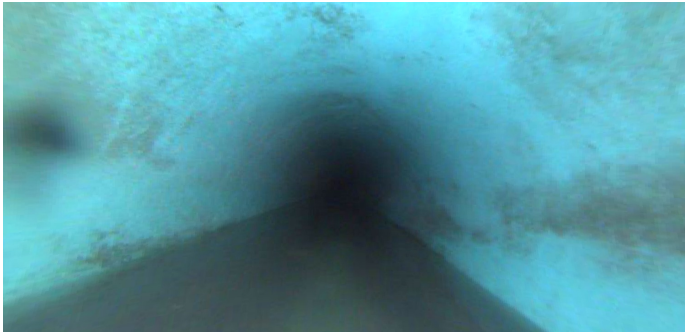
Code:	<b>MWL</b>
Description:	<b>Water Level</b>

Distance (ft):	<b>.0</b>
Structural Grade:	<b>0</b>
O&M Grade:	<b>0</b>
Clock Start/From:	
Clock To:	
1st Value:	
2nd Value:	
Value Percent:	<b>5.000</b>
Continuous Index:	
Within 8" of Joint:	<b>NO</b>
Remarks:

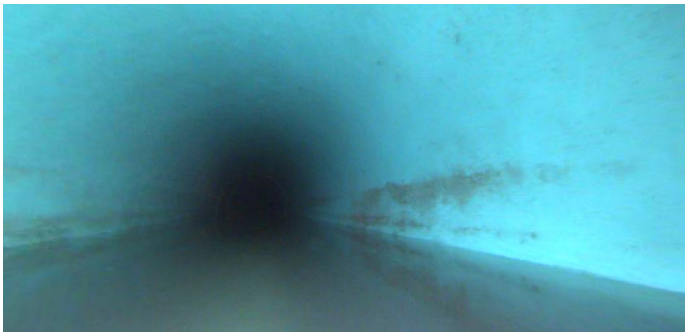
Code:	<b>MWL</b>
Description:	<b>Water Level</b>

Distance (ft):	<b>6.6</b>
Structural Grade:	<b>0</b>
O&M Grade:	<b>0</b>
Clock Start/From:	
Clock To:	
1st Value:	
2nd Value:	
Value Percent:	<b>25.000</b>
Continuous Index:	
Within 8" of Joint:	<b>NO</b>
Remarks:

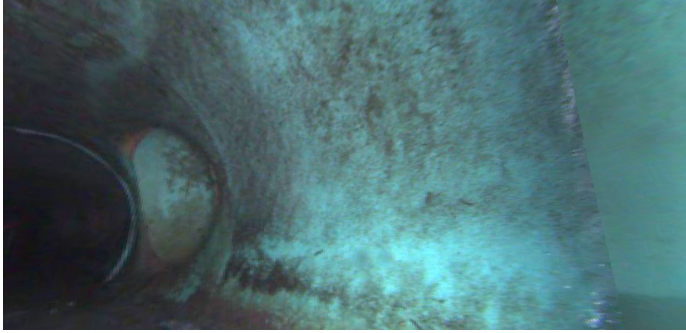
Code: **TF**  
Description: **Tap Factory**

Distance (ft): **15.2**  
Structural Grade: **0**  
O&M Grade: **0**  
Clock Start/From: **9**  
Clock To:  
1st Value: **4.000**  
2nd Value:  
Value Percent:  
Continuous Index:  
Within 8" of Joint: **YES**  
Remarks:

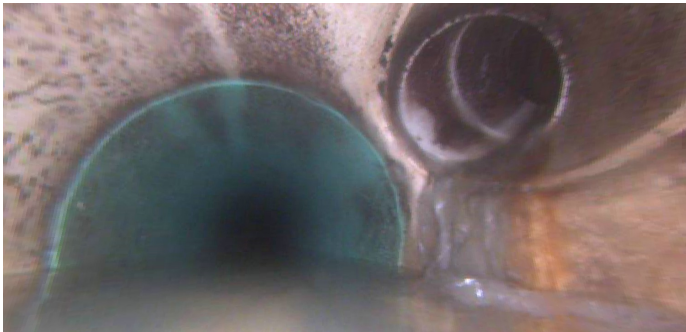
Code: **TF**  
Description: **Tap Factory**

Distance (ft): **25.8**  
Structural Grade: **0**  
O&M Grade: **0**  
Clock Start/From: **2**  
Clock To:  
1st Value: **4.000**  
2nd Value:  
Value Percent:  
Continuous Index:  
Within 8" of Joint: **YES**  
Remarks:

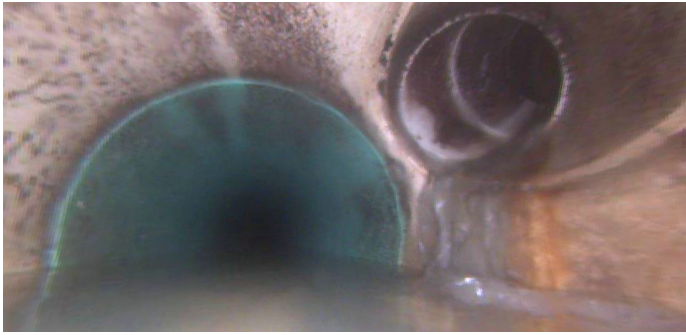
Code: **DAGS**  
Description: **Deposits Attached Grease**

Distance (ft): **25.8**  
Structural Grade: **0**  
O&M Grade: **2**  
Clock Start/From: **4**  
Clock To:  
1st Value:  
2nd Value:  
Value Percent: **5.000**  
Continuous Index:  
Within 8" of Joint: **NO**  
Remarks:

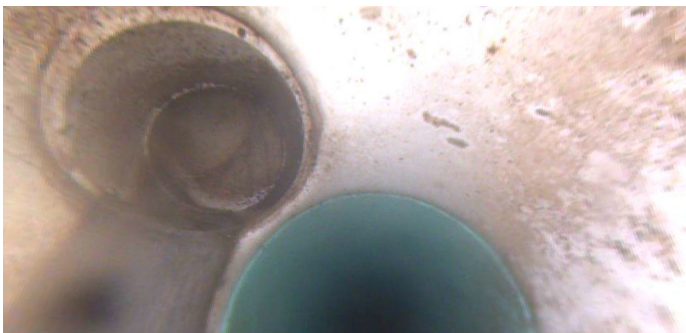
Code: **TF**  
Description: **Tap Factory**

Distance (ft): **93.3**  
Structural Grade: **0**  
O&M Grade: **0**  
Clock Start/From: **11**  
Clock To:  
1st Value: **4.000**  
2nd Value:  
Value Percent:  
Continuous Index:  
Within 8" of Joint: **YES**  
Remarks:

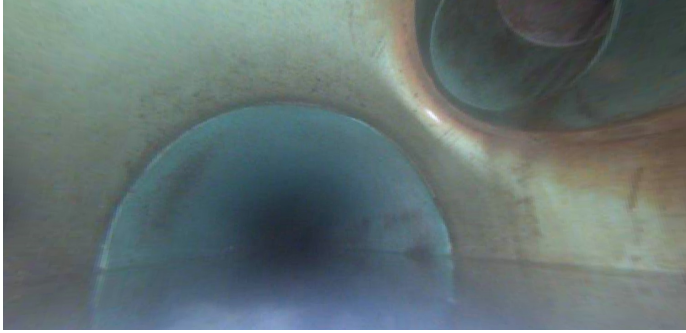
Code: **TF**  
Description: **Tap Factory**

Distance (ft): **114.5**  
Structural Grade: **0**  
O&M Grade: **0**  
Clock Start/From: **1**  
Clock To:  
1st Value: **4.000**  
2nd Value:  
Value Percent:  
Continuous Index:  
Within 8" of Joint: **YES**  
Remarks:

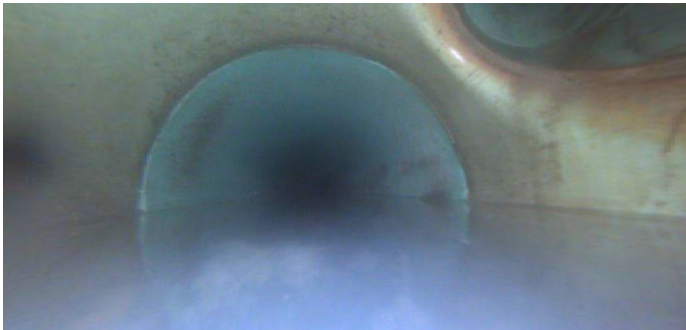
Code: **MWL**  
Description: **Water Level**

Distance (ft): **114.5**  
Structural Grade: **0**  
O&M Grade: **0**  
Clock Start/From:  
Clock To:  
1st Value:  
2nd Value:  
Value Percent: **40.000**  
Continuous Index:  
Within 8" of Joint: **NO**  
Remarks:

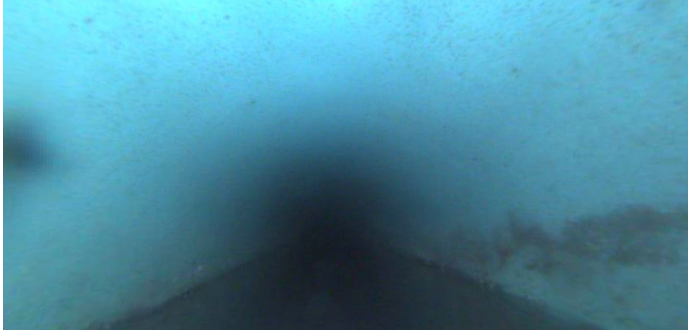
Code:	<b>MSA</b>
Description:	<b>Abandoned Survey</b>
Distance (ft):	<b>116.3</b>
Structural Grade:	<b>0</b>
O&M Grade:	<b>0</b>
Clock Start/From:	
Clock To:	
1st Value:	
2nd Value:	
Value Percent:	
Continuous Index:	
Within 8" of Joint:	<b>NO</b>
Remarks:	<b>debris under water</b>
