Profile/Photo Observation Report

Street:	STATE ST	Flow Control:	Not Controlled
City:	Hobart, IN	Year Renewed:	
Location:	Easement/Right of Way	Tape/Media #:	
Purpose:	Maintenance Related	Dia/Height:	12"
Use:	Sanitary	Material:	PVC
Drain Area:	NA	Lining:	Cured in Place
Category:	NA		
Comment:	Reverse setup. heavy silt at 21'-flow incorrect.

Location Details:		Direction of Survey:	Upstream
US MH:	M-706-010.1	DS MH:	M-706-010.2
		Total Length Surveyed (ft):	22.8

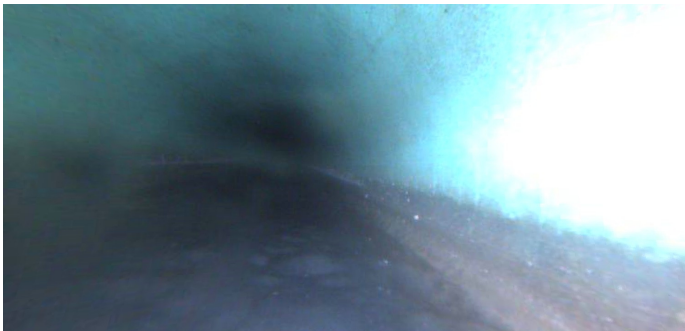
Code: **AMH**
Description: **Manhole**

Distance (ft): .0

Remarks: **M-706-010.2**

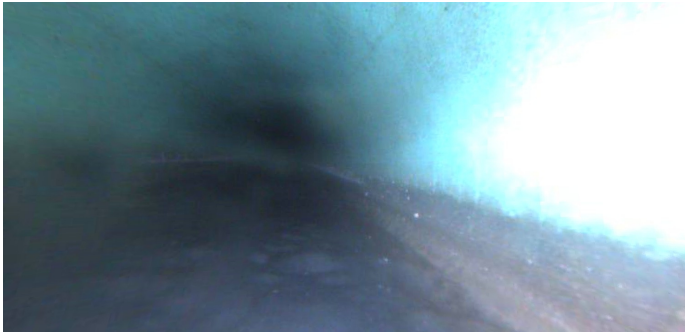
Code:	MWL
Description:	Water Level

Distance (ft):	.0
Structural Grade:	0
O&M Grade:	0
Clock Start/From:	
Clock To:	
1st Value:	
2nd Value:	
Value Percent:	10.000
Continuous Index:	
Within 8" of Joint:	NO
Remarks:

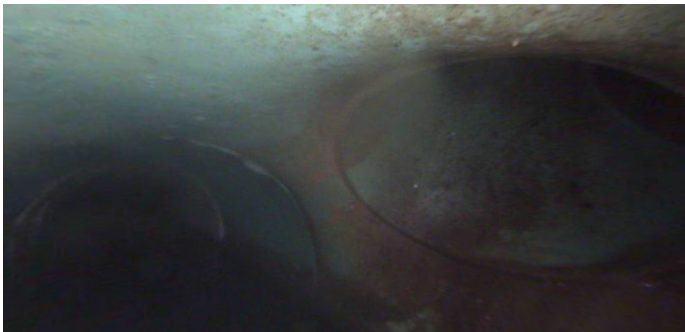
Code:	TF
Description:	Tap Factory

Distance (ft):	12.7
Structural Grade:	0
O&M Grade:	0
Clock Start/From:	3
Clock To:	
1st Value:	4.000
2nd Value:	
Value Percent:	
Continuous Index:	
Within 8" of Joint:	
Remarks:

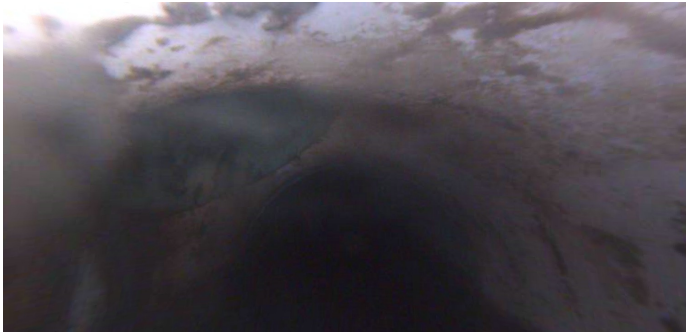
Code: **TF**
Description: **Tap Factory**

Distance (ft): **14.8**
Structural Grade: **0**
O&M Grade: **0**
Clock Start/From: **10**
Clock To:
1st Value: **4.000**
2nd Value:
Value Percent:
Continuous Index:
Within 8" of Joint:
Remarks:

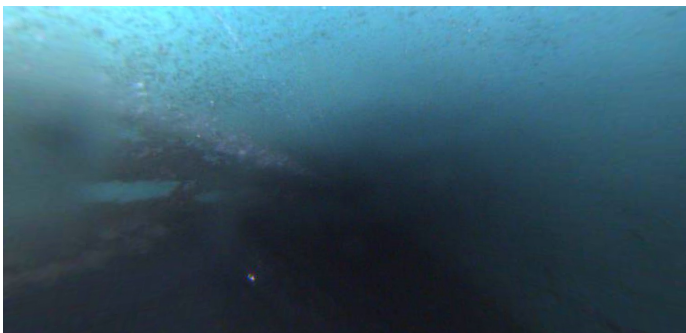
Code: **MSA**
Description: **Abandoned Survey**

Distance (ft): **22.8**
Structural Grade: **0**
O&M Grade: **0**
Clock Start/From:
Clock To:
1st Value:
2nd Value:
Value Percent:
Continuous Index:
Within 8" of Joint: **NO**
Remarks: **debris under water**
