## Profile/Photo Observation Report

Street:	<b>E 9TH ST &amp; STATE ST</b>	Flow Control:	<b>Not Controlled</b>
City:	<b>Hobart, IN</b>	Year Renewed:	
Location:	<b>Ditch</b>	Tape/Media #:	
Purpose:	<b>Maintenance Related</b>	Dia/Height:	<b>12"</b>
Use:	<b>Sanitary</b>	Material:	<b>PVC</b>
Drain Area:	<b>NA</b>	Lining:	<b>Cured in Place</b>
Category:	<b>NA</b>		
Comment:	<b>flow incorrect.</b>

Location Details:		Direction of Survey:	<b>Downstream</b>
US MH:	<b>M-706-010.2</b>	DS MH:	<b>M-706-010.3</b>
		Total Length Surveyed (ft):	<b>219.4</b>

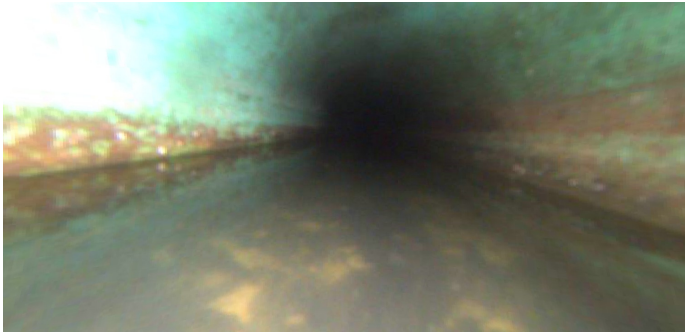
Code:	<b>MWL</b>
Description:	<b>Water Level</b>

Distance (ft):	<b>.0</b>
Structural Grade:	<b>0</b>
O&M Grade:	<b>0</b>
Clock Start/From:	
Clock To:	
1st Value:	
2nd Value:	
Value Percent:	<b>5.000</b>
Continuous Index:	
Within 8" of Joint:	<b>NO</b>
Remarks:

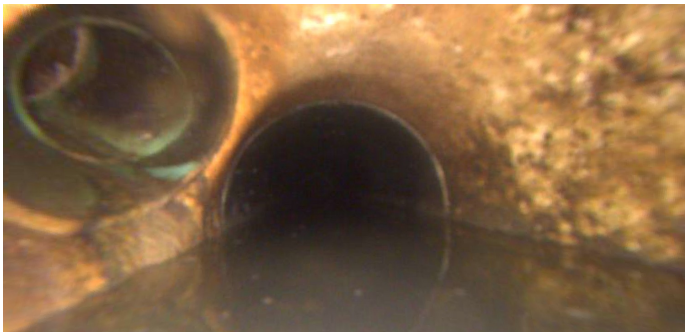
Code:	<b>TF</b>
Description:	<b>Tap Factory</b>

Distance (ft):	<b>22.9</b>
Structural Grade:	<b>0</b>
O&M Grade:	<b>0</b>
Clock Start/From:	<b>10</b>
Clock To:	
1st Value:	<b>4.000</b>
2nd Value:	
Value Percent:	
Continuous Index:	
Within 8" of Joint:	
Remarks:

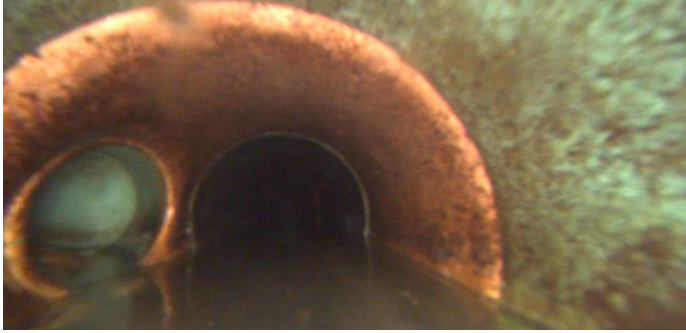
Code: **TFA**  
Description: **Tap Factory Active**

Distance (ft): **62.1**  
Structural Grade: **0**  
O&M Grade: **0**  
Clock Start/From: **9**  
Clock To:  
1st Value: **4.000**  
2nd Value:  
Value Percent:  
Continuous Index:  
Within 8" of Joint:  
Remarks:

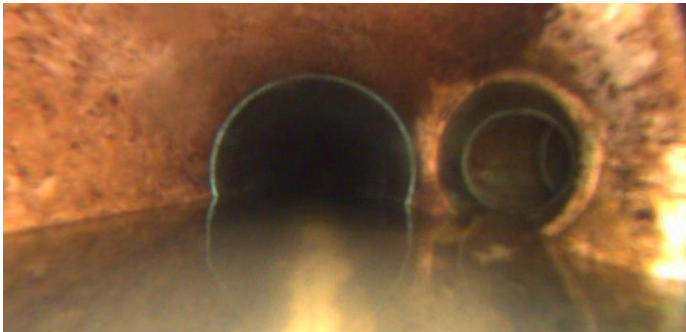
Code: **TFA**  
Description: **Tap Factory Active**

Distance (ft): **66.9**  
Structural Grade: **0**  
O&M Grade: **0**  
Clock Start/From: **3**  
Clock To:  
1st Value: **4.000**  
2nd Value:  
Value Percent:  
Continuous Index:  
Within 8" of Joint:  
Remarks:

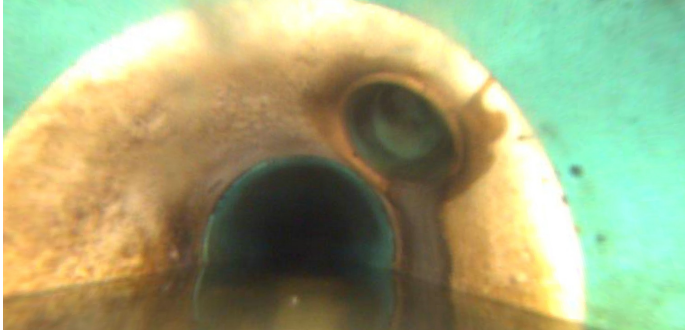
Code: **TF**  
Description: **Tap Factory**

Distance (ft): **96.7**  
Structural Grade: **0**  
O&M Grade: **0**  
Clock Start/From: **2**  
Clock To:  
1st Value: **4.000**  
2nd Value:  
Value Percent:  
Continuous Index:  
Within 8" of Joint:  
Remarks:

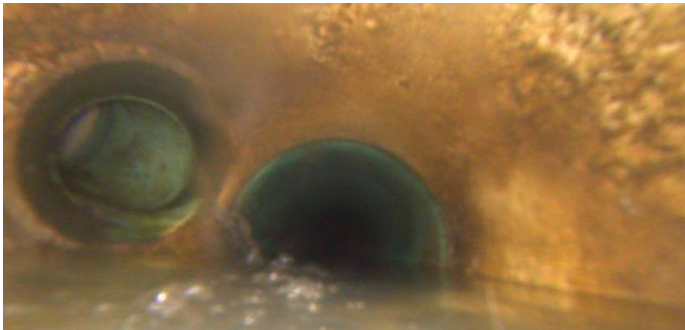
Code: **TFA**  
Description: **Tap Factory Active**

Distance (ft): **114.2**  
Structural Grade: **0**  
O&M Grade: **0**  
Clock Start/From: **10**  
Clock To:  
1st Value: **4.000**  
2nd Value:  
Value Percent:  
Continuous Index:  
Within 8" of Joint:  
Remarks:

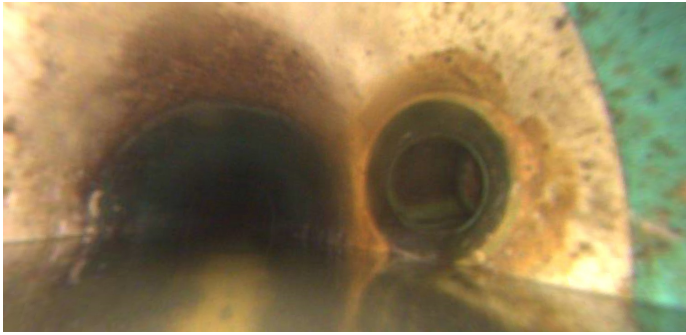
Code: **TF**  
Description: **Tap Factory**

Distance (ft): **147.6**  
Structural Grade: **0**  
O&M Grade: **0**  
Clock Start/From: **3**  
Clock To:  
1st Value: **4.000**  
2nd Value:  
Value Percent:  
Continuous Index:  
Within 8" of Joint:  
Remarks:

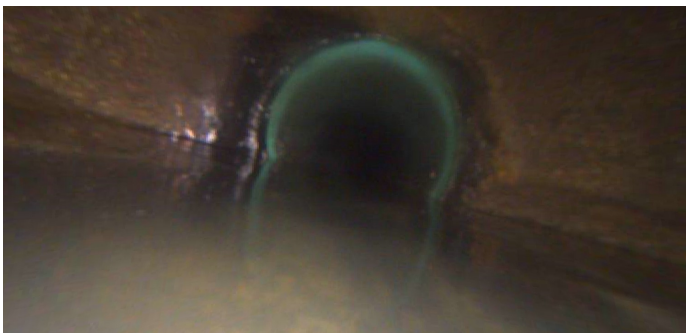
Code: **AMH**  
Description: **Manhole**

Distance (ft): **219.4**  
Structural Grade: **0**  
O&M Grade: **0**  
Clock Start/From:  
Clock To:  
1st Value:  
2nd Value:  
Value Percent:  
Continuous Index:  
Within 8" of Joint: **NO**  
Remarks: **M-706-010.3**
