Profile/Photo Observation Report

Date:	04/16/2018	Weather:		Coding:	PACP 6.0
Pipe Length (ft):	238.9	Owner:	NA	Pre Clean:	Not Known
P.O.#:		Surveyor:	Selasie Honu	PSR:	P-706-010.3-010.2
Customer:		Clean Date:	01/01/1900	Shape:	C

Street:	Capitol	Flow Control:	Not Controlled
City:	Hobart, IN	Year Renewed:	
Location:	Ditch	Tape/Media #:	
Purpose:	Maintenance Related	Dia/Height:	12"
Use:	Sanitary	Material:	PVC
Drain Area:	NA	Lining:	Cured in Place
Category:	NA		
Comment:	flow incorrect.

Location Details:		Direction of Survey:	Downstream
US MH:	M-706-010.2	DS MH:	M-706-010.3
		Total Length Surveyed (ft):	219.4

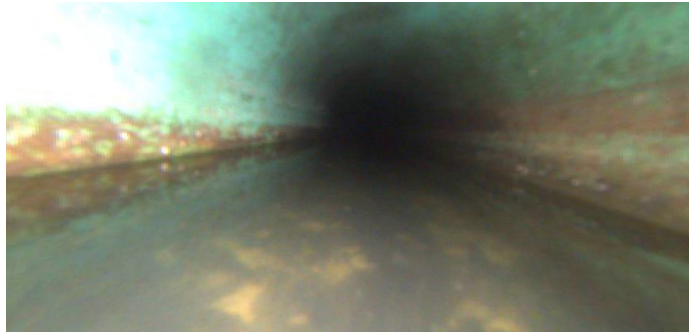
Code: **AMH**
Description: **Manhole**

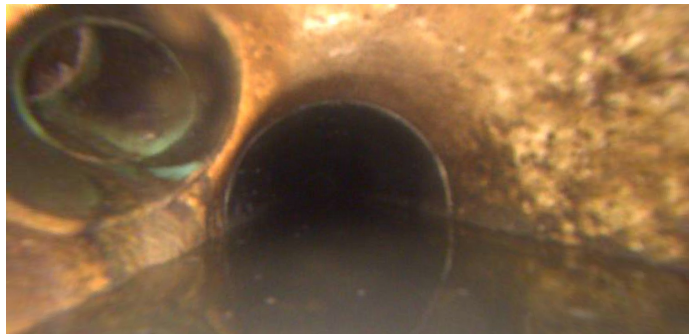
Code:	MWL
Description:	Water Level
Distance (ft):	.0
Structural Grade:	0
O&M Grade:	0
Clock Start/From:	
Clock To:	
1st Value:	
2nd Value:	
Value Percent:	5.000
Continuous Index:	
Within 8" of Joint:	NO
Remarks:

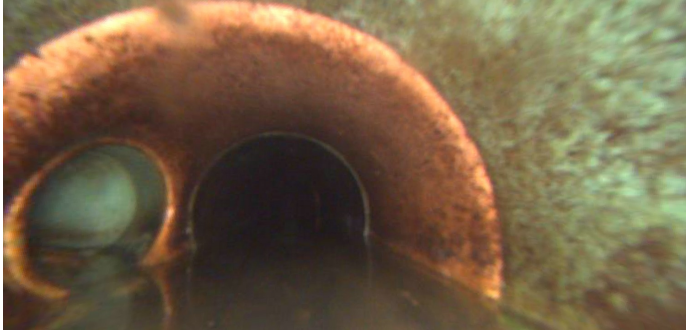
Code:	TF
Description:	Tap Factory
Distance (ft):	22.9
Structural Grade:	0
O&M Grade:	0
Clock Start/From:	10
Clock To:	
1st Value:	4.000
2nd Value:	
Value Percent:	
Continuous Index:	
Within 8" of Joint:	
Remarks:

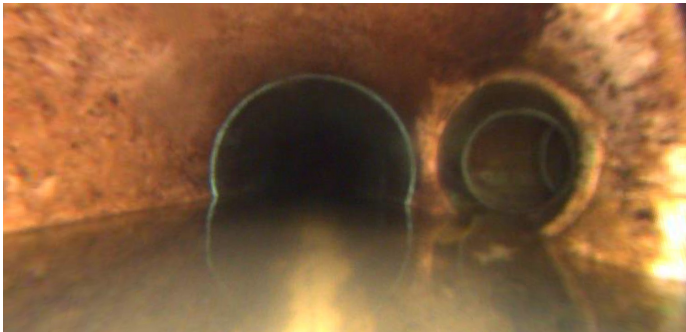
Code: **TFA**
Description: **Tap Factory Active**

Distance (ft): **62.1**
Structural Grade: **0**
O&M Grade: **0**
Clock Start/From: **9**
Clock To:
1st Value: **4.000**
2nd Value:
Value Percent:
Continuous Index:
Within 8" of Joint:
Remarks:

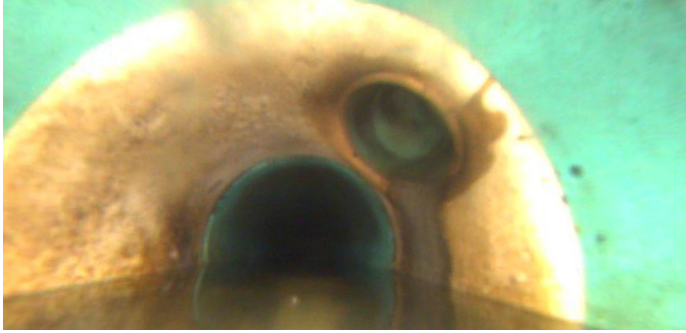
Code: **TFA**
Description: **Tap Factory Active**

Distance (ft): **66.9**
Structural Grade: **0**
O&M Grade: **0**
Clock Start/From: **3**
Clock To:
1st Value: **4.000**
2nd Value:
Value Percent:
Continuous Index:
Within 8" of Joint:
Remarks:

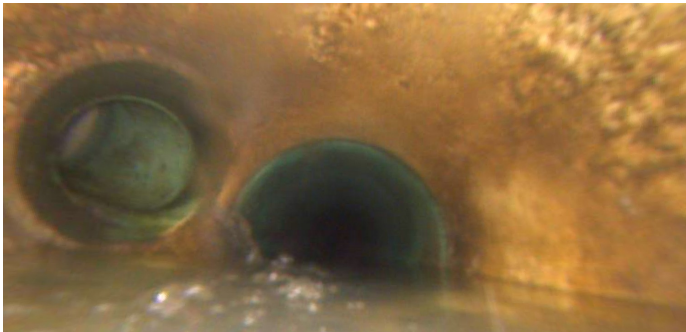
Code: **TF**
Description: **Tap Factory**

Distance (ft): **96.7**
Structural Grade: **0**
O&M Grade: **0**
Clock Start/From: **2**
Clock To:
1st Value: **4.000**
2nd Value:
Value Percent:
Continuous Index:
Within 8" of Joint:
Remarks:

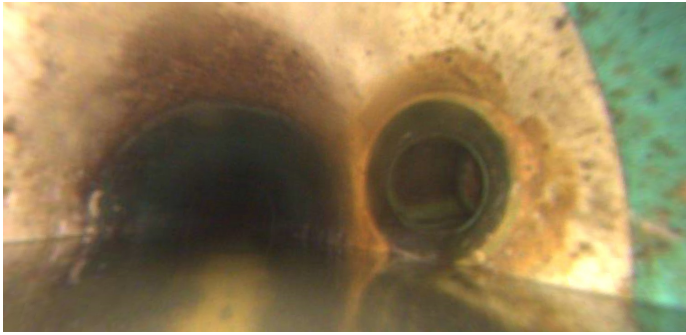
Code: **TFA**
Description: **Tap Factory Active**

Distance (ft): **114.2**
Structural Grade: **0**
O&M Grade: **0**
Clock Start/From: **10**
Clock To:
1st Value: **4.000**
2nd Value:
Value Percent:
Continuous Index:
Within 8" of Joint:
Remarks:

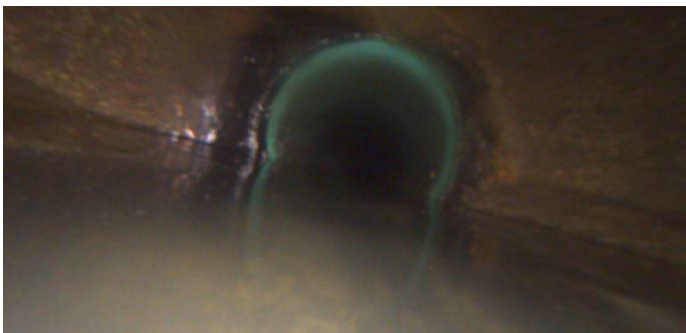
Code: **TF**
Description: **Tap Factory**

Distance (ft): **147.6**
Structural Grade: **0**
O&M Grade: **0**
Clock Start/From: **3**
Clock To:
1st Value: **4.000**
2nd Value:
Value Percent:
Continuous Index:
Within 8" of Joint:
Remarks:
