Profile/Photo Observation Report

Date:	04/16/2018	Weather:		Coding:	PACP 6.0
Pipe Length (ft):	192.9	Owner:	NA	Pre Clean:	Not Known
P.O.#:		Surveyor:	Selasie Honu	PSR:	P-706-010.5-010.4
Customer:		Clean Date:	01/01/1900	Shape:	C

Street:	STATE ST	Flow Control:	Not Controlled
City:	Hobart, IN	Year Renewed:	
Location:	Ditch	Tape/Media #:	
Purpose:	Maintenance Related	Dia/Height:	12"
Use:	Sanitary	Material:	PVC
Drain Area:	NA	Lining:	Cured in Place
Category:	NA		
Comment:	blk silt at 12'. flow incorrect.		
Location Details:		Direction of Survey:	Upstream
US MH:	M-706-010.4	DS MH:	M-706-010.5
		Total Length Surveyed (ft):	13.7

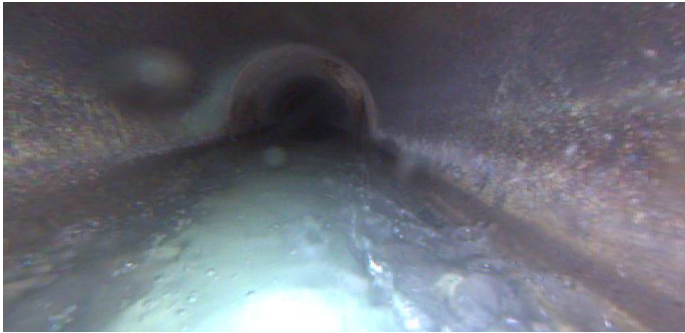
Code:	MWL
Description:	Water Level

Distance (ft):	.0
Structural Grade:	0
O&M Grade:	0
Clock Start/From:	
Clock To:	
1st Value:	
2nd Value:	
Value Percent:	5.000
Continuous Index:	
Within 8" of Joint:	NO
Remarks:

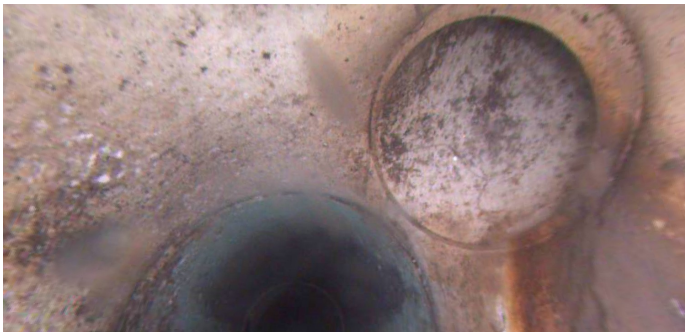
Code:	TF
Description:	Tap Factory

Distance (ft):	3.3
Structural Grade:	0
O&M Grade:	0
Clock Start/From:	2
Clock To:	
1st Value:	4.000
2nd Value:	
Value Percent:	
Continuous Index:	
Within 8" of Joint:	
Remarks:

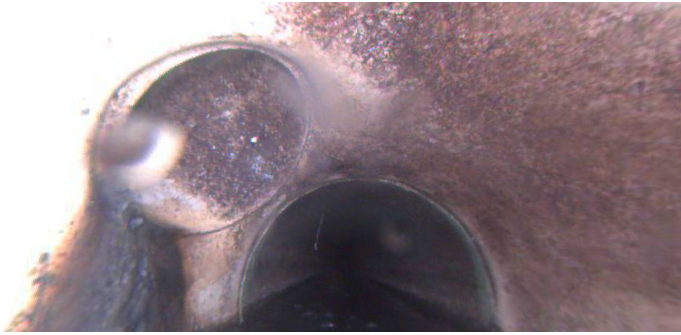
Code: **TF**
Description: **Tap Factory**

Distance (ft): **6.4**
Structural Grade: **0**
O&M Grade: **0**
Clock Start/From: **10**
Clock To:
1st Value: **4.000**
2nd Value:
Value Percent:
Continuous Index:
Within 8" of Joint:
Remarks:

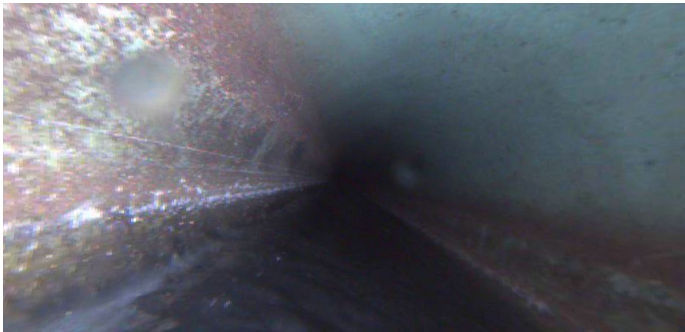
Code: **MSA**
Description: **Abandoned Survey**

Distance (ft): **13.7**
Structural Grade: **0**
O&M Grade: **0**
Clock Start/From:
Clock To:
1st Value:
2nd Value:
Value Percent:
Continuous Index:
Within 8" of Joint: **NO**
Remarks: **camera stopped**
