Profile/Photo Observation Report

Date:	04/16/2018	Weather:		Coding:	PACP 6.0
Pipe Length (ft):	181.0	Owner:	NA	Pre Clean:	Not Known
P.O.#:		Surveyor:	Selasie Honu	PSR:	P-706-010.6-010.5
Customer:		Clean Date:	01/01/1900	Shape:	C

Street:	STATE ST	Flow Control:	Not Controlled
City:	Hobart, IN	Year Renewed:	
Location:	Ditch	Tape/Media #:	
Purpose:	Maintenance Related	Dia/Height:	12"
Use:	Sanitary	Material:	PVC
Drain Area:	NA	Lining:	Cured in Place
Category:	NA		
Comment:	flow incorrect.

Location Details:		Direction of Survey:	Downstream
US MH:	M-706-010.5	DS MH:	M-706-010.6
		Total Length Surveyed (ft):	179.1

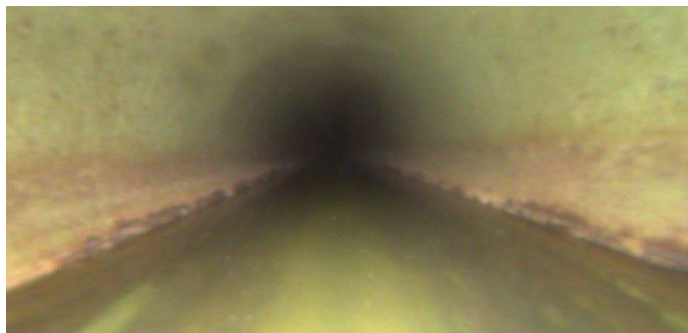
Code: **AMH**
Description: **Manhole**

Distance (ft): **.0**
Structural Grade: **0**
O&M Grade: **0**
Clock Start/From:
Clock To:
1st Value:
2nd Value:
Value Percent:
Continuous Index:
Within 8" of Joint: **NO**
Remarks: **M-706-010.5**

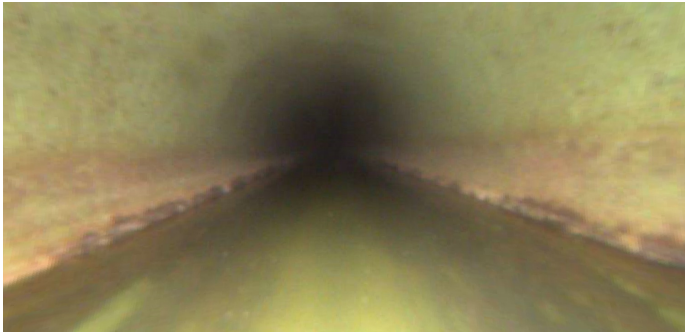
Code:	MWL
Description:	Water Level

Distance (ft):	.0
Structural Grade:	0
O&M Grade:	0
Clock Start/From:	
Clock To:	
1st Value:	
2nd Value:	
Value Percent:	30.000
Continuous Index:	
Within 8" of Joint:	NO
Remarks:

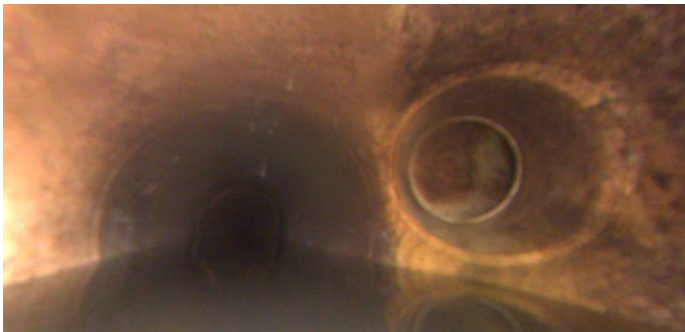
Code:	TF
Description:	Tap Factory

Distance (ft):	24.7
Structural Grade:	0
O&M Grade:	0
Clock Start/From:	3
Clock To:	
1st Value:	4.000
2nd Value:	
Value Percent:	
Continuous Index:	
Within 8" of Joint:	
Remarks:

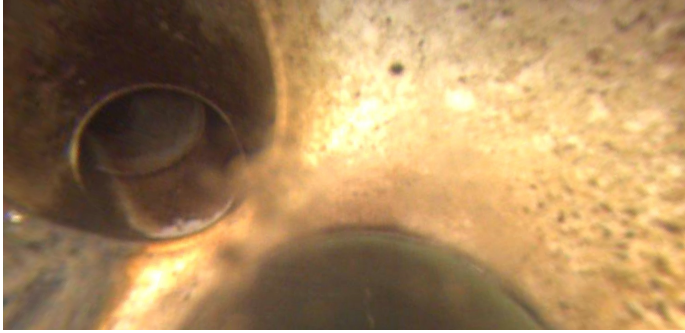
Code: **TF**
Description: **Tap Factory**

Distance (ft): **29.1**
Structural Grade: **0**
O&M Grade: **0**
Clock Start/From: **11**
Clock To:
1st Value: **4.000**
2nd Value:
Value Percent:
Continuous Index:
Within 8" of Joint:
Remarks:

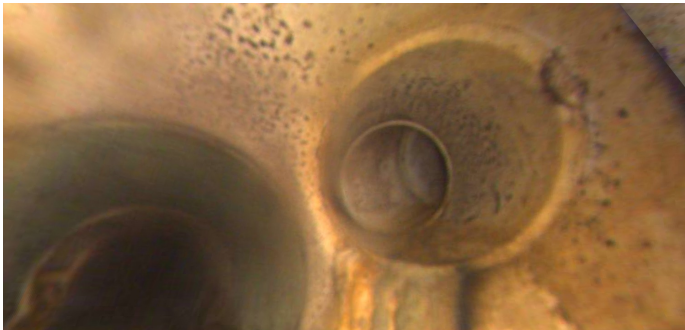
Code: **TF**
Description: **Tap Factory**

Distance (ft): **66.2**
Structural Grade: **0**
O&M Grade: **0**
Clock Start/From: **2**
Clock To:
1st Value: **4.000**
2nd Value:
Value Percent:
Continuous Index:
Within 8" of Joint:
Remarks:

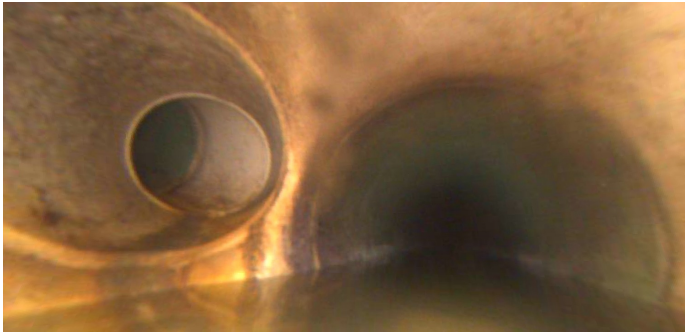
Code: **TF**
Description: **Tap Factory**

Distance (ft): **68.6**
Structural Grade: **0**
O&M Grade: **0**
Clock Start/From: **9**
Clock To:
1st Value: **4.000**
2nd Value:
Value Percent:
Continuous Index:
Within 8" of Joint:
Remarks:

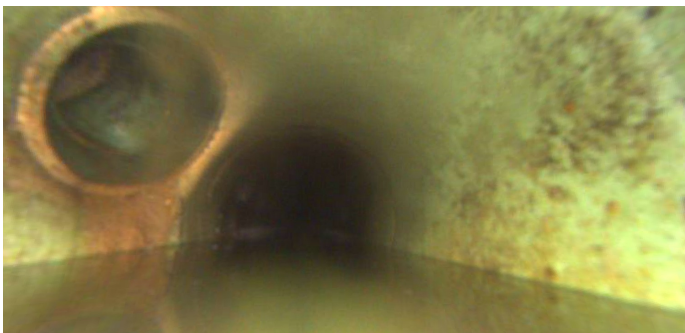
Code: **TF**
Description: **Tap Factory**

Distance (ft): **109.7**
Structural Grade: **0**
O&M Grade: **0**
Clock Start/From: **10**
Clock To:
1st Value: **4.000**
2nd Value:
Value Percent:
Continuous Index:
Within 8" of Joint:
Remarks:

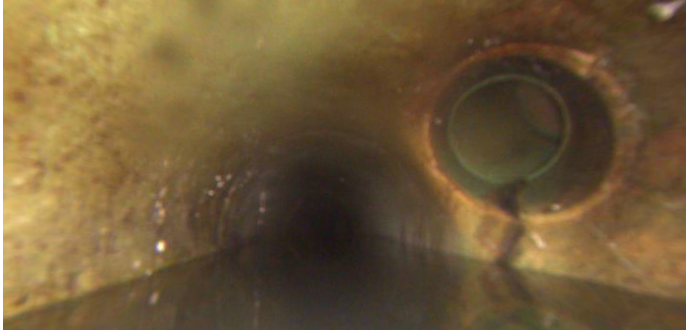
Code: **TF**
Description: **Tap Factory**

Distance (ft): **156.7**
Structural Grade: **0**
O&M Grade: **0**
Clock Start/From: **2**
Clock To:
1st Value: **4.000**
2nd Value:
Value Percent:
Continuous Index:
Within 8" of Joint:
Remarks:

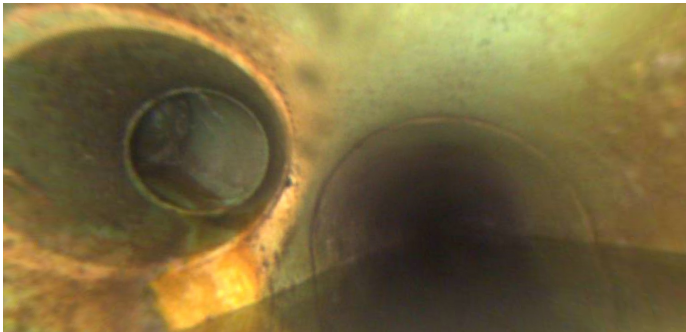
Code: **TF**
Description: **Tap Factory**

Distance (ft): **160.8**
Structural Grade: **0**
O&M Grade: **0**
Clock Start/From: **10**
Clock To:
1st Value: **4.000**
2nd Value:
Value Percent:
Continuous Index:
Within 8" of Joint:
Remarks:

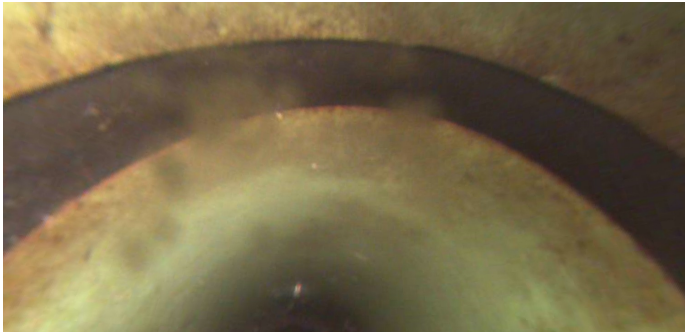
Code: **JSM**
Description: **Joint Separated Medium**

Distance (ft): **173.8**
Structural Grade: **1**
O&M Grade: **0**
Clock Start/From:
Clock To:
1st Value:
2nd Value:
Value Percent:
Continuous Index:
Within 8" of Joint: **NO**
Remarks:

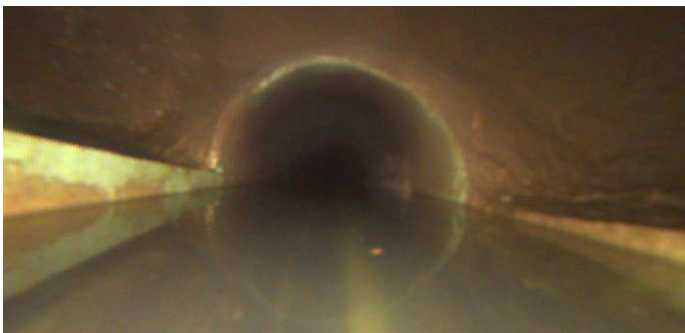
Code: **AMH**
Description: **Manhole**

Distance (ft): **179.1**
Structural Grade: **0**
O&M Grade: **0**
Clock Start/From:
Clock To:
1st Value:
2nd Value:
Value Percent:
Continuous Index:
Within 8" of Joint: **NO**
Remarks: **M-706-010.6**
