## Profile/Photo Observation Report

Date:	<b>05/01/2018</b>	Weather:		Coding:	<b>PACP 6.0</b>
Pipe Length (ft):		Owner:	<b>City of Hobart</b>	Pre Clean:	<b>Not Known</b>
P.O.#:	<b>278</b>	Surveyor:	<b>B. Helbling</b>	PSR:	<b>P-706-011.1-011</b>
Customer:	<b>City of Hobart</b>	Clean Date:		Shape:	<b>C</b>

Street:	<b>Lake Street</b>	Flow Control:	<b>Not Controlled</b>
City:	<b>Hobart, IN</b>	Year Renewed:	
Location:	<b>Light Highway</b>	Tape/Media #:	<b>DEP278</b>
Purpose:	<b>Routine Assessment</b>	Dia/Height:	<b>12"</b>
Use:	<b>Sanitary</b>	Material:	<b>PVC</b>
Drain Area:		Lining:	
Category:	<b>NA</b>		
Comment:	<b>5-21-2018</b>

Location Details:		Direction of Survey:	<b>Downstream</b>
US MH:	<b>M-706-011</b>	DS MH:	<b>M-706-011.1</b>
		Total Length Surveyed (ft):	<b>203.0</b>

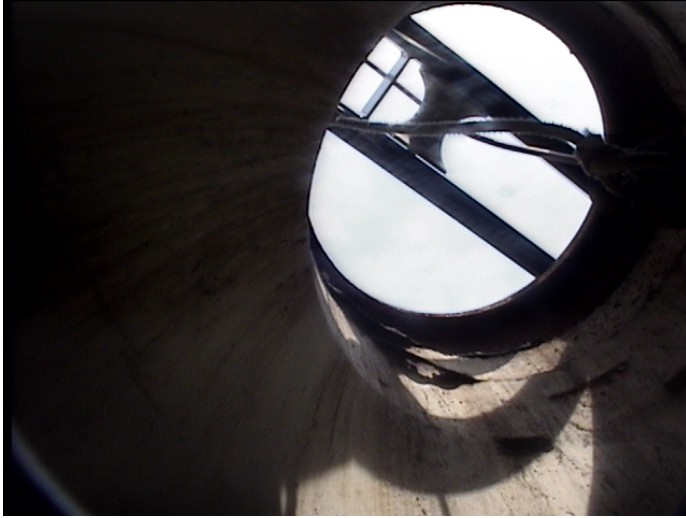
Code:	<b>AMH</b>
Description:	<b>Manhole</b>
Distance (ft):	<b>.0</b>
Structural Grade:	<b>0</b>
O&M Grade:	<b>0</b>
Clock Start/From:	
Clock To:	
1st Value:	
2nd Value:	
Value Percent:	
Continuous Index:	
Within 8" of Joint:	<b>NO</b>
Remarks:	<b>M-706-011.1</b>

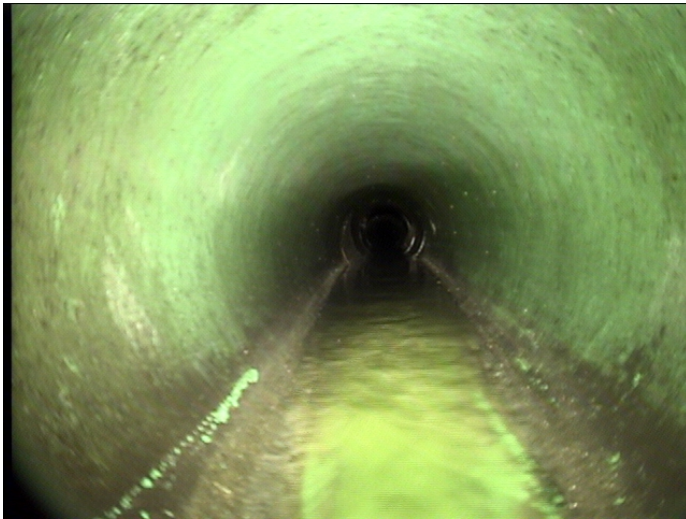
Code:	<b>MWL</b>
Description:	<b>Water Level</b>
Distance (ft):	<b>.0</b>
Structural Grade:	<b>0</b>
O&M Grade:	<b>0</b>
Clock Start/From:	
Clock To:	
1st Value:	
2nd Value:	
Value Percent:	<b>5.000</b>
Continuous Index:	
Within 8" of Joint:	<b>NO</b>
Remarks:

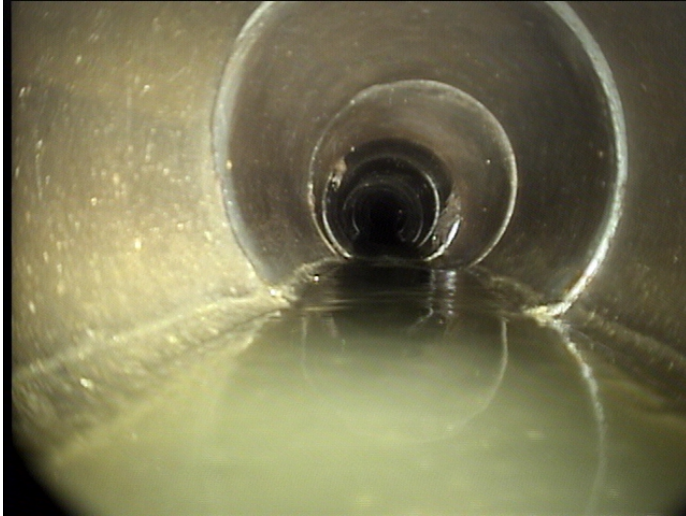
Code:	<b>MMC</b>
Description:	<b>Material Change</b>
Distance (ft):	<b>6.6</b>
Structural Grade:	<b>0</b>
O&M Grade:	<b>0</b>
Clock Start/From:	
Clock To:	
1st Value:	
2nd Value:	
Value Percent:	
Continuous Index:	
Within 8" of Joint:	<b>NO</b>
Remarks:	<b>Change from PVC to VCP.</b>

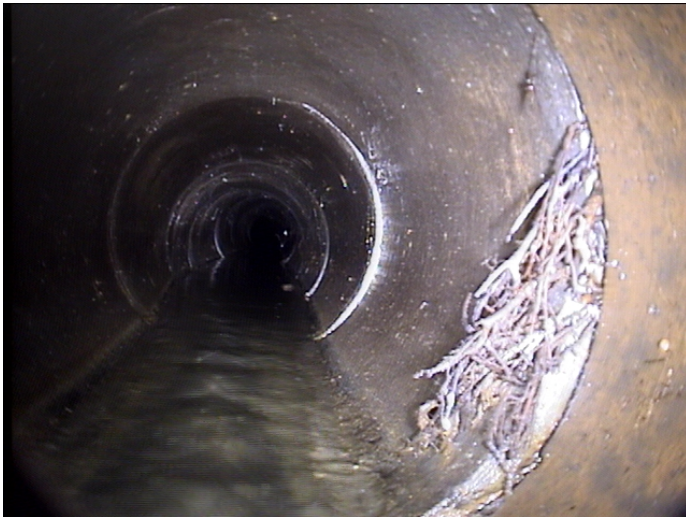
Code:	<b>RFJ</b>
Description:	<b>Roots Fine Joint</b>
Distance (ft):	<b>11.8</b>
Structural Grade:	<b>0</b>
O&M Grade:	<b>1</b>
Clock Start/From:	<b>2</b>
Clock To:	<b>5</b>
1st Value:	
2nd Value:	
Value Percent:	
Continuous Index:	
Within 8" of Joint:	<b>YES</b>
Remarks:

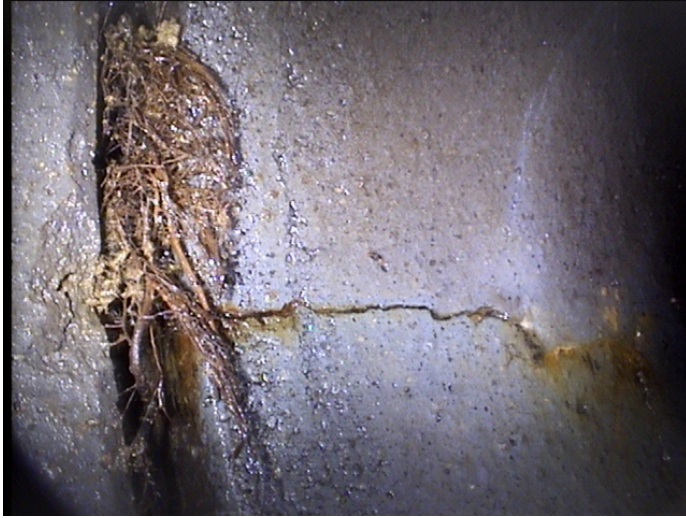
Code: **RFJ**  
Description: **Roots Fine Joint**

Distance (ft): **21.9**  
Structural Grade: **0**  
O&M Grade: **1**  
Clock Start/From: **9**  
Clock To:  
1st Value:  
2nd Value:  
Value Percent:  
Continuous Index:  
Within 8" of Joint: **YES**  
Remarks:

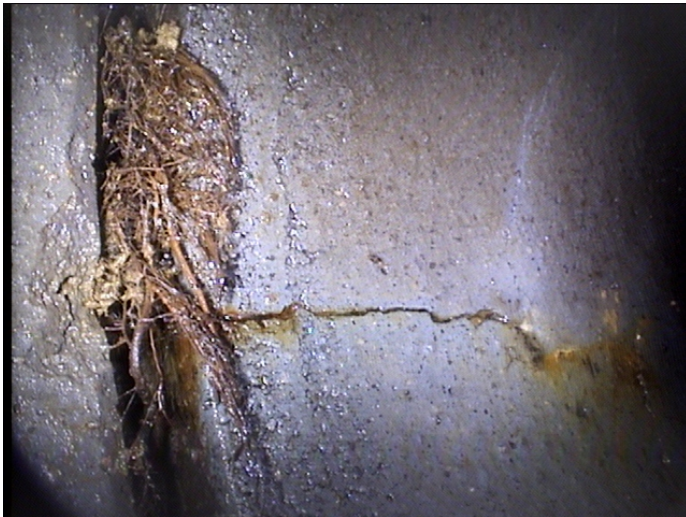
Code: **CL**  
Description: **Crack Longitudinal**

Distance (ft): **21.9**  
Structural Grade: **2**  
O&M Grade: **0**  
Clock Start/From: **9**  
Clock To:  
1st Value:  
2nd Value:  
Value Percent:  
Continuous Index:  
Within 8" of Joint: **NO**  
Remarks:

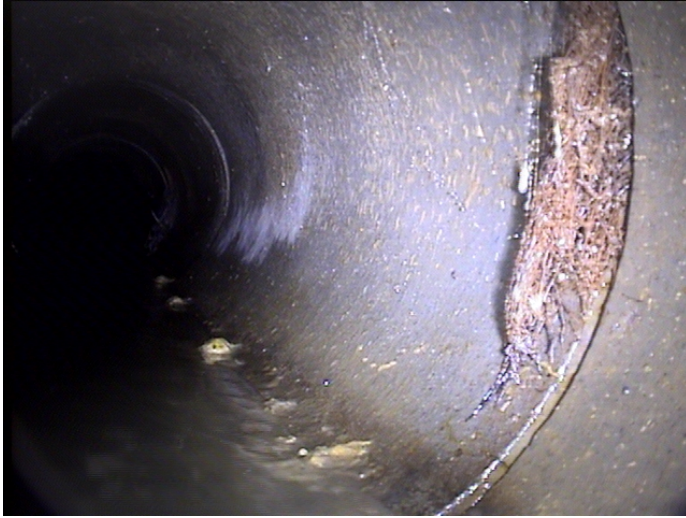
Code: **RFJ**  
Description: **Roots Fine Joint**

Distance (ft): **27.5**  
Structural Grade: **0**  
O&M Grade: **1**  
Clock Start/From: **2**  
Clock To: **4**  
1st Value:  
2nd Value:  
Value Percent:  
Continuous Index:  
Within 8" of Joint: **YES**  
Remarks:

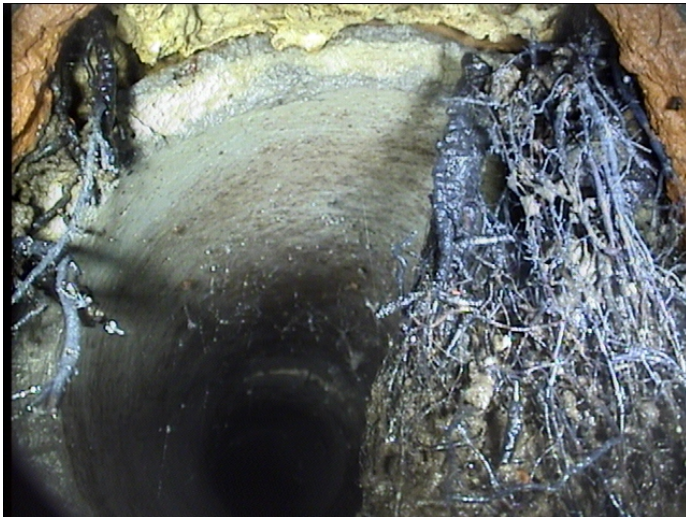
Code: **TBD**  
Description: **Tap Break-in Defective**

Distance (ft): **34.7**  
Structural Grade: **0**  
O&M Grade: **3**  
Clock Start/From: **3**  
Clock To:  
1st Value: **6.000**  
2nd Value:  
Value Percent:  
Continuous Index:  
Within 8" of Joint: **NO**  
Remarks: **Defective**

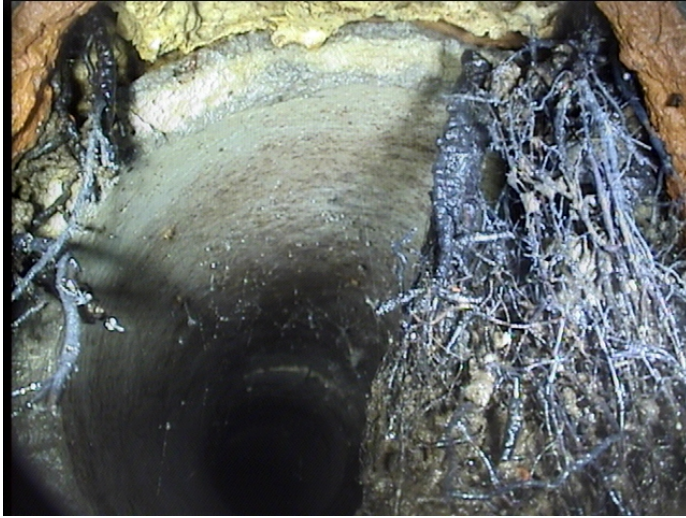
Code: **RFL**  
Description: **Roots Fine Lateral**

Distance (ft): **34.7**  
Structural Grade: **0**  
O&M Grade: **1**  
Clock Start/From: **2**  
Clock To: **4**  
1st Value:  
2nd Value:  
Value Percent:  
Continuous Index:  
Within 8" of Joint: **NO**  
Remarks:

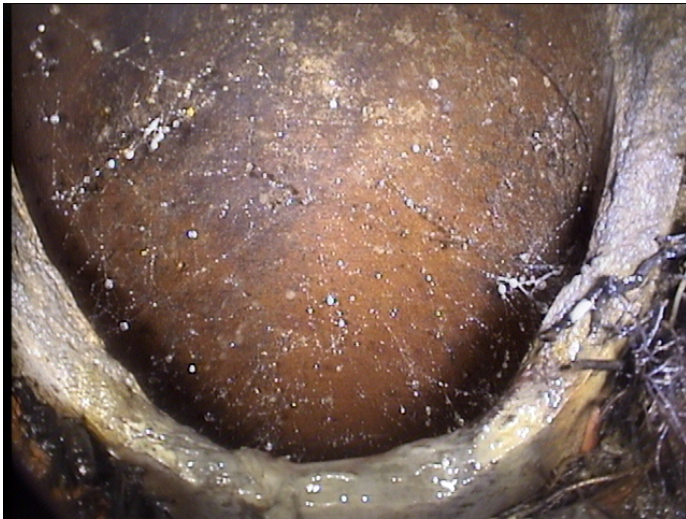
Code: **TBD**  
Description: **Tap Break-in Defective**

Distance (ft): **44.6**  
Structural Grade: **0**  
O&M Grade: **3**  
Clock Start/From: **11**  
Clock To:  
1st Value: **4.000**  
2nd Value:  
Value Percent:  
Continuous Index:  
Within 8" of Joint: **NO**  
Remarks: **Defective**

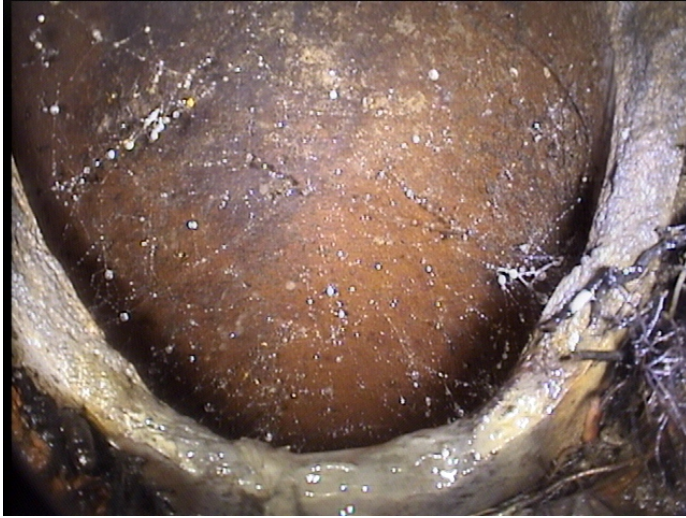
Code: **RFL**  
Description: **Roots Fine Lateral**

Distance (ft): **44.6**  
Structural Grade: **0**  
O&M Grade: **1**  
Clock Start/From: **8**  
Clock To: **11**  
1st Value:  
2nd Value:  
Value Percent:  
Continuous Index:  
Within 8" of Joint: **NO**  
Remarks:

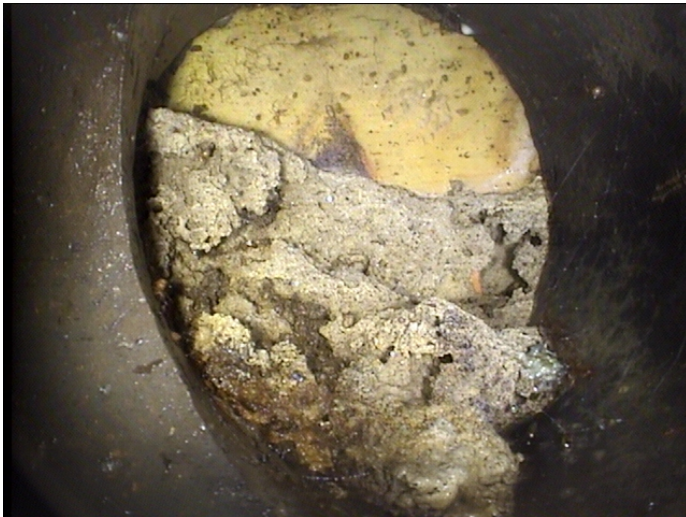
Code: **TFC**  
Description: **Tap Factory Capped**

Distance (ft): **54.4**  
Structural Grade: **0**  
O&M Grade: **0**  
Clock Start/From: **10**  
Clock To:  
1st Value: **4.000**  
2nd Value:  
Value Percent:  
Continuous Index:  
Within 8" of Joint: **NO**  
Remarks:

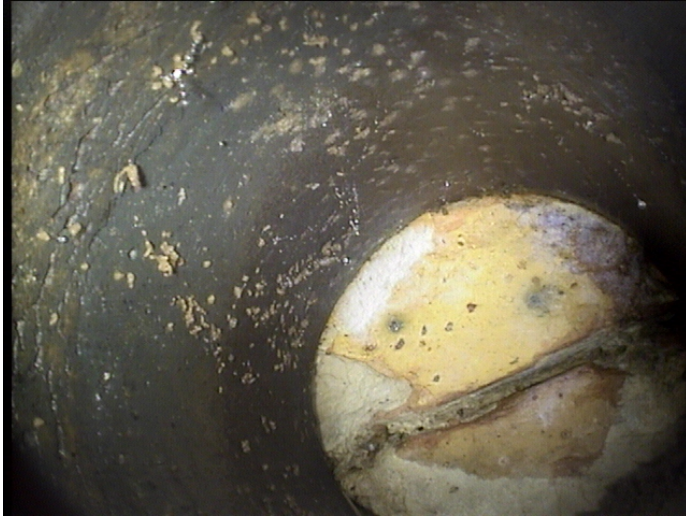
Code: **TFC**  
Description: **Tap Factory Capped**

Distance (ft): **57.7**  
Structural Grade: **0**  
O&M Grade: **0**  
Clock Start/From: **2**  
Clock To:  
1st Value: **4.000**  
2nd Value:  
Value Percent:  
Continuous Index:  
Within 8" of Joint: **NO**  
Remarks:

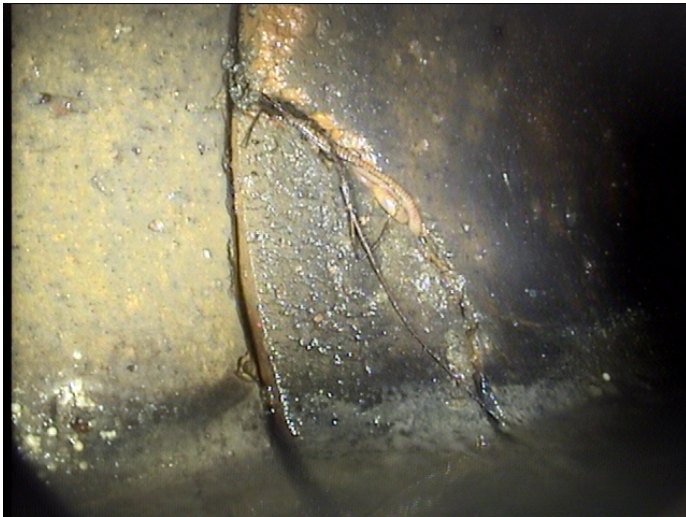
Code: **FS**  
Description: **Fracture Spiral**

Distance (ft): **59.0**  
Structural Grade: **3**  
O&M Grade: **0**  
Clock Start/From: **7**  
Clock To: **8**  
1st Value:  
2nd Value:  
Value Percent:  
Continuous Index:  
Within 8" of Joint: **NO**  
Remarks:

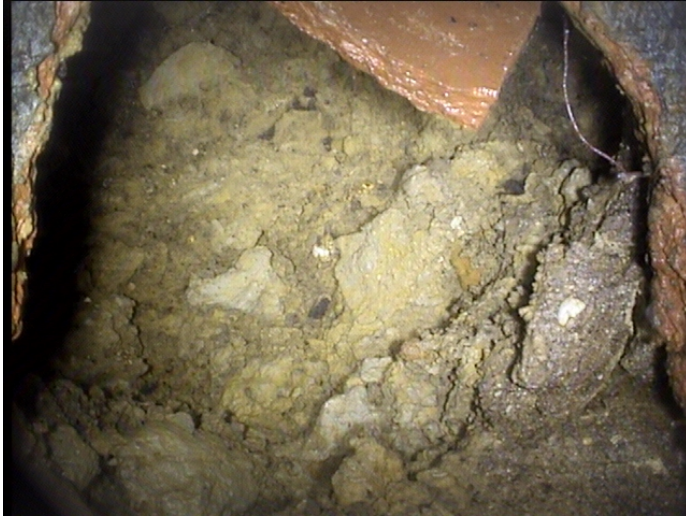
Code: **HSV**  
Description: **Hole Soil Visible**

Distance (ft): **68.9**  
Structural Grade: **5**  
O&M Grade: **0**  
Clock Start/From: **10**  
Clock To:  
1st Value:  
2nd Value:  
Value Percent:  
Continuous Index:  
Within 8" of Joint: **NO**  
Remarks:

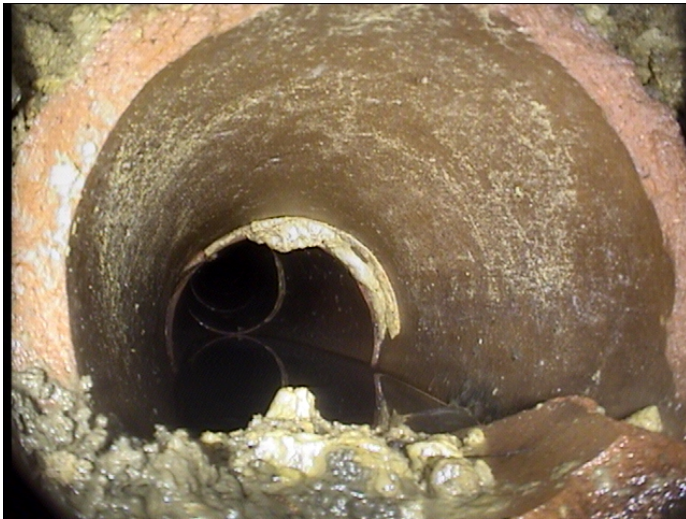
Code: **TBD**  
Description: **Tap Break-in Defective**

Distance (ft): **68.9**  
Structural Grade: **0**  
O&M Grade: **3**  
Clock Start/From: **9**  
Clock To:  
1st Value: **6.000**  
2nd Value:  
Value Percent:  
Continuous Index:  
Within 8" of Joint: **NO**  
Remarks: **Defective**

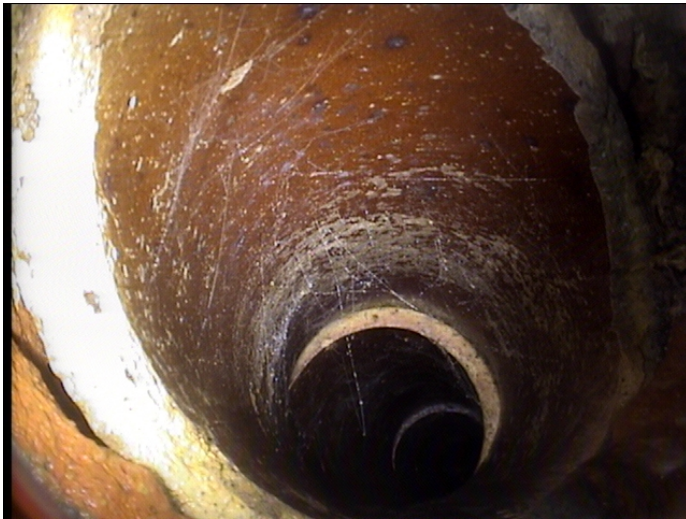
Code: **TB**  
Description: **Tap Break-in**

Distance (ft): **100.9**  
Structural Grade: **0**  
O&M Grade: **0**  
Clock Start/From: **2**  
Clock To:  
1st Value: **6.000**  
2nd Value:  
Value Percent:  
Continuous Index:  
Within 8" of Joint: **NO**  
Remarks:

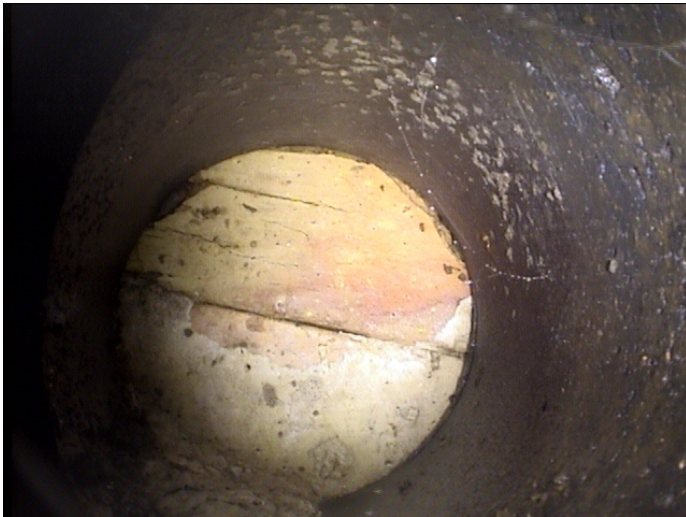
Code: **TFC**  
Description: **Tap Factory Capped**

Distance (ft): **104.0**  
Structural Grade: **0**  
O&M Grade: **0**  
Clock Start/From: **10**  
Clock To:  
1st Value: **4.000**  
2nd Value:  
Value Percent:  
Continuous Index:  
Within 8" of Joint: **NO**  
Remarks:

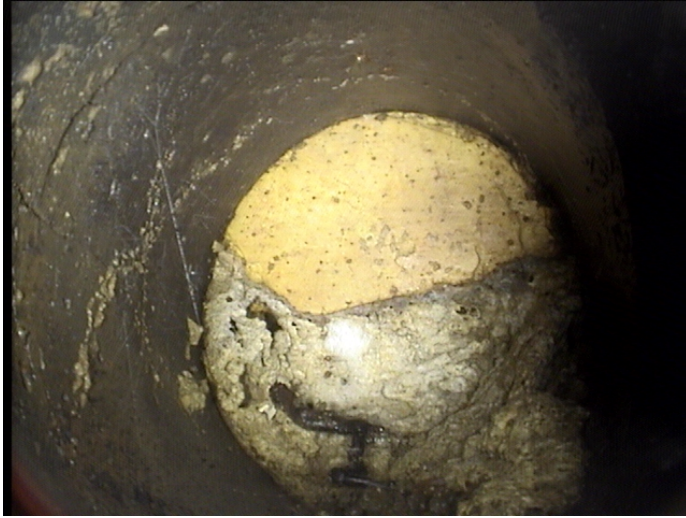
Code: **TFC**  
Description: **Tap Factory Capped**

Distance (ft): **106.9**  
Structural Grade: **0**  
O&M Grade: **0**  
Clock Start/From: **2**  
Clock To:  
1st Value: **4.000**  
2nd Value:  
Value Percent:  
Continuous Index:  
Within 8" of Joint: **NO**  
Remarks:

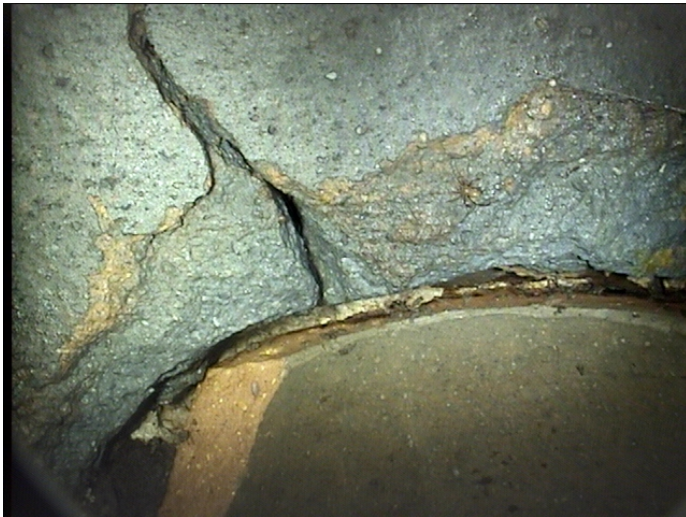
Code: **FS**  
Description: **Fracture Spiral**

Distance (ft): **112.3**  
Structural Grade: **3**  
O&M Grade: **0**  
Clock Start/From: **11**  
Clock To: **2**  
1st Value:  
2nd Value:  
Value Percent:  
Continuous Index:  
Within 8" of Joint: **NO**  
Remarks:

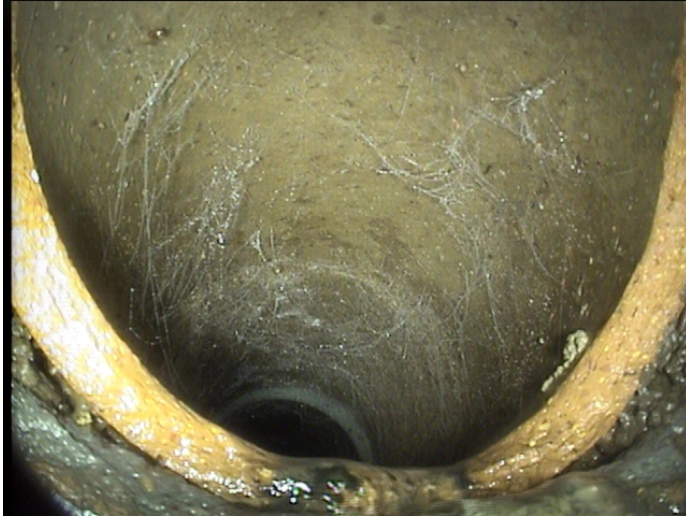
Code: **TBA**  
Description: **Tap Break-in Active**

Distance (ft): **112.3**  
Structural Grade: **0**  
O&M Grade: **0**  
Clock Start/From: **2**  
Clock To:  
1st Value: **4.000**  
2nd Value:  
Value Percent:  
Continuous Index:  
Within 8" of Joint: **NO**  
Remarks:

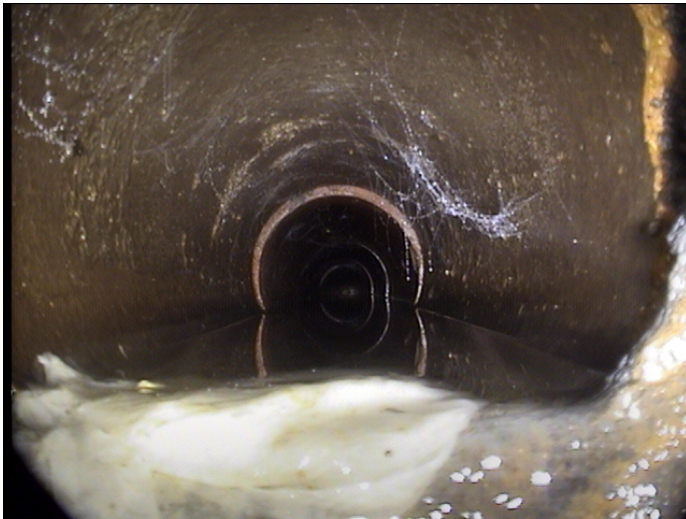
Code: **TBA**  
Description: **Tap Break-in Active**

Distance (ft): **113.0**  
Structural Grade: **0**  
O&M Grade: **0**  
Clock Start/From: **9**  
Clock To:  
1st Value: **6.000**  
2nd Value:  
Value Percent:  
Continuous Index:  
Within 8" of Joint: **NO**  
Remarks:

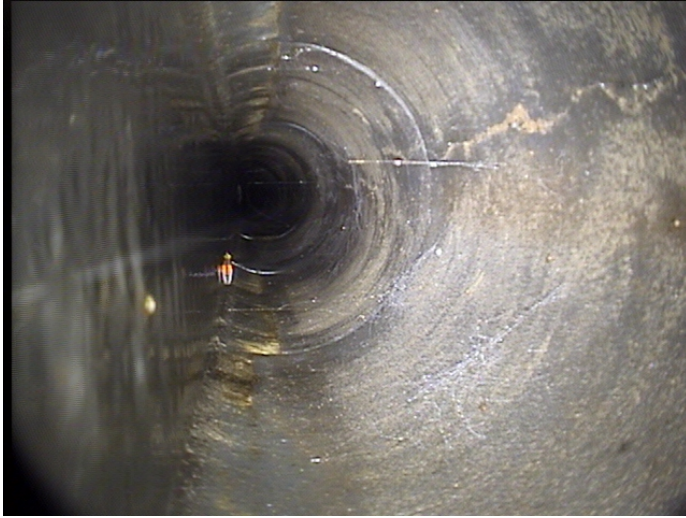
Code: **FL**  
Description: **Fracture Longitudinal**

Distance (ft): **115.0**  
Structural Grade: **3**  
O&M Grade: **0**  
Clock Start/From: **12**  
Clock To:  
1st Value:  
2nd Value:  
Value Percent:  
Continuous Index: **S01**  
Within 8" of Joint: **NO**  
Remarks:

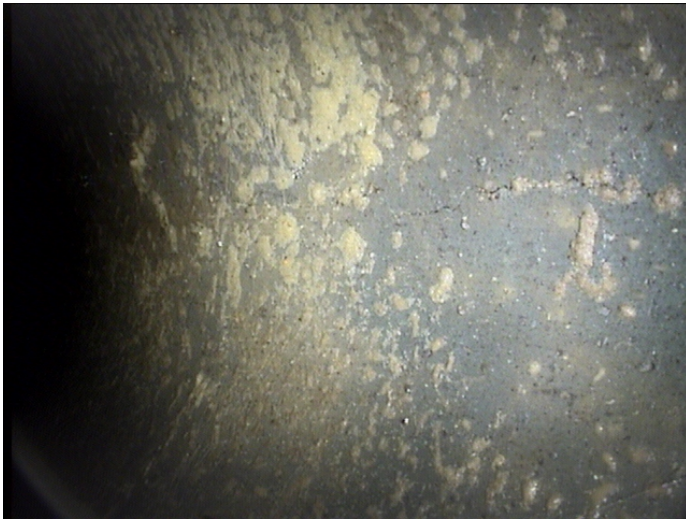
Code: **FL**  
Description: **Fracture Longitudinal**

Distance (ft): **121.6**  
Structural Grade: **3**  
O&M Grade: **0**  
Clock Start/From: **12**  
Clock To:  
1st Value:  
2nd Value:  
Value Percent:  
Continuous Index: **F01**  
Within 8" of Joint: **NO**  
Remarks:

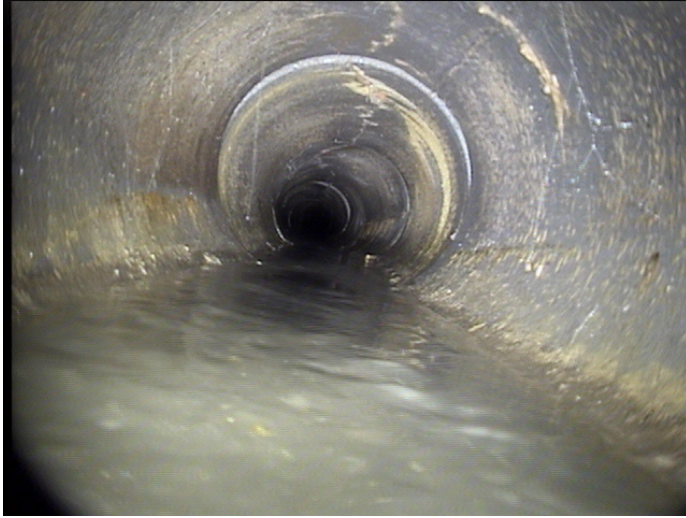
Code: **FL**  
Description: **Fracture Longitudinal**

Distance (ft): **129.8**  
Structural Grade: **3**  
O&M Grade: **0**  
Clock Start/From: **12**  
Clock To:  
1st Value:  
2nd Value:  
Value Percent:  
Continuous Index: **S02**  
Within 8" of Joint: **NO**  
Remarks:

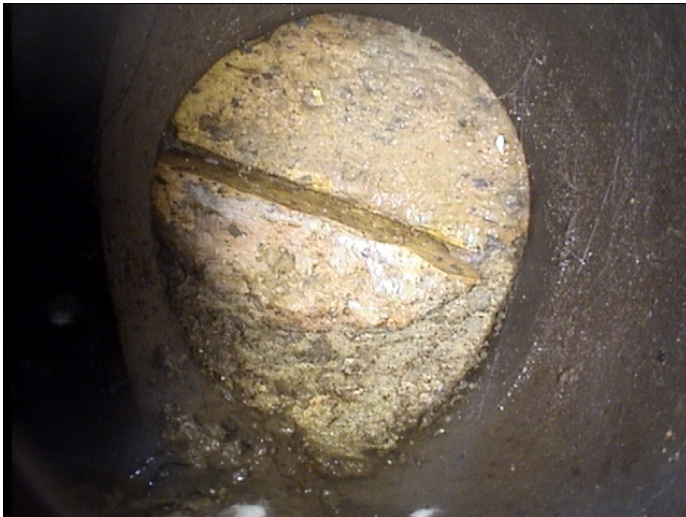
Code: **TFC**  
Description: **Tap Factory Capped**

Distance (ft): **156.3**  
Structural Grade: **0**  
O&M Grade: **0**  
Clock Start/From: **10**  
Clock To:  
1st Value: **4.000**  
2nd Value:  
Value Percent:  
Continuous Index:  
Within 8" of Joint: **NO**  
Remarks:

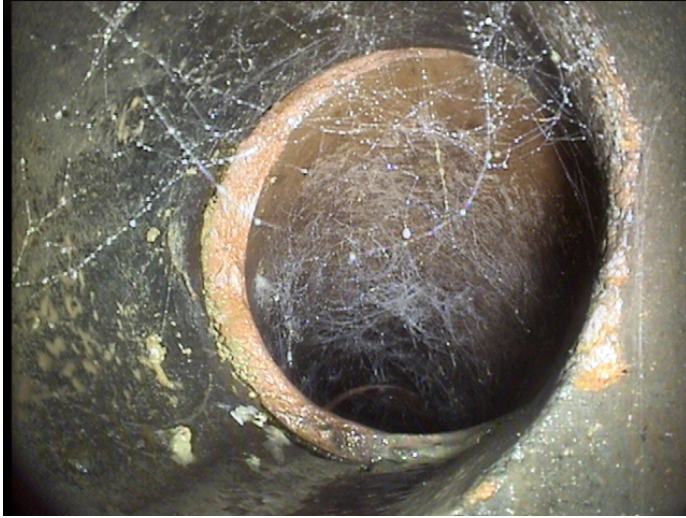
Code: **TF**  
Description: **Tap Factory**

Distance (ft): **159.1**  
Structural Grade: **0**  
O&M Grade: **0**  
Clock Start/From: **2**  
Clock To:  
1st Value: **4.000**  
2nd Value:  
Value Percent:  
Continuous Index:  
Within 8" of Joint: **NO**  
Remarks:

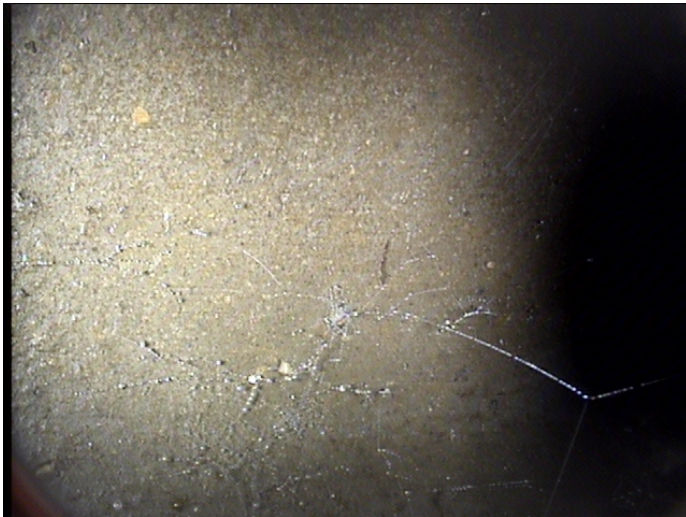
Code: **FL**  
Description: **Fracture Longitudinal**

Distance (ft): **159.1**  
Structural Grade: **3**  
O&M Grade: **0**  
Clock Start/From: **12**  
Clock To:  
1st Value:  
2nd Value:  
Value Percent:  
Continuous Index: **F02**  
Within 8" of Joint: **NO**  
Remarks:

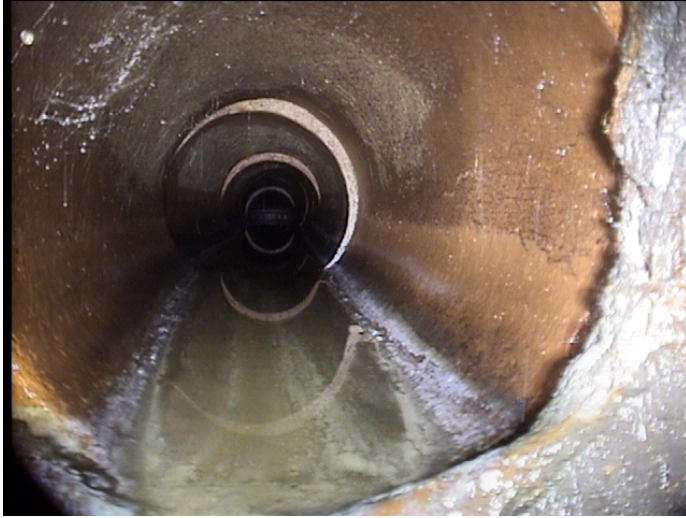
Code: **TB**  
Description: **Tap Break-in**

Distance (ft): **168.0**  
Structural Grade: **0**  
O&M Grade: **0**  
Clock Start/From: **9**  
Clock To:  
1st Value: **6.000**  
2nd Value:  
Value Percent:  
Continuous Index:  
Within 8" of Joint: **NO**  
Remarks:

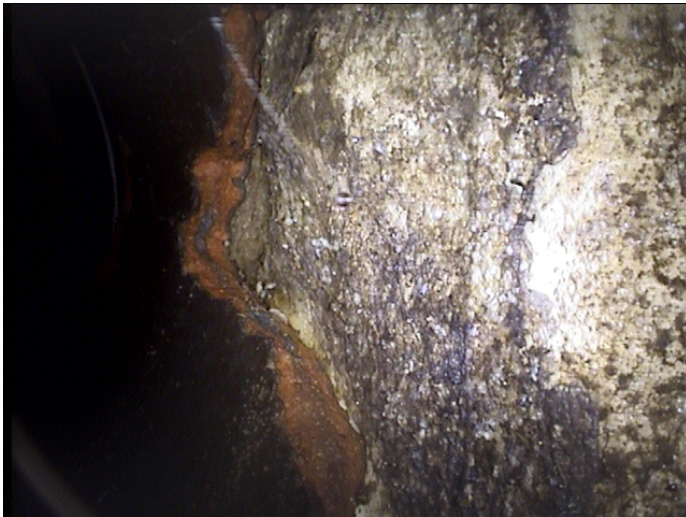
Code: **SMW**  
Description: **Surface Missing Wall**

Distance (ft): **191.9**  
Structural Grade: **5**  
O&M Grade: **0**  
Clock Start/From: **12**  
Clock To: **3**  
1st Value:  
2nd Value:  
Value Percent:  
Continuous Index:  
Within 8" of Joint: **NO**  
Remarks:

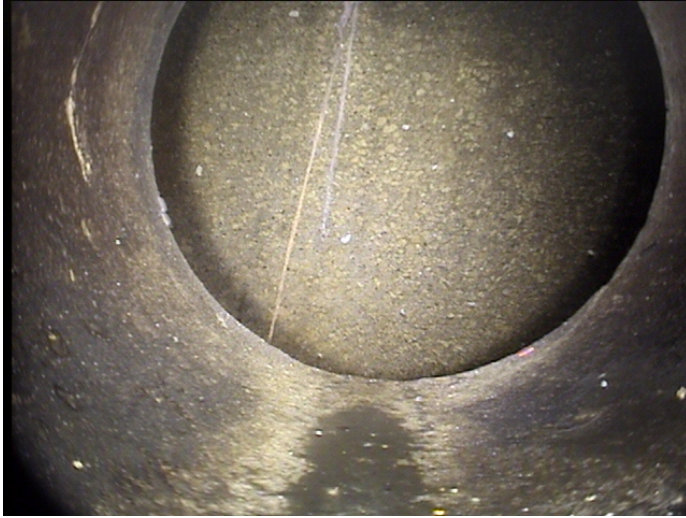
Code:	AMH
Description:	Manhole
Distance (ft):	203.0
Structural Grade:	0
O&M Grade:	0
Clock Start/From:	
Clock To:	
1st Value:	
2nd Value:	
Value Percent:	
Continuous Index:	
Within 8" of Joint:	NO
Remarks:	M-706-011
