Profile/Photo Observation Report

Date:	04/20/2018	Weather:		Coding:	PACP 6.0
Pipe Length (ft):	194.5	Owner:	NA	Pre Clean:	Not Known
P.O.#:		Surveyor:	Byrd Fitzgerald	PSR:	P-706-011.2-011.1
Customer:		Clean Date:	01/01/1900	Shape:	C

Street:	Capitol	Flow Control:	Not Controlled
City:	Hobart, IN	Year Renewed:	
Location:	Light Highway	Tape/Media #:	
Purpose:	Maintenance Related	Dia/Height:	12"
Use:	Sanitary	Material:	PVC
Drain Area:	NA	Lining:	Cured in Place
Category:	NA		
Comment:	unknown rollover at 120'. flow incorrect.

Location Details:		Direction of Survey:	Downstream
US MH:	M-706-011.1	DS MH:	M-706-011.2
		Total Length Surveyed (ft):	121.1

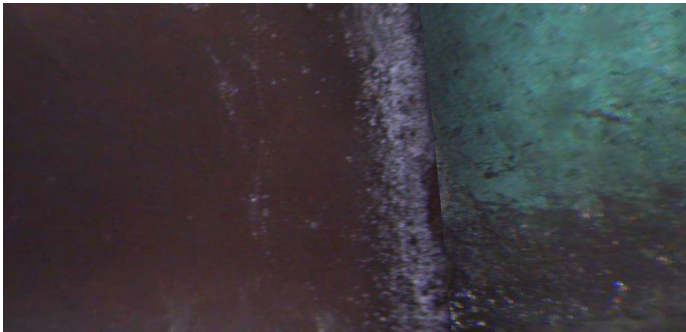
Code: **MMC**
Description: **Material Change**

Distance (ft): **15.2**
Structural Grade: **0**
O&M Grade: **0**
Clock Start/From:
Clock To:
1st Value:
2nd Value:
Value Percent:
Continuous Index:
Within 8" of Joint: **NO**
Remarks: **vcp**

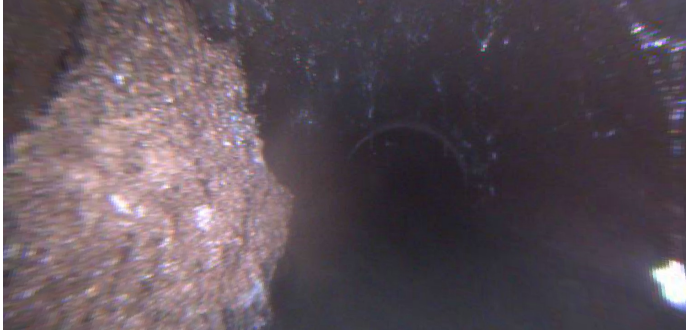
Code: **RMJ**
Description: **Roots Medium Joint**

Distance (ft): **16.9**
Structural Grade: **0**
O&M Grade: **3**
Clock Start/From: **7**
Clock To: **5**
1st Value:
2nd Value:
Value Percent: **5.000**
Continuous Index:
Within 8" of Joint: **YES**
Remarks:

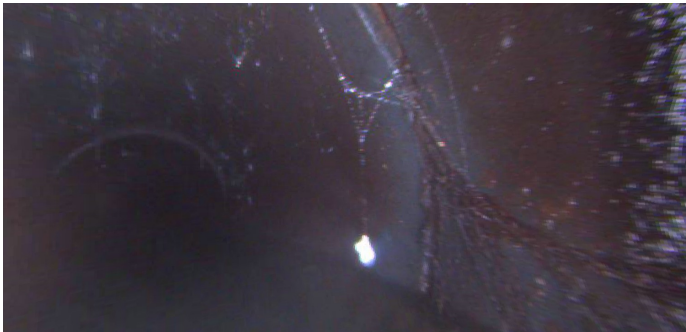
Code: **RFJ**
Description: **Roots Fine Joint**

Distance (ft): **16.9**
Structural Grade: **0**
O&M Grade: **1**
Clock Start/From: **3**
Clock To:
1st Value:
2nd Value:
Value Percent:
Continuous Index:
Within 8" of Joint: **YES**
Remarks:

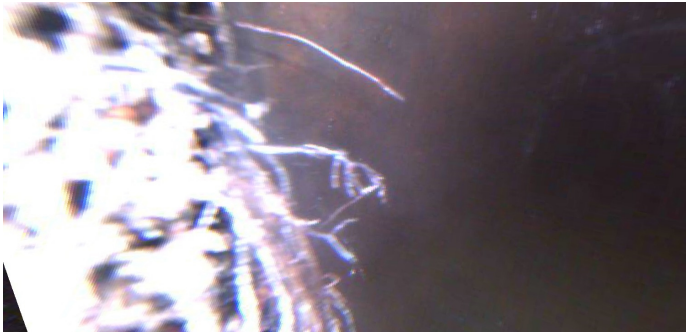
Code: **RMJ**
Description: **Roots Medium Joint**

Distance (ft): **20.8**
Structural Grade: **0**
O&M Grade: **3**
Clock Start/From: **9**
Clock To:
1st Value:
2nd Value:
Value Percent: **5.000**
Continuous Index:
Within 8" of Joint: **YES**
Remarks:

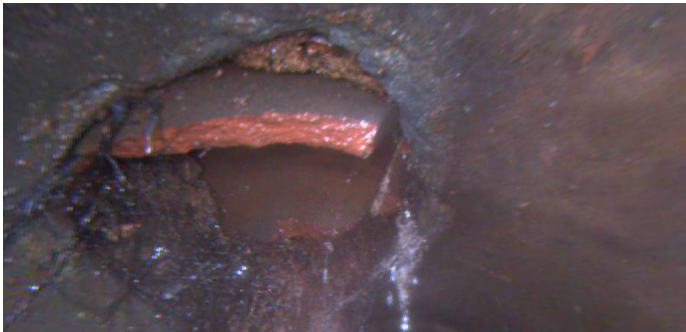
Code: **TBD**
Description: **Tap Break-in Defective**

Distance (ft): **27.7**
Structural Grade: **0**
O&M Grade: **3**
Clock Start/From: **11**
Clock To:
1st Value: **4.000**
2nd Value:
Value Percent:
Continuous Index:
Within 8" of Joint:
Remarks: **tap broken**

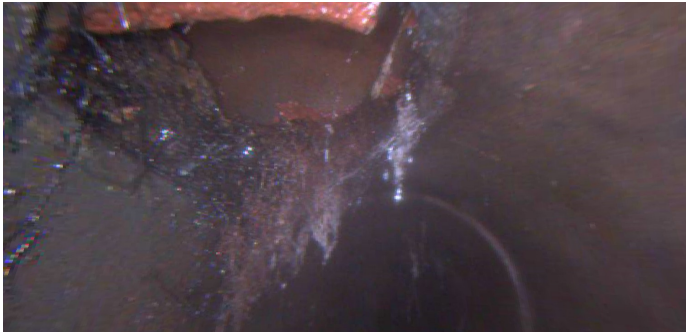
Code: **RMC**
Description: **Roots Medium Connection**

Distance (ft): **27.7**
Structural Grade: **0**
O&M Grade: **3**
Clock Start/From: **12**
Clock To: **12**
1st Value:
2nd Value:
Value Percent: **5.000**
Continuous Index:
Within 8" of Joint: **NO**
Remarks: **around tap**

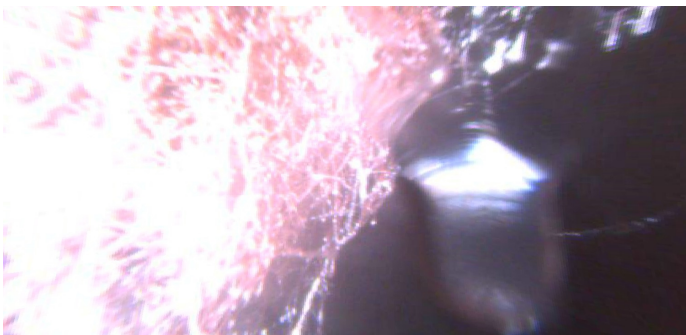
Code: **RMJ**
Description: **Roots Medium Joint**

Distance (ft): **30.9**
Structural Grade: **0**
O&M Grade: **3**
Clock Start/From: **7**
Clock To: **5**
1st Value:
2nd Value:
Value Percent: **5.000**
Continuous Index: **S01**
Within 8" of Joint: **YES**
Remarks: **wandering**

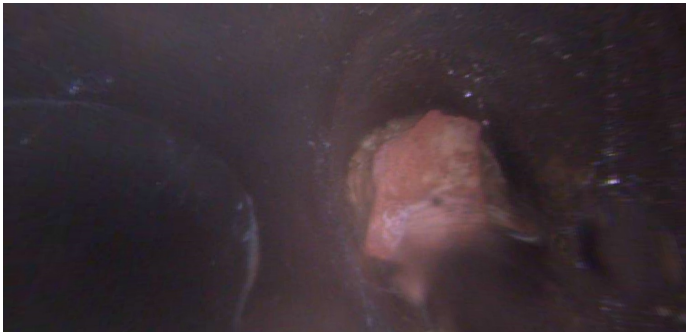
Code: **TFC**
Description: **Tap Factory Capped**

Distance (ft): **40.1**
Structural Grade: **0**
O&M Grade: **0**
Clock Start/From: **2**
Clock To:
1st Value: **4.000**
2nd Value:
Value Percent:
Continuous Index:
Within 8" of Joint: **YES**
Remarks: **capped or blocked???**

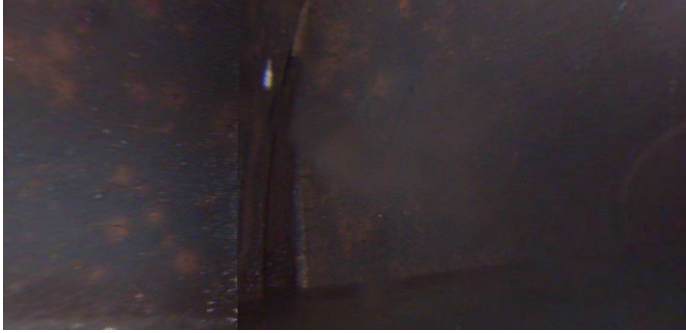
Code: **RMJ**
Description: **Roots Medium Joint**

Distance (ft): **75.9**
Structural Grade: **0**
O&M Grade: **3**
Clock Start/From: **7**
Clock To: **5**
1st Value:
2nd Value:
Value Percent: **5.000**
Continuous Index: **F01**
Within 8" of Joint: **YES**
Remarks: **wandering**

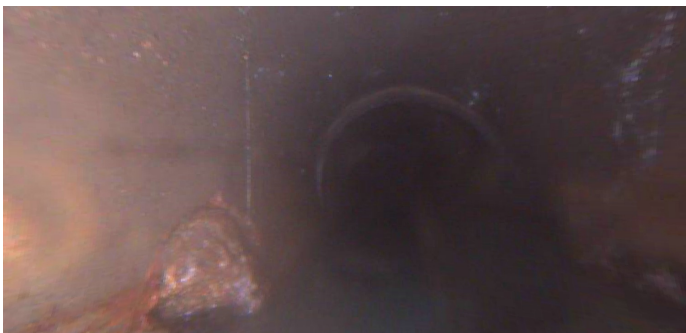
Code: **DAZ**
Description: **Deposits Attached Other**

Distance (ft): **89.6**
Structural Grade: **0**
O&M Grade: **2**
Clock Start/From: **8**
Clock To:
1st Value:
2nd Value:
Value Percent: **5.000**
Continuous Index:
Within 8" of Joint: **NO**
Remarks: **mud?**

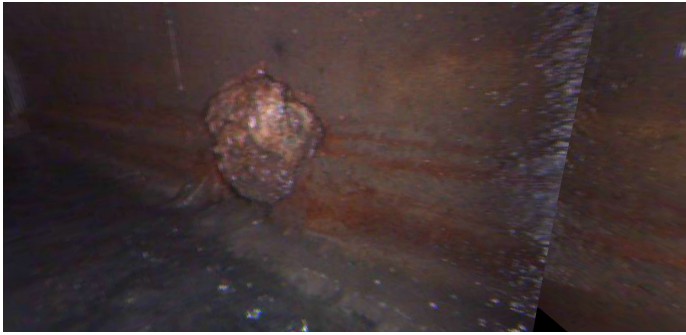
Code: **H**
Description: **Hole**

Distance (ft): **90.8**
Structural Grade: **3**
O&M Grade: **0**
Clock Start/From: **7**
Clock To:
1st Value:
2nd Value:
Value Percent:
Continuous Index:
Within 8" of Joint:
Remarks:
