## Profile/Photo Observation Report

Date:	<b>04/17/2018</b>	Weather:		Coding:	<b>PACP 6.0</b>
Pipe Length (ft):	<b>44.7</b>	Owner:	<b>NA</b>	Pre Clean:	<b>Not Known</b>
P.O.#:		Surveyor:	<b>Byrd Fitzgerald</b>	PSR:	<b>P-706-011.3-011.2</b>
Customer:		Clean Date:	<b>01/01/1900</b>	Shape:	<b>C</b>

Street:	<b>LAKE ST</b>	Flow Control:	<b>Not Controlled</b>
City:	<b>Hobart, IN</b>	Year Renewed:	
Location:	<b>Light Highway</b>	Tape/Media #:	
Purpose:	<b>Maintenance Related</b>	Dia/Height:	<b>12"</b>
Use:	<b>Sanitary</b>	Material:	<b>PVC</b>
Drain Area:	<b>NA</b>	Lining:	<b>Cured in Place</b>
Category:	<b>NA</b>		
Comment:	<b>unknown at 58'- bot dipped its front camera on the start. flow incorrect. segment further than PCM.</b>		
Location Details:		Direction of Survey:	<b>Upstream</b>
US MH:	<b>M-706-011.2</b>	DS MH:	<b>M-706-011.3</b>
		Total Length Surveyed (ft):	<b>59.9</b>

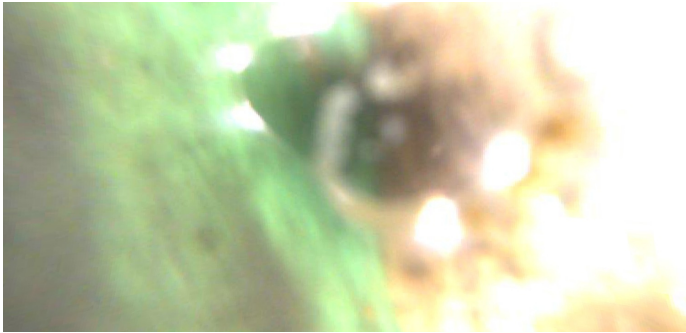
Code:	<b>MWL</b>
Description:	<b>Water Level</b>

Distance (ft):	<b>.0</b>
Structural Grade:	<b>0</b>
O&M Grade:	<b>0</b>
Clock Start/From:	
Clock To:	
1st Value:	
2nd Value:	
Value Percent:	<b>5.000</b>
Continuous Index:	
Within 8" of Joint:	<b>NO</b>
Remarks:

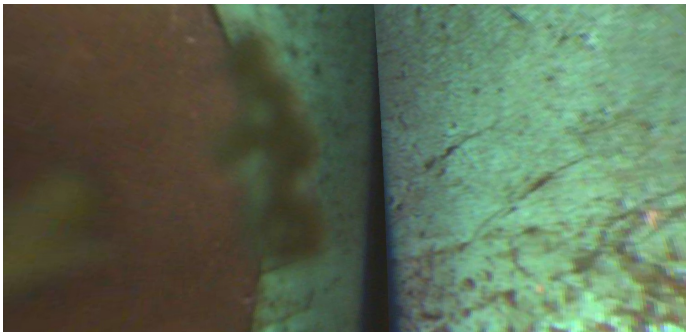
Code:	<b>MMC</b>
Description:	<b>Material Change</b>

Distance (ft):	<b>9.9</b>
Structural Grade:	<b>0</b>
O&M Grade:	<b>0</b>
Clock Start/From:	
Clock To:	
1st Value:	
2nd Value:	
Value Percent:	
Continuous Index:	
Within 8" of Joint:	<b>NO</b>
Remarks:	<b>vcp</b>

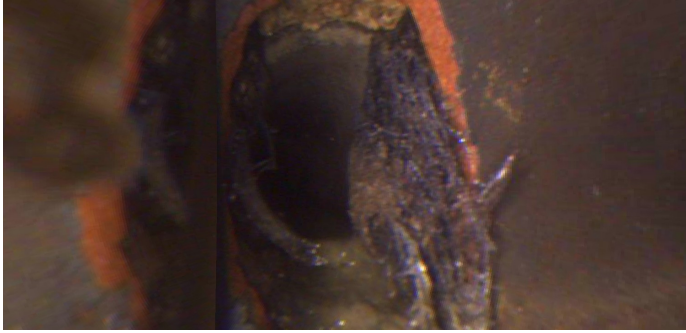
Code: **TB**  
Description: **Tap Break-in**

Distance (ft): **37.4**  
Structural Grade: **0**  
O&M Grade: **0**  
Clock Start/From: **2**  
Clock To:  
1st Value: **4.000**  
2nd Value:  
Value Percent:  
Continuous Index:  
Within 8" of Joint:  
Remarks:

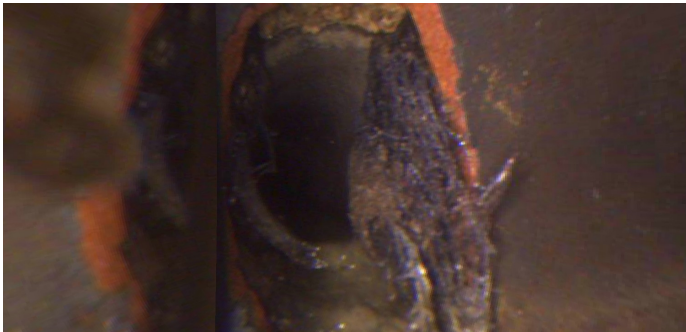
Code: **RMC**  
Description: **Roots Medium Connection**

Distance (ft): **37.4**  
Structural Grade: **0**  
O&M Grade: **3**  
Clock Start/From: **2**  
Clock To:  
1st Value:  
2nd Value:  
Value Percent: **5.000**  
Continuous Index:  
Within 8" of Joint: **NO**  
Remarks:

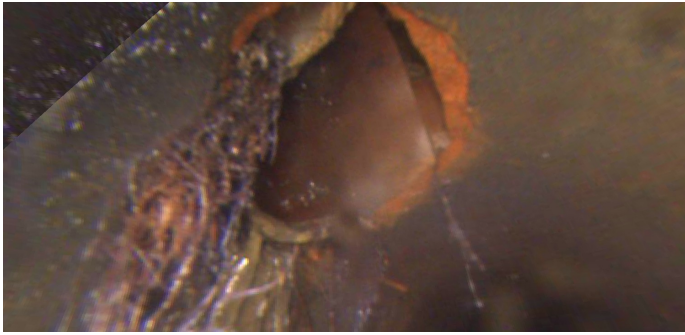
Code: **TB**  
Description: **Tap Break-in**

Distance (ft): **47.3**  
Structural Grade: **0**  
O&M Grade: **0**  
Clock Start/From: **11**  
Clock To:  
1st Value: **4.000**  
2nd Value:  
Value Percent:  
Continuous Index:  
Within 8" of Joint:  
Remarks:

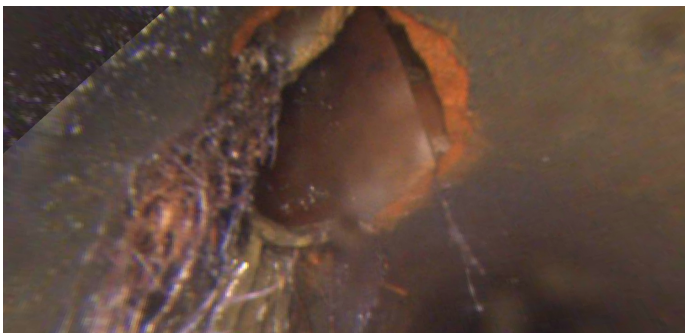
Code: **RMC**  
Description: **Roots Medium Connection**

Distance (ft): **47.3**  
Structural Grade: **0**  
O&M Grade: **3**  
Clock Start/From: **10**  
Clock To:  
1st Value:  
2nd Value:  
Value Percent: **5.000**  
Continuous Index:  
Within 8" of Joint: **NO**  
Remarks:

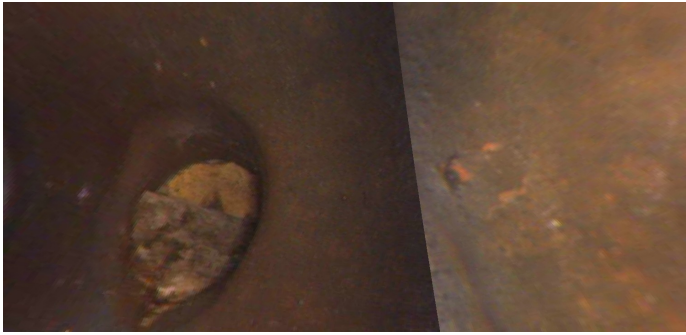
Code: **TFC**  
Description: **Tap Factory Capped**

Distance (ft): **58.2**  
Structural Grade: **0**  
O&M Grade: **0**  
Clock Start/From: **10**  
Clock To:  
1st Value: **4.000**  
2nd Value:  
Value Percent:  
Continuous Index:  
Within 8" of Joint: **YES**  
Remarks:

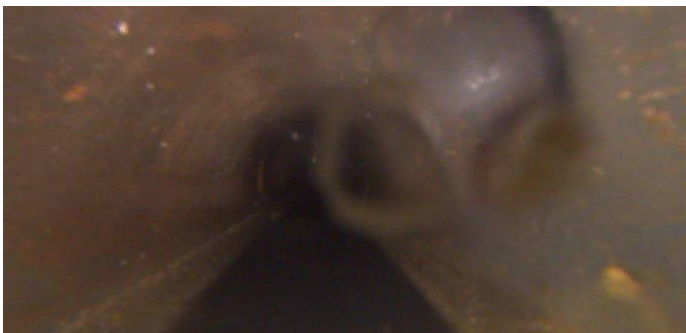
Code: **MSA**  
Description: **Abandoned Survey**

Distance (ft): **59.9**  
Structural Grade: **0**  
O&M Grade: **0**  
Clock Start/From:  
Clock To:  
1st Value:  
2nd Value:  
Value Percent:  
Continuous Index:  
Within 8" of Joint: **NO**  
Remarks: **no blockage**
