Profile/Photo Observation Report

Date:	04/17/2018	Weather:		Coding:	PACP 6.0
Pipe Length (ft):	44.7	Owner:	NA	Pre Clean:	Not Known
P.O.#:		Surveyor:	Byrd Fitzgerald	PSR:	P-706-011.3-011.2
Customer:		Clean Date:	01/01/1900	Shape:	C

Street:	Capitol	Flow Control:	Not Controlled
City:	Hobart, IN	Year Renewed:	
Location:	Light Highway	Tape/Media #:	
Purpose:	Maintenance Related	Dia/Height:	12"
Use:	Sanitary	Material:	PVC
Drain Area:	NA	Lining:	Cured in Place
Category:	NA		
Comment:	unknown at 58'- bot dipped its front camera on the start. flow incorrect. segment further than PCM.		
Location Details:		Direction of Survey:	Upstream
US MH:	M-706-011.2	DS MH:	M-706-011.3
		Total Length Surveyed (ft):	59.9

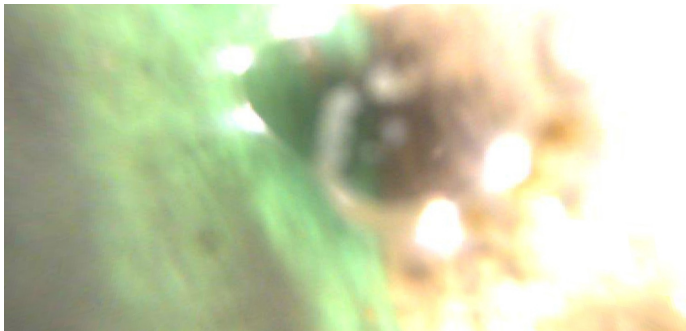
Code: **AMH**
Description: **Manhole**

Distance (ft): **.0**
Structural Grade: **0**
O&M Grade: **0**
Clock Start/From:
Clock To:
1st Value:
2nd Value:
Value Percent:
Continuous Index:
Within 8" of Joint: **NO**
Remarks: **M-706-011.3**

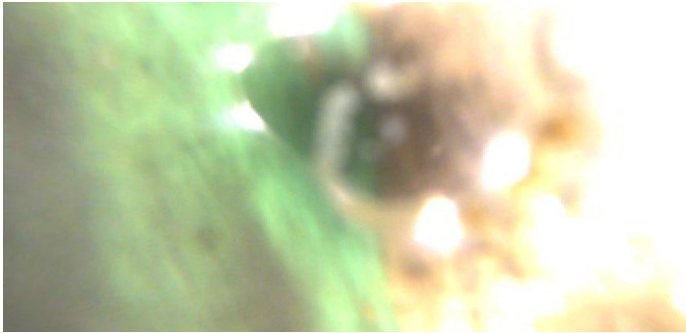
Code:	MWL
Description:	Water Level

Distance (ft):	.0
Structural Grade:	0
O&M Grade:	0
Clock Start/From:	
Clock To:	
1st Value:	
2nd Value:	
Value Percent:	5.000
Continuous Index:	
Within 8" of Joint:	NO
Remarks:

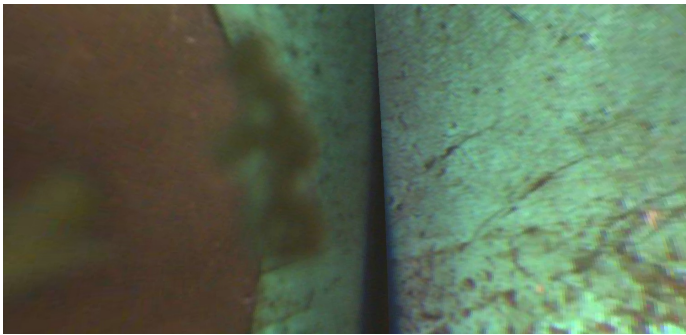
Code:	MMC
Description:	Material Change

Distance (ft):	9.9
Structural Grade:	0
O&M Grade:	0
Clock Start/From:	
Clock To:	
1st Value:	
2nd Value:	
Value Percent:	
Continuous Index:	
Within 8" of Joint:	NO
Remarks:	vcp

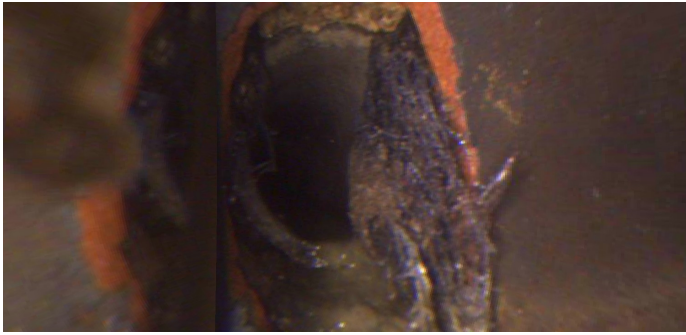
Code: **TB**
Description: **Tap Break-in**

Distance (ft): **37.4**
Structural Grade: **0**
O&M Grade: **0**
Clock Start/From: **2**
Clock To:
1st Value: **4.000**
2nd Value:
Value Percent:
Continuous Index:
Within 8" of Joint:
Remarks:

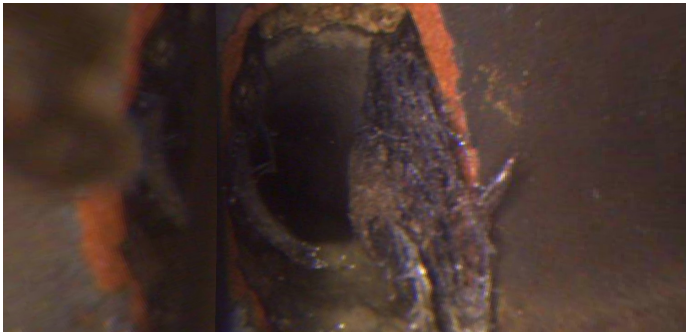
Code: **RMC**
Description: **Roots Medium Connection**

Distance (ft): **37.4**
Structural Grade: **0**
O&M Grade: **3**
Clock Start/From: **2**
Clock To:
1st Value:
2nd Value:
Value Percent: **5.000**
Continuous Index:
Within 8" of Joint: **NO**
Remarks:

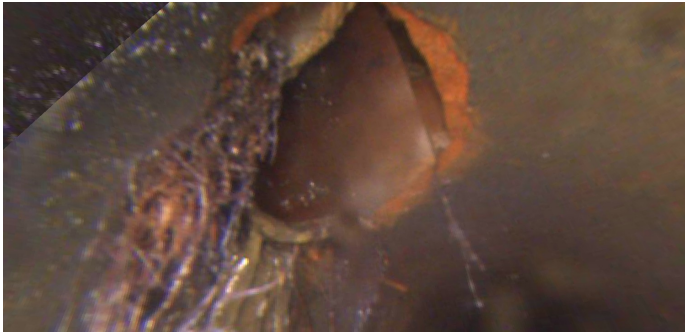
Code: **TB**
Description: **Tap Break-in**

Distance (ft): **47.3**
Structural Grade: **0**
O&M Grade: **0**
Clock Start/From: **11**
Clock To:
1st Value: **4.000**
2nd Value:
Value Percent:
Continuous Index:
Within 8" of Joint:
Remarks:

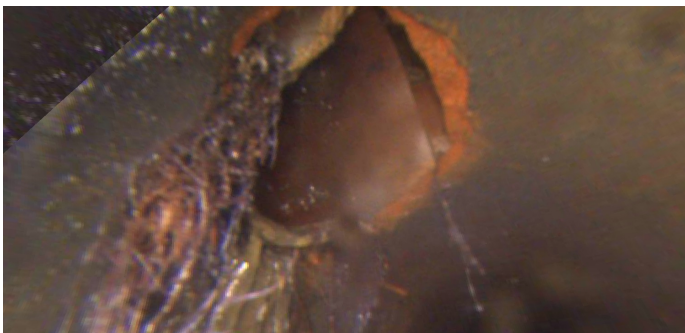
Code: **RMC**
Description: **Roots Medium Connection**

Distance (ft): **47.3**
Structural Grade: **0**
O&M Grade: **3**
Clock Start/From: **10**
Clock To:
1st Value:
2nd Value:
Value Percent: **5.000**
Continuous Index:
Within 8" of Joint: **NO**
Remarks:

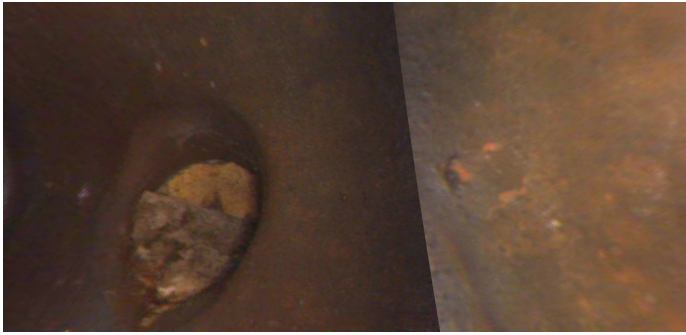
Code: **TFC**
Description: **Tap Factory Capped**

Distance (ft): **58.2**
Structural Grade: **0**
O&M Grade: **0**
Clock Start/From: **10**
Clock To:
1st Value: **4.000**
2nd Value:
Value Percent:
Continuous Index:
Within 8" of Joint: **YES**
Remarks:

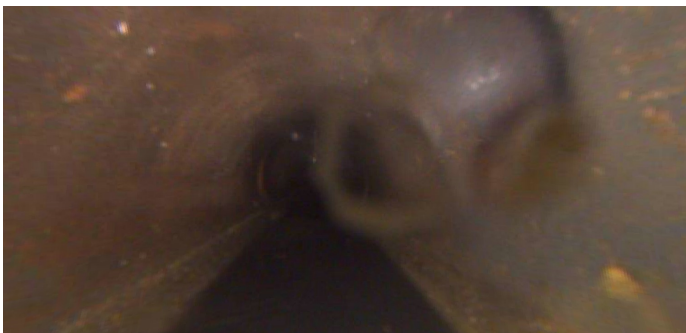
Code: **MSA**
Description: **Abandoned Survey**

Distance (ft): **59.9**
Structural Grade: **0**
O&M Grade: **0**
Clock Start/From:
Clock To:
1st Value:
2nd Value:
Value Percent:
Continuous Index:
Within 8" of Joint: **NO**
Remarks: **no blockage**
