## Profile/Photo Observation Report

Street:	<b>LAKE ST</b>	Flow Control:	<b>Not Controlled</b>
City:	<b>Hobart, IN</b>	Year Renewed:	
Location:	<b>Light Highway</b>	Tape/Media #:	
Purpose:	<b>Maintenance Related</b>	Dia/Height:	<b>12"</b>
Use:	<b>Sanitary</b>	Material:	<b>VCP</b>
Drain Area:	<b>NA</b>	Lining:	<b>Cured in Place</b>
Category:	<b>NA</b>		
Comment:	<b>heavy blk silt at 19'. flow incorrect.</b>

Location Details:		Direction of Survey:	<b>Upstream</b>
US MH:	<b>M-706-011.3</b>	DS MH:	<b>M-706-011.4</b>
		Total Length Surveyed (ft):	<b>20.1</b>

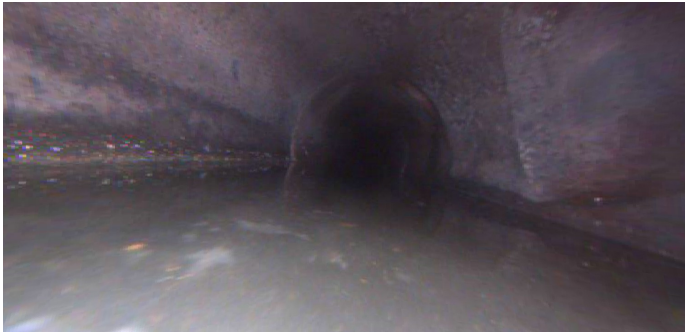
Code:	<b>MWL</b>
Description:	<b>Water Level</b>

Distance (ft):	<b>.0</b>
Structural Grade:	<b>0</b>
O&M Grade:	<b>0</b>
Clock Start/From:	
Clock To:	
1st Value:	
2nd Value:	
Value Percent:	<b>5.000</b>
Continuous Index:	
Within 8" of Joint:	<b>NO</b>
Remarks:

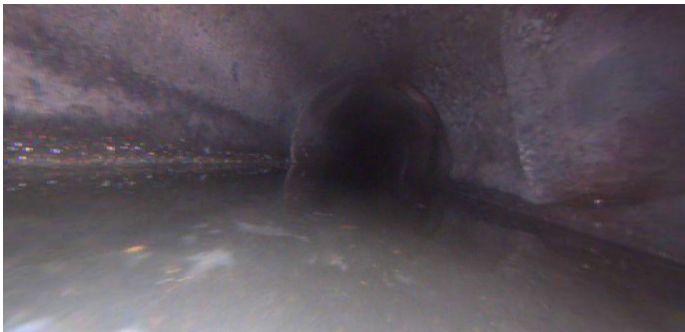
Code:	<b>TF</b>
Description:	<b>Tap Factory</b>

Distance (ft):	<b>.0</b>
Structural Grade:	<b>0</b>
O&M Grade:	<b>0</b>
Clock Start/From:	<b>10</b>
Clock To:	
1st Value:	<b>4.000</b>
2nd Value:	
Value Percent:	
Continuous Index:	
Within 8" of Joint:	
Remarks:

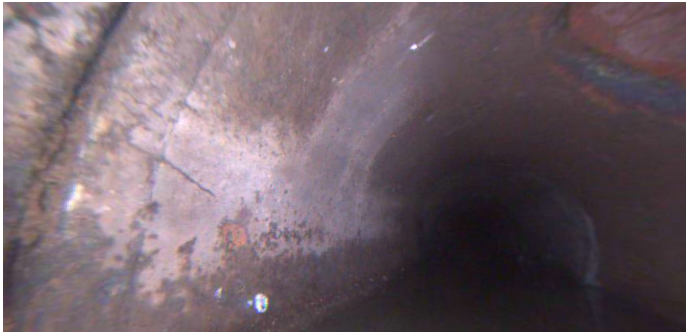
Code: **CM**  
Description: **Crack Multiple**

Distance (ft): **2.6**  
Structural Grade: **3**  
O&M Grade: **0**  
Clock Start/From: **9**  
Clock To: **10**  
1st Value:  
2nd Value:  
Value Percent:  
Continuous Index:  
Within 8" of Joint: **YES**  
Remarks:

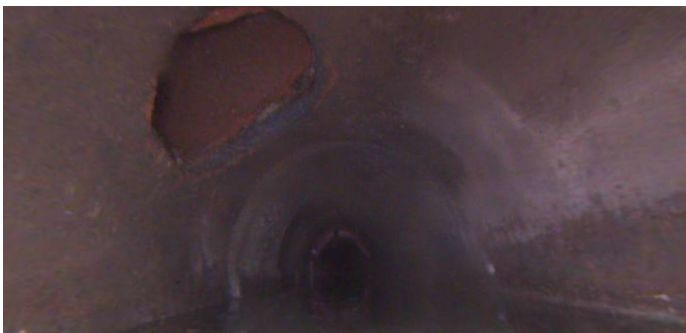
Code: **TB**  
Description: **Tap Break-in**

Distance (ft): **4.1**  
Structural Grade: **0**  
O&M Grade: **0**  
Clock Start/From: **1**  
Clock To:  
1st Value: **4.000**  
2nd Value:  
Value Percent:  
Continuous Index:  
Within 8" of Joint:  
Remarks:

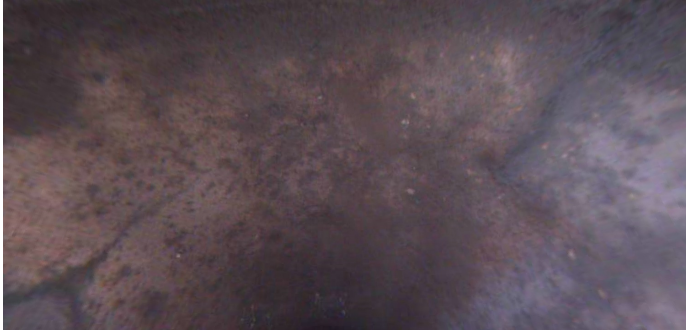
Code: **FM**  
Description: **Fracture Multiple**

Distance (ft): **4.5**  
Structural Grade: **4**  
O&M Grade: **0**  
Clock Start/From: **10**  
Clock To: **2**  
1st Value:  
2nd Value:  
Value Percent:  
Continuous Index:  
Within 8" of Joint: **YES**  
Remarks:

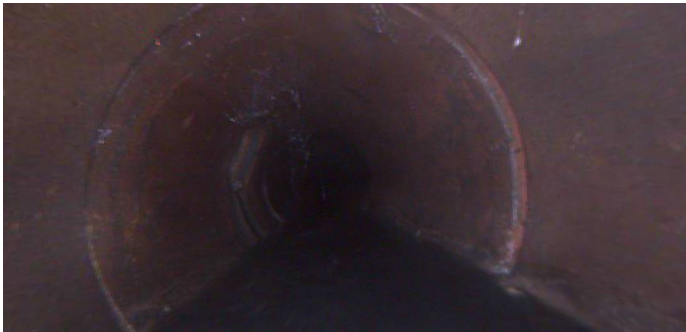
Code: **MSA**  
Description: **Abandoned Survey**

Distance (ft): **20.1**  
Structural Grade: **0**  
O&M Grade: **0**  
Clock Start/From:  
Clock To:  
1st Value:  
2nd Value:  
Value Percent:  
Continuous Index:  
Within 8" of Joint: **NO**  
Remarks: **debris**
