Profile/Photo Observation Report

Date:	04/16/2018	Weather:		Coding:	PACP 6.0
Pipe Length (ft):	235.6	Owner:	NA	Pre Clean:	Not Known
P.O.#:		Surveyor:	Selasie Honu	PSR:	P-706-011.4-011.3
Customer:		Clean Date:	01/01/1900	Shape:	C

Street:	Capitol	Flow Control:	Not Controlled
City:	Hobart, IN	Year Renewed:	
Location:	Light Highway	Tape/Media #:	
Purpose:	Maintenance Related	Dia/Height:	12"
Use:	Sanitary	Material:	VCP
Drain Area:	NA	Lining:	Cured in Place
Category:	NA		
Comment:	heavy blk silt at 19'. flow incorrect.

Location Details:	Direction of Survey:	Upstream
US MH: M-706-011.3	DS MH: M-706-011.4	Total Length Surveyed (ft): 20.1

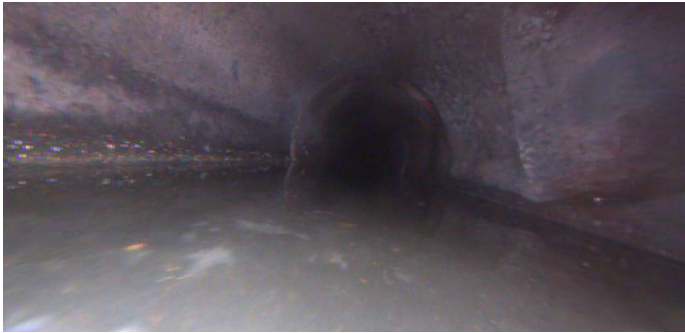
Code:	MWL
Description:	Water Level

Distance (ft):	.0
Structural Grade:	0
O&M Grade:	0
Clock Start/From:	
Clock To:	
1st Value:	
2nd Value:	
Value Percent:	5.000
Continuous Index:	
Within 8" of Joint:	NO
Remarks:

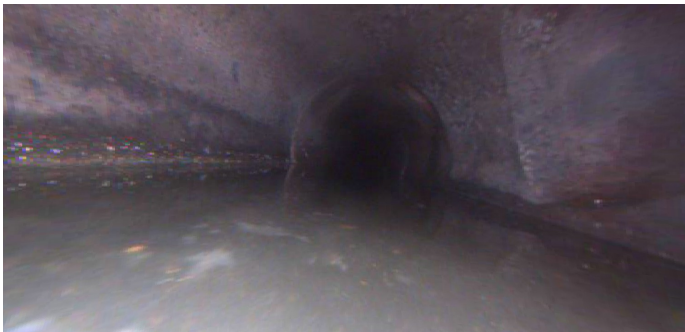
Code:	TF
Description:	Tap Factory

Distance (ft):	.0
Structural Grade:	0
O&M Grade:	0
Clock Start/From:	10
Clock To:	
1st Value:	4.000
2nd Value:	
Value Percent:	
Continuous Index:	
Within 8" of Joint:	
Remarks:

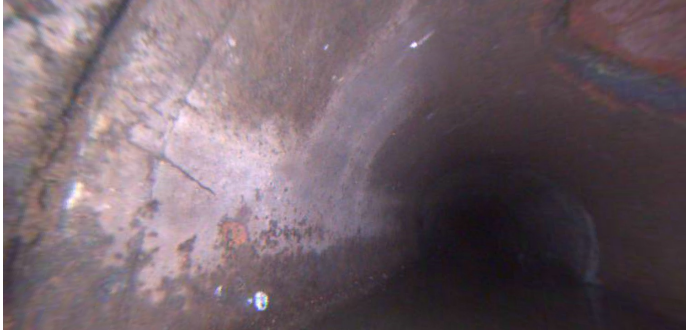
Code: **CM**
Description: **Crack Multiple**

Distance (ft): **2.6**
Structural Grade: **3**
O&M Grade: **0**
Clock Start/From: **9**
Clock To: **10**
1st Value:
2nd Value:
Value Percent:
Continuous Index:
Within 8" of Joint: **YES**
Remarks:

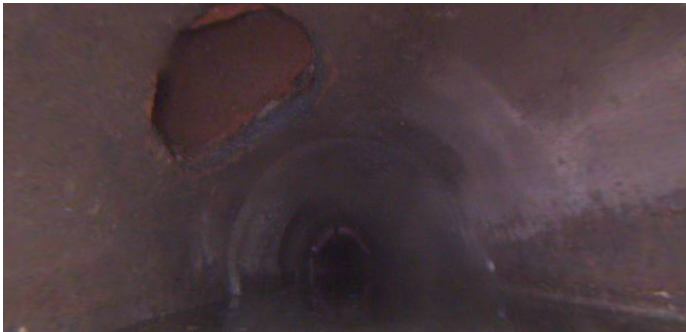
Code: **TB**
Description: **Tap Break-in**

Distance (ft): **4.1**
Structural Grade: **0**
O&M Grade: **0**
Clock Start/From: **1**
Clock To:
1st Value: **4.000**
2nd Value:
Value Percent:
Continuous Index:
Within 8" of Joint:
Remarks:

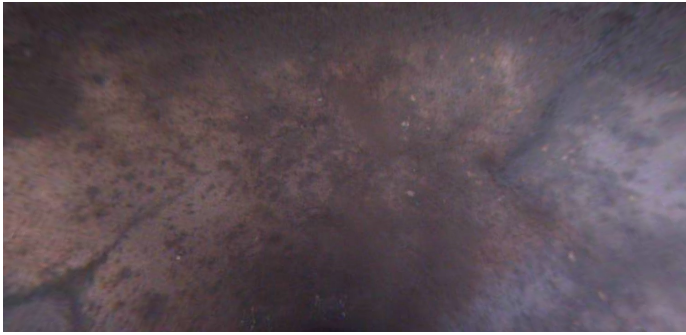
Code: **FM**
Description: **Fracture Multiple**

Distance (ft): **4.5**
Structural Grade: **4**
O&M Grade: **0**
Clock Start/From: **10**
Clock To: **2**
1st Value:
2nd Value:
Value Percent:
Continuous Index:
Within 8" of Joint: **YES**
Remarks:

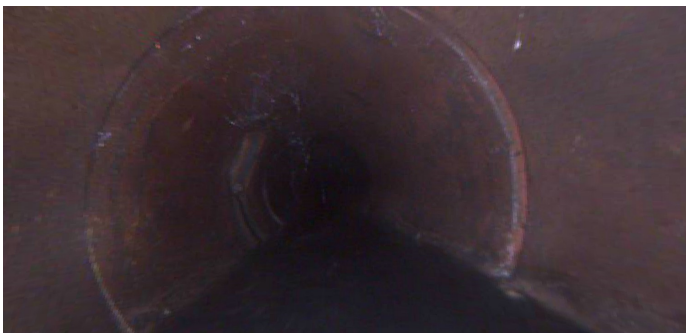
Code: **MSA**
Description: **Abandoned Survey**

Distance (ft): **20.1**
Structural Grade: **0**
O&M Grade: **0**
Clock Start/From:
Clock To:
1st Value:
2nd Value:
Value Percent:
Continuous Index:
Within 8" of Joint: **NO**
Remarks: **debris**
