## Profile/Photo Observation Report

Date:	<b>04/17/2018</b>	Weather:		Coding:	<b>PACP 6.0</b>
Pipe Length (ft):	<b>235.6</b>	Owner:	<b>NA</b>	Pre Clean:	<b>Not Known</b>
P.O.#:		Surveyor:	<b>Jen Costello</b>	PSR:	<b>P-706-011.4-011.3</b>
Customer:		Clean Date:	<b>01/01/1900</b>	Shape:	<b>C</b>

Street:	<b>LAKE ST</b>	Flow Control:	<b>Not Controlled</b>
City:	<b>Hobart, IN</b>	Year Renewed:	
Location:	<b>Light Highway</b>	Tape/Media #:	
Purpose:	<b>Maintenance Related</b>	Dia/Height:	<b>12"</b>
Use:	<b>Sanitary</b>	Material:	<b>PVC</b>
Drain Area:	<b>NA</b>	Lining:	<b>Cured in Place</b>
Category:	<b>NA</b>		
Comment:	<b>Reverse setup. heavy blk silt at 17'. -flow is incorrect.</b>		
Location Details:		Direction of Survey:	<b>Downstream</b>
US MH:	<b>M-706-011.3</b>	DS MH:	<b>M-706-011.4</b>
		Total Length Surveyed (ft):	<b>18.9</b>

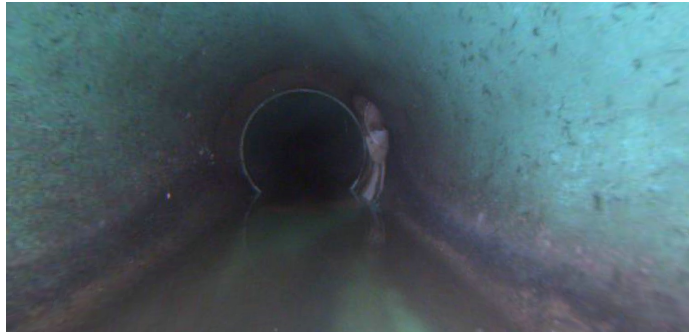
Code: **AMH**  
Description: **Manhole**

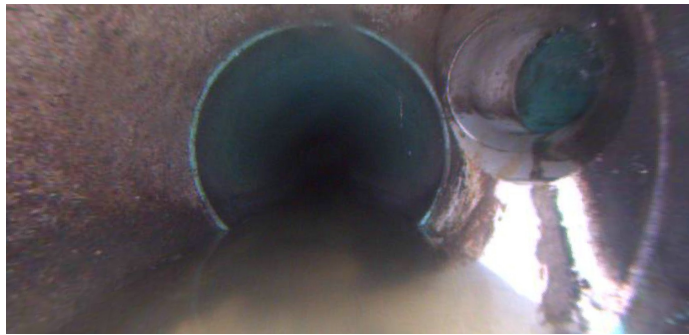
Code:	<b>MWL</b>
Description:	<b>Water Level</b>
Distance (ft):	<b>.0</b>
Structural Grade:	<b>0</b>
O&M Grade:	<b>0</b>
Clock Start/From:	
Clock To:	
1st Value:	
2nd Value:	
Value Percent:	<b>10.000</b>
Continuous Index:	
Within 8" of Joint:	<b>NO</b>
Remarks:

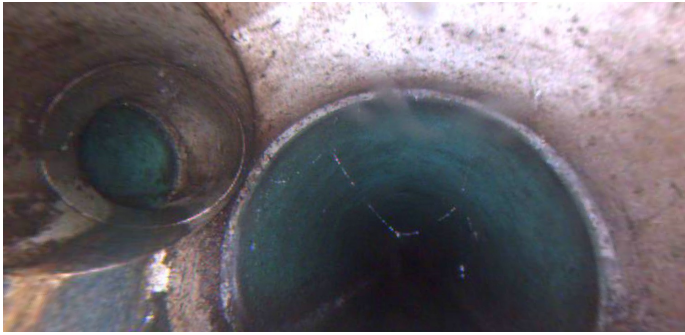
Code: **TF**  
Description: **Tap Factory**

Distance (ft): **10.0**  
Structural Grade: **0**  
O&M Grade: **0**  
Clock Start/From: **10**  
Clock To:  
1st Value: **4.000**  
2nd Value:  
Value Percent:  
Continuous Index:  
Within 8" of Joint:  
Remarks:

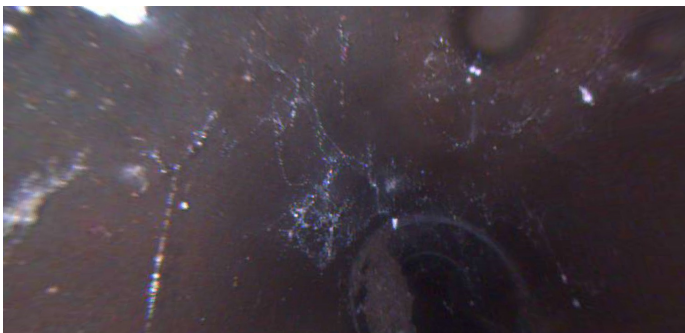
Code: **MMC**  
Description: **Material Change**

Distance (ft): **15.5**  
Structural Grade: **0**  
O&M Grade: **0**  
Clock Start/From:  
Clock To:  
1st Value:  
2nd Value:  
Value Percent:  
Continuous Index:  
Within 8" of Joint: **NO**  
Remarks: **VCP**

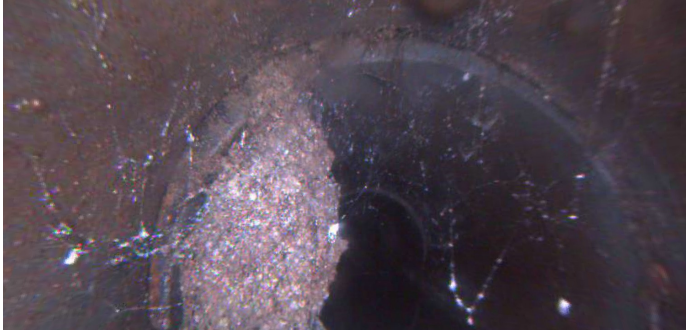
Code: **RMJ**  
Description: **Roots Medium Joint**

Distance (ft): **16.9**  
Structural Grade: **0**  
O&M Grade: **3**  
Clock Start/From: **8**  
Clock To: **4**  
1st Value:  
2nd Value:  
Value Percent: **20.000**  
Continuous Index:  
Within 8" of Joint: **YES**  
Remarks:

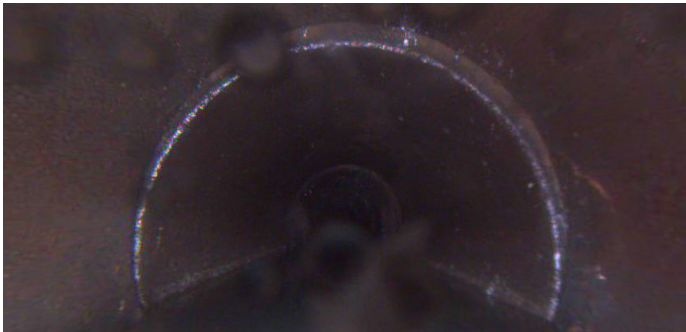
Code: **MSA**  
Description: **Abandoned Survey**

Distance (ft): **18.9**  
Structural Grade: **0**  
O&M Grade: **0**  
Clock Start/From:  
Clock To:  
1st Value:  
2nd Value:  
Value Percent:  
Continuous Index:  
Within 8" of Joint: **NO**  
Remarks: **RMJ**
