## Profile/Photo Observation Report

Date:	<b>04/17/2018</b>	Weather:		Coding:	<b>PACP 6.0</b>
Pipe Length (ft):	<b>235.6</b>	Owner:	<b>NA</b>	Pre Clean:	<b>Not Known</b>
P.O.#:		Surveyor:	<b>Jen Costello</b>	PSR:	<b>P-706-011.4-011.3</b>
Customer:		Clean Date:	<b>01/01/1900</b>	Shape:	<b>C</b>

Street:	<b>Capitol</b>	Flow Control:	<b>Not Controlled</b>
City:	<b>Hobart, IN</b>	Year Renewed:	
Location:	<b>Light Highway</b>	Tape/Media #:	
Purpose:	<b>Maintenance Related</b>	Dia/Height:	<b>12"</b>
Use:	<b>Sanitary</b>	Material:	<b>PVC</b>
Drain Area:	<b>NA</b>	Lining:	<b>Cured in Place</b>
Category:	<b>NA</b>		
Comment:	<b>Reverse setup. heavy blk silt at 17'.-flow is incorrect.</b>		
Location Details:		Direction of Survey:	<b>Downstream</b>
US MH:	<b>M-706-011.3</b>	DS MH:	<b>M-706-011.4</b>
		Total Length Surveyed (ft):	<b>18.9</b>

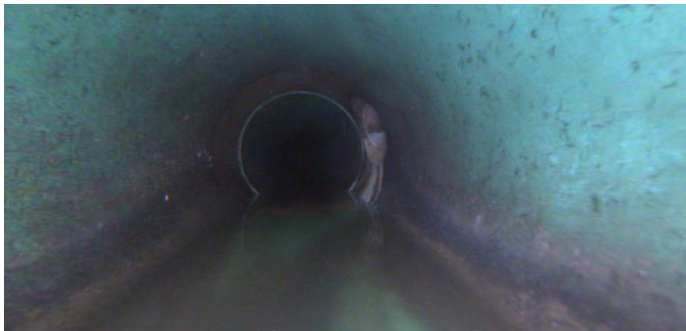
Code: **AMH**  
Description: **Manhole**

Distance (ft): **.0**  
Structural Grade: **0**  
O&M Grade: **0**  
Clock Start/From:  
Clock To:  
1st Value:  
2nd Value:  
Value Percent:  
Continuous Index:  
Within 8" of Joint: **NO**  
Remarks: **M-706-011.3**

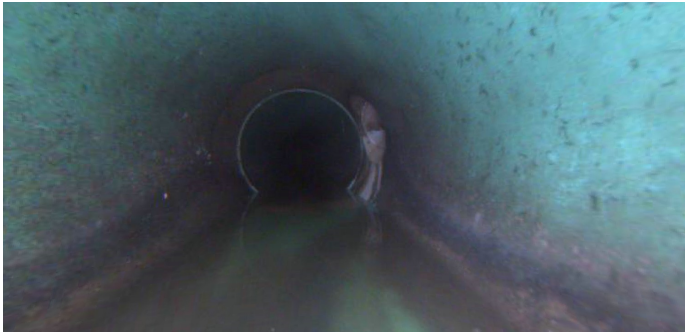
Code:	<b>MWL</b>
Description:	<b>Water Level</b>

Distance (ft):	<b>.0</b>
Structural Grade:	<b>0</b>
O&M Grade:	<b>0</b>
Clock Start/From:	
Clock To:	
1st Value:	
2nd Value:	
Value Percent:	<b>10.000</b>
Continuous Index:	
Within 8" of Joint:	<b>NO</b>
Remarks:

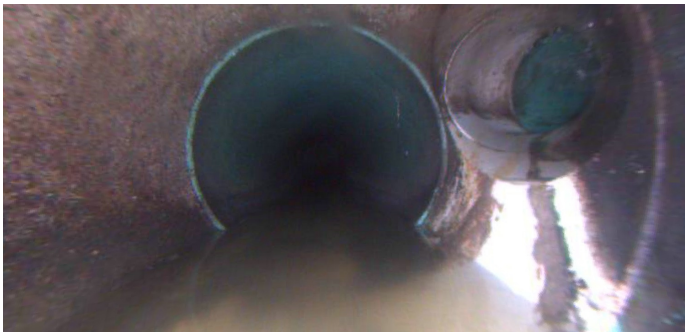
Code:	<b>TF</b>
Description:	<b>Tap Factory</b>

Distance (ft):	<b>2.2</b>
Structural Grade:	<b>0</b>
O&M Grade:	<b>0</b>
Clock Start/From:	<b>2</b>
Clock To:	
1st Value:	<b>4.000</b>
2nd Value:	
Value Percent:	
Continuous Index:	
Within 8" of Joint:	
Remarks:

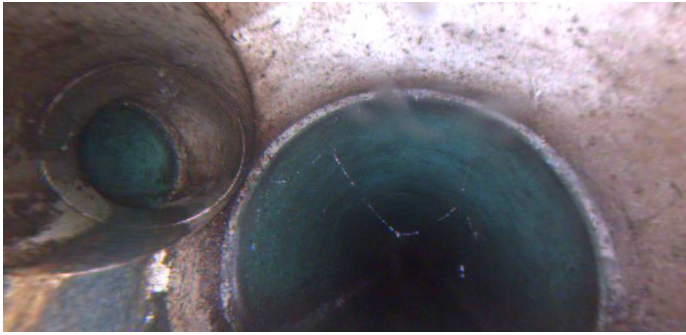
Code: **TF**  
Description: **Tap Factory**

Distance (ft): **10.0**  
Structural Grade: **0**  
O&M Grade: **0**  
Clock Start/From: **10**  
Clock To:  
1st Value: **4.000**  
2nd Value:  
Value Percent:  
Continuous Index:  
Within 8" of Joint:  
Remarks:

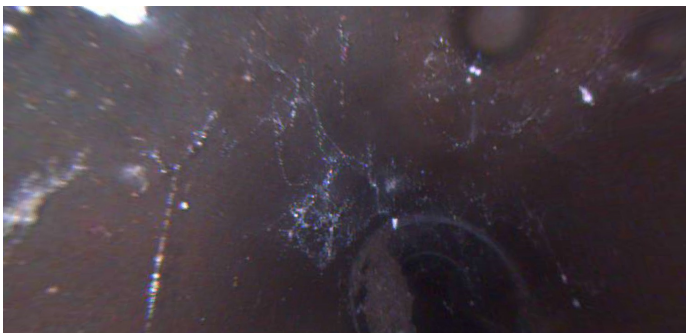
Code: **MMC**  
Description: **Material Change**

Distance (ft): **15.5**  
Structural Grade: **0**  
O&M Grade: **0**  
Clock Start/From:  
Clock To:  
1st Value:  
2nd Value:  
Value Percent:  
Continuous Index:  
Within 8" of Joint: **NO**  
Remarks: **VCP**

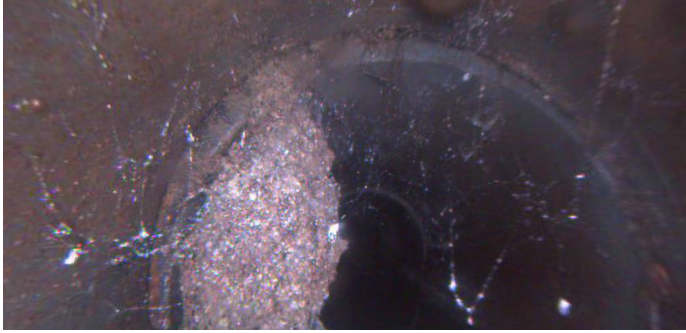
Code: **RMJ**  
Description: **Roots Medium Joint**

Distance (ft): **16.9**  
Structural Grade: **0**  
O&M Grade: **3**  
Clock Start/From: **8**  
Clock To: **4**  
1st Value:  
2nd Value:  
Value Percent: **20.000**  
Continuous Index:  
Within 8" of Joint: **YES**  
Remarks:

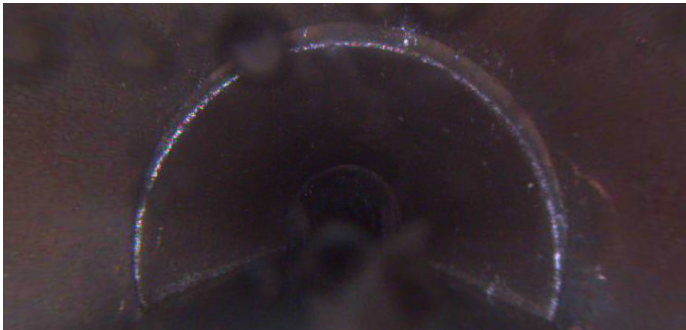
Code: **MSA**  
Description: **Abandoned Survey**

Distance (ft): **18.9**  
Structural Grade: **0**  
O&M Grade: **0**  
Clock Start/From:  
Clock To:  
1st Value:  
2nd Value:  
Value Percent:  
Continuous Index:  
Within 8" of Joint: **NO**  
Remarks: **RMJ**
