Profile/Photo Observation Report

Street:	LAKE ST	Flow Control:	Not Controlled
City:	Hobart, IN	Year Renewed:	
Location:	Light Highway	Tape/Media #:	
Purpose:	Maintenance Related	Dia/Height:	12"
Use:	Sanitary	Material:	VCP
Drain Area:	NA	Lining:	Cured in Place
Category:	NA		
Comment:	line 1/2 full of silt, spinning tracks.		
Location Details:		Direction of Survey:	Downstream
US MH:	M-706-011.4	DS MH:	M-706-011.5
		Total Length Surveyed (ft):	1.8

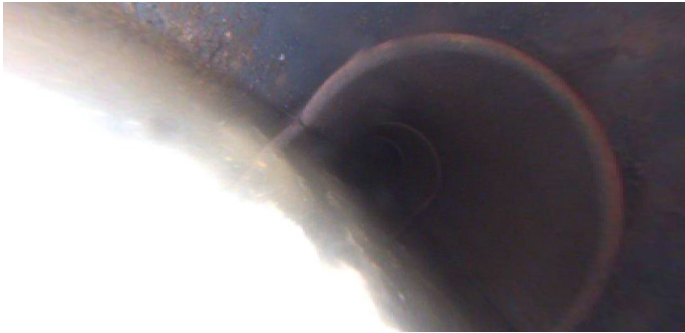
Code:	MWL
Description:	Water Level

Distance (ft):	.0
Structural Grade:	0
O&M Grade:	0
Clock Start/From:	
Clock To:	
1st Value:	
2nd Value:	
Value Percent:	5.000
Continuous Index:	
Within 8" of Joint:	NO
Remarks:
