## Profile/Photo Observation Report

Date:	<b>04/16/2018</b>	Weather:		Coding:	<b>PACP 6.0</b>
Pipe Length (ft):	<b>123.2</b>	Owner:	<b>NA</b>	Pre Clean:	<b>Not Known</b>
P.O.#:		Surveyor:	<b>Selasie Honu</b>	PSR:	<b>P-706-011.5-011.4</b>
Customer:		Clean Date:	<b>01/01/1900</b>	Shape:	<b>C</b>

Street:	<b>Capitol</b>	Flow Control:	<b>Not Controlled</b>
City:	<b>Hobart, IN</b>	Year Renewed:	
Location:	<b>Light Highway</b>	Tape/Media #:	
Purpose:	<b>Maintenance Related</b>	Dia/Height:	<b>12"</b>
Use:	<b>Sanitary</b>	Material:	<b>VCP</b>
Drain Area:	<b>NA</b>	Lining:	<b>Cured in Place</b>
Category:	<b>NA</b>		
Comment:	<b>line 1/2 full of silt, spinning tracks.</b>		
Location Details:		Direction of Survey:	<b>Downstream</b>
US MH:	<b>M-706-011.4</b>	DS MH:	<b>M-706-011.5</b>
		Total Length Surveyed (ft):	<b>1.8</b>

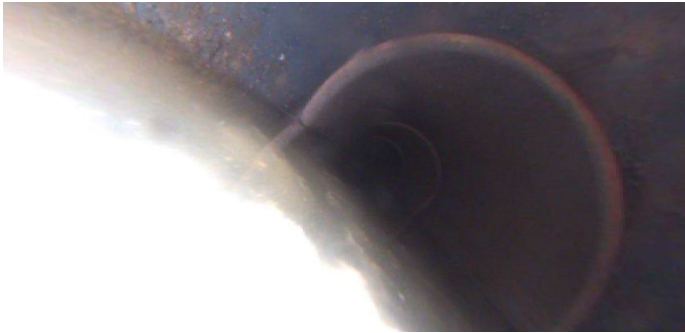
Code:	<b>MWL</b>
Description:	<b>Water Level</b>

Distance (ft):	<b>.0</b>
Structural Grade:	<b>0</b>
O&M Grade:	<b>0</b>
Clock Start/From:	
Clock To:	
1st Value:	
2nd Value:	
Value Percent:	<b>5.000</b>
Continuous Index:	
Within 8" of Joint:	<b>NO</b>
Remarks:
