## Profile/Photo Observation Report

Date:	<b>04/17/2018</b>	Weather:		Coding:	<b>PACP 6.0</b>
Pipe Length (ft):	<b>193.2</b>	Owner:	<b>NA</b>	Pre Clean:	<b>Not Known</b>
P.O.#:		Surveyor:	<b>Jen Costello</b>	PSR:	<b>P-706-011.7-011.6</b>
Customer:		Clean Date:	<b>01/01/1900</b>	Shape:	<b>C</b>

Street:	<b>Capitol</b>	Flow Control:	<b>Not Controlled</b>
City:	<b>Hobart, IN</b>	Year Renewed:	
Location:	<b>Light Highway</b>	Tape/Media #:	
Purpose:	<b>Maintenance Related</b>	Dia/Height:	<b>12"</b>
Use:	<b>Sanitary</b>	Material:	<b>VCP</b>
Drain Area:	<b>NA</b>	Lining:	<b>Cured in Place</b>
Category:	<b>NA</b>		
Comment:	<b>Reverse setup. debris rollover at 18', may be brick.</b>		
Location Details:		Direction of Survey:	<b>Upstream</b>
US MH:	<b>M-706-011.6</b>	DS MH:	<b>M-706-011.7</b>
		Total Length Surveyed (ft):	<b>19.1</b>

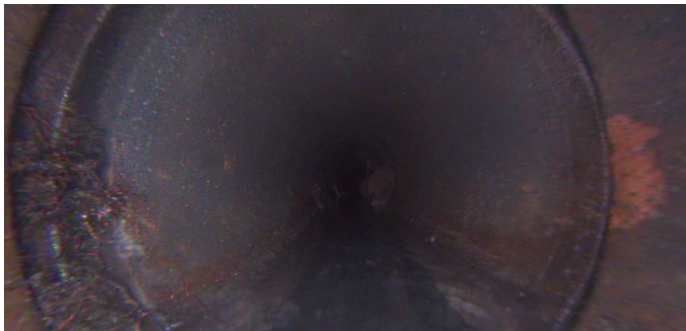
Code: **AMH**  
Description: **Manhole**

Distance (ft): **.0**  
Structural Grade: **0**  
O&M Grade: **0**  
Clock Start/From:  
Clock To:  
1st Value:  
2nd Value:  
Value Percent:  
Continuous Index:  
Within 8" of Joint: **NO**  
Remarks: **M-706-011.7**

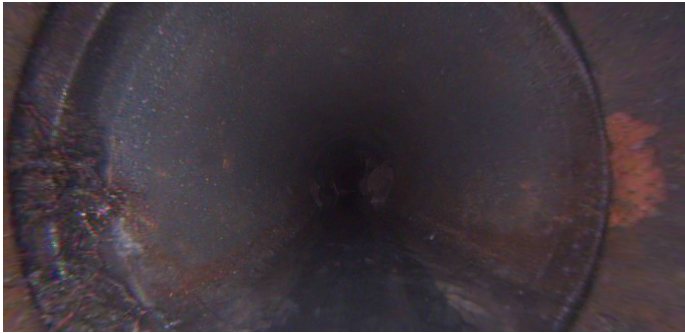
Code:	<b>MWL</b>
Description:	<b>Water Level</b>

Distance (ft):	<b>.0</b>
Structural Grade:	<b>0</b>
O&M Grade:	<b>0</b>
Clock Start/From:	
Clock To:	
1st Value:	
2nd Value:	
Value Percent:	<b>5.000</b>
Continuous Index:	
Within 8" of Joint:	<b>NO</b>
Remarks:

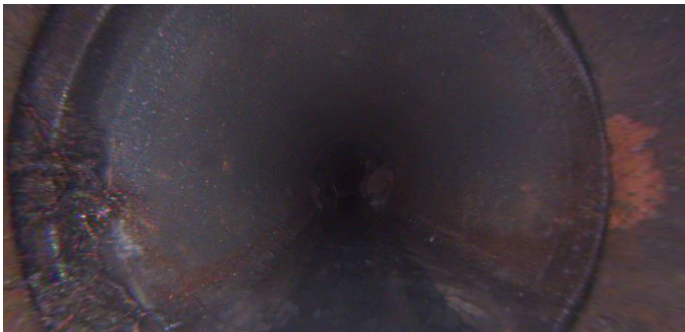
Code:	<b>RFJ</b>
Description:	<b>Roots Fine Joint</b>

Distance (ft):	<b>.0</b>
Structural Grade:	<b>0</b>
O&M Grade:	<b>1</b>
Clock Start/From:	<b>8</b>
Clock To:	<b>9</b>
1st Value:	
2nd Value:	
Value Percent:	
Continuous Index:	
Within 8" of Joint:	<b>YES</b>
Remarks:

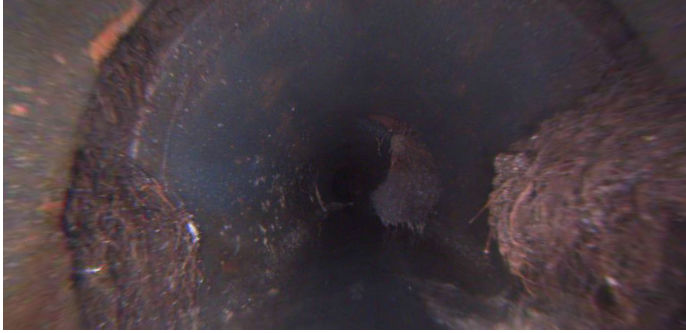
Code: **RMJ**  
Description: **Roots Medium Joint**

Distance (ft): **3.1**  
Structural Grade: **0**  
O&M Grade: **3**  
Clock Start/From: **7**  
Clock To: **5**  
1st Value:  
2nd Value:  
Value Percent: **10.000**  
Continuous Index:  
Within 8" of Joint: **YES**  
Remarks:

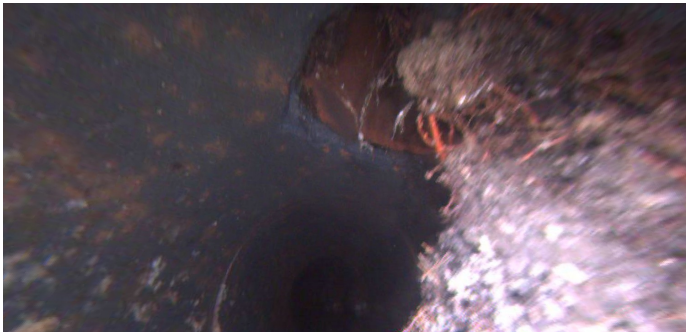
Code: **TBD**  
Description: **Tap Break-in Defective**

Distance (ft): **4.2**  
Structural Grade: **0**  
O&M Grade: **3**  
Clock Start/From: **1**  
Clock To:  
1st Value: **4.000**  
2nd Value:  
Value Percent:  
Continuous Index:  
Within 8" of Joint:  
Remarks: **rml**

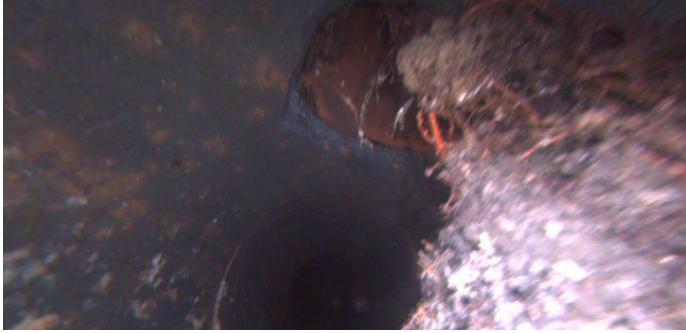
Code: **RML**  
Description: **Roots Medium Lateral**

Distance (ft): **4.2**  
Structural Grade: **0**  
O&M Grade: **3**  
Clock Start/From: **1**  
Clock To: **6**  
1st Value:  
2nd Value:  
Value Percent: **30.000**  
Continuous Index:  
Within 8" of Joint: **NO**  
Remarks:

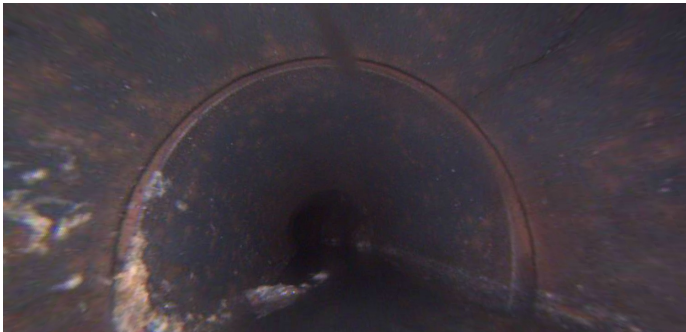
Code: **FL**  
Description: **Fracture Longitudinal**

Distance (ft): **4.8**  
Structural Grade: **3**  
O&M Grade: **0**  
Clock Start/From: **1**  
Clock To:  
1st Value:  
2nd Value:  
Value Percent:  
Continuous Index:  
Within 8" of Joint: **YES**  
Remarks:

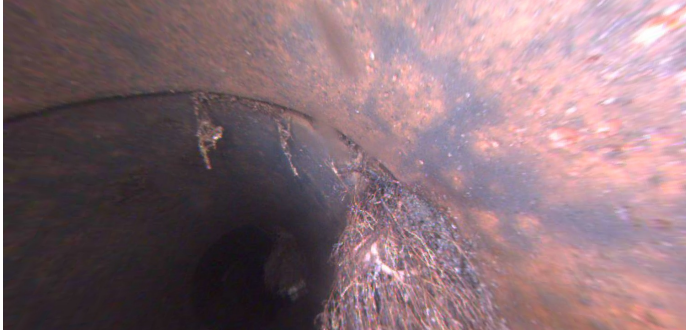
Code: **RMJ**  
Description: **Roots Medium Joint**

Distance (ft): **7.0**  
Structural Grade: **0**  
O&M Grade: **3**  
Clock Start/From: **1**  
Clock To: **4**  
1st Value:  
2nd Value:  
Value Percent: **10.000**  
Continuous Index:  
Within 8" of Joint: **YES**  
Remarks:

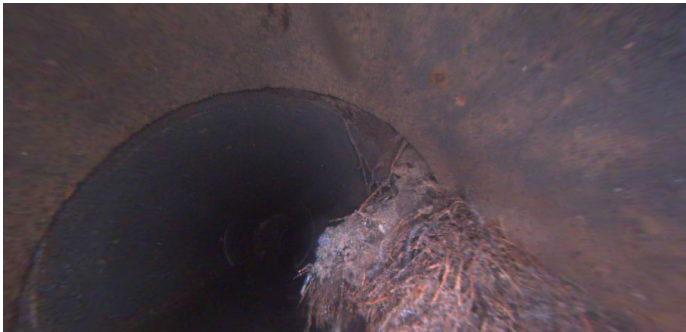
Code: **RMJ**  
Description: **Roots Medium Joint**

Distance (ft): **8.8**  
Structural Grade: **0**  
O&M Grade: **3**  
Clock Start/From: **1**  
Clock To: **4**  
1st Value:  
2nd Value:  
Value Percent: **20.000**  
Continuous Index:  
Within 8" of Joint: **YES**  
Remarks:

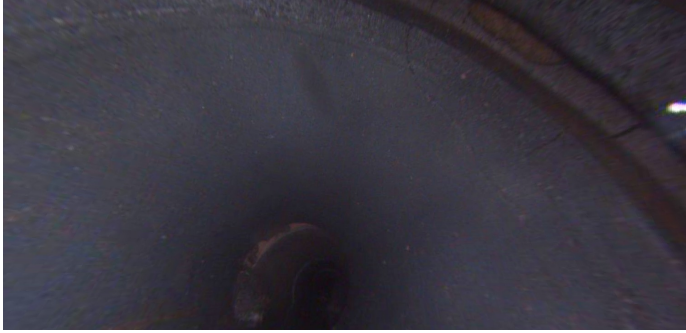
Code: **FM**  
Description: **Fracture Multiple**

Distance (ft): **11.3**  
Structural Grade: **4**  
O&M Grade: **0**  
Clock Start/From: **1**  
Clock To: **3**  
1st Value:  
2nd Value:  
Value Percent:  
Continuous Index:  
Within 8" of Joint: **YES**  
Remarks:

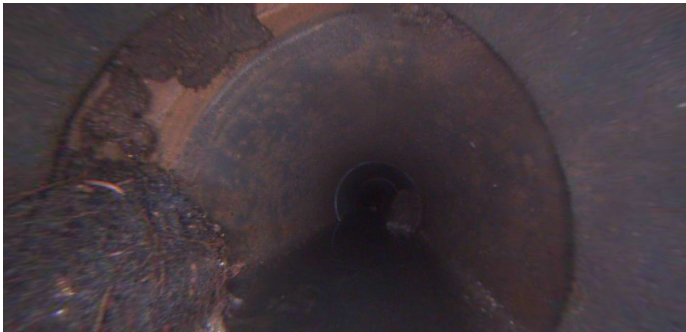
Code: **JOM**  
Description: **Joint Offset Medium**

Distance (ft): **12.9**  
Structural Grade: **1**  
O&M Grade: **0**  
Clock Start/From:  
Clock To:  
1st Value:  
2nd Value:  
Value Percent:  
Continuous Index:  
Within 8" of Joint: **NO**  
Remarks:

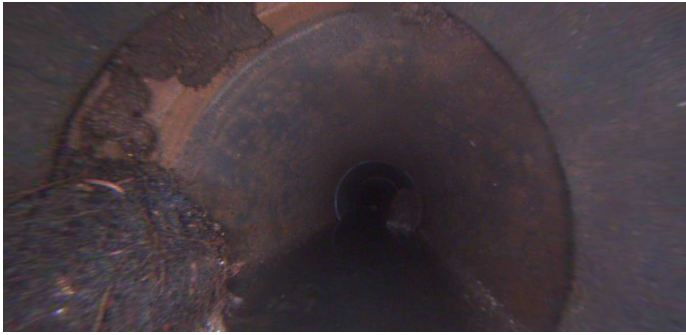
Code: **RMJ**  
Description: **Roots Medium Joint**

Distance (ft): **12.9**  
Structural Grade: **0**  
O&M Grade: **3**  
Clock Start/From: **7**  
Clock To: **11**  
1st Value:  
2nd Value:  
Value Percent: **10.000**  
Continuous Index:  
Within 8" of Joint: **YES**  
Remarks:

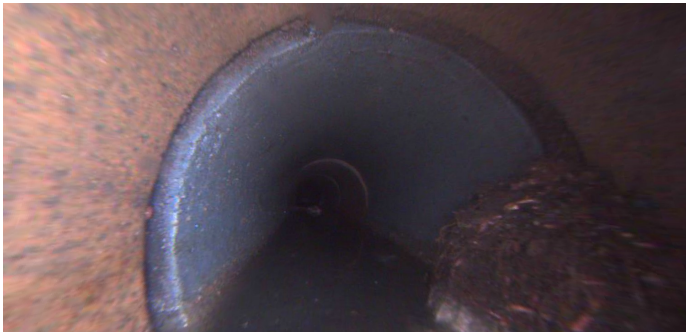
Code: **RMJ**  
Description: **Roots Medium Joint**

Distance (ft): **15.0**  
Structural Grade: **0**  
O&M Grade: **3**  
Clock Start/From: **3**  
Clock To: **5**  
1st Value:  
2nd Value:  
Value Percent: **15.000**  
Continuous Index:  
Within 8" of Joint: **YES**  
Remarks:

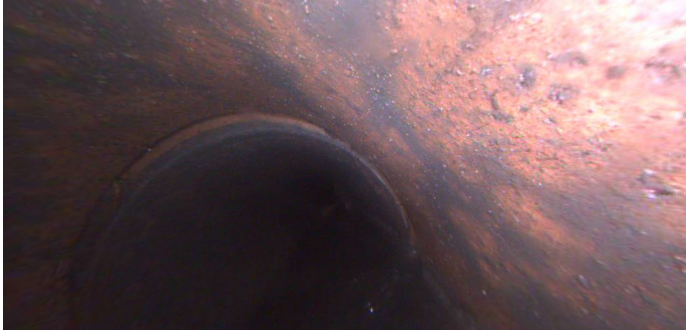
Code: **RFJ**  
Description: **Roots Fine Joint**

Distance (ft): **19.1**  
Structural Grade: **0**  
O&M Grade: **1**  
Clock Start/From: **8**  
Clock To: **11**  
1st Value:  
2nd Value:  
Value Percent:  
Continuous Index:  
Within 8" of Joint: **YES**  
Remarks:

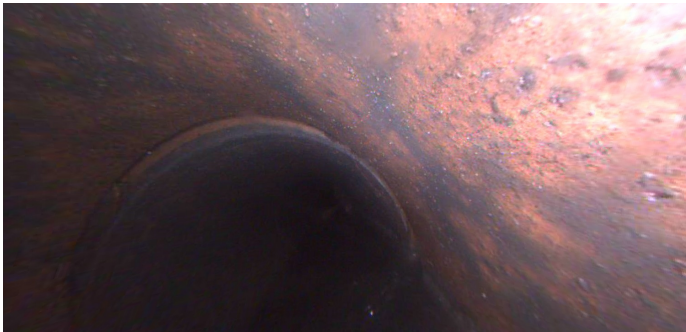
Code: **MSA**  
Description: **Abandoned Survey**

Distance (ft): **19.1**  
Structural Grade: **0**  
O&M Grade: **0**  
Clock Start/From:  
Clock To:  
1st Value:  
2nd Value:  
Value Percent:  
Continuous Index:  
Within 8" of Joint: **NO**  
Remarks: **roots**
