Profile/Photo Observation Report

Profile/Photo Observation Report							
Date: 04/29/2018 Pipe Length (ft):		Weather: Owner: City of Hobart		Coding: Pre Clean:	PACP 6.0 Not Known		
P.O.#:	260	Surveyor:	B. Helbling	PSR:	P-706-011.8-011.7		
Customer:	City of Hobart	Clean Date:		Shape:	С		
Street:	Lake Street		Flow Control:	Not Controlled	I		
City:	Hobart, IN		Year Renewed:				
Location:	Light Highway		Tape/Media #:	DEP260			
Purpose:	Routine Assessment		Dia/Height:	12"			
Use:	Sanitary		Material:	PVC			
Drain Area:			Lining:				
Category:	NA						
Comment:	5-21-2018						
Location Detai	ils:		Direction of Survey	/: Downstream			
US MH:	M-706-011.8	DS MH: N	1-706-011.7	Total Length Surveyed (ft): 3.9		
O&M Index:	3.00	O&M Quick:	3100	O&M Rating:	3.00		
Structural Index	. 0.00	— Structural Quic	k: 0000	Structural Rating	0.00		
Overall Index:	3.00	Overall Quick:	3100	Overall Rating:	3.00

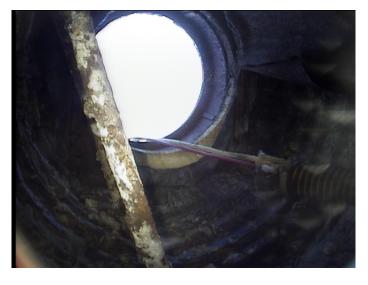
Description:	Manhole		
Distance (ft):	.0		
Structural Grade:	0		
O&M Grade:	0		
Clock Start/From:			
Clock To:			
1st Value:			
2nd Value:			
Value Percent:			
Continuous Index:			
Within 8" of Joint:	NO		
Remarks:	M-706-011.8

AMH

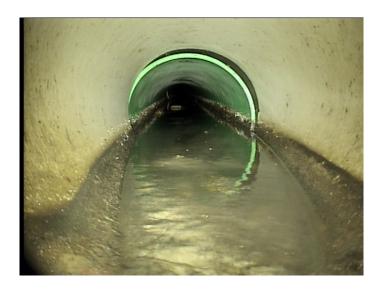
Code: MWL

Description: Water Level

Distance (ft): .0
Structural Grade: 0
O&M Grade: 0

Value Percent: 5.000

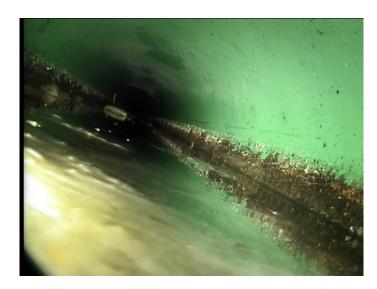
Code: MWL
Description: Water Level

Distance (ft): 1.2
Structural Grade: 0
O&M Grade: 0
Clock Start/From:

Value Percent: 30.000

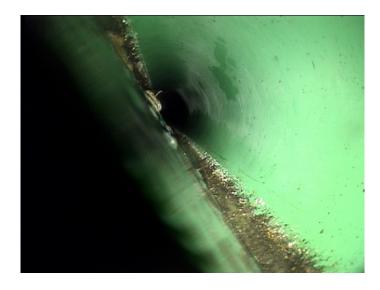
Code: **DSF**

Description: Deposits Settled Fine

Distance (ft): 3.8
Structural Grade: 0
O&M Grade: 3
Clock Start/From: 4
Clock To: 8

20.000

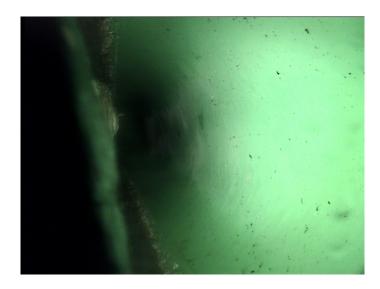
Code: MSA

Description: Abandoned Survey

Distance (ft): 3.9
Structural Grade: 0

Remarks: **Heavy sediment**
