Profile/Photo Observation Report

Date:	10/21/2021	Weather:		Coding:	PACP 6.0
Pipe Length (ft):		Owner:	Hobart, IN	Pre Clean:	Not Known
P.O.#:	941_1	Surveyor:	M. Pielacha	PSR:	P-707-068-011.8
Customer:	Hobart, IN	Clean Date:		Shape:	C

Street:	10th Street	Flow Control:	
City:	Hobart, IN	Year Renewed:	
Location:	Light Highway	Tape/Media #:	941
Purpose:	Routine Assessment	Dia/Height:	12"
Use:	Sanitary	Material:	PVC
Drain Area:		Lining:	
Category:	NA		
Comment:

Location Details:		Direction of Survey:	Downstream
US MH:	M-706-11.8	DS MH:	M-707-68
		Total Length Surveyed (ft):	24.8

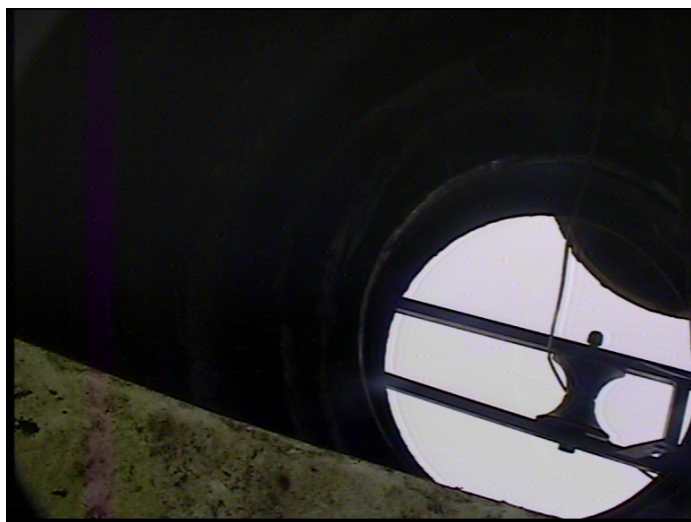
Code: **AMH**
Description: **Manhole**

Distance (ft): **.0**
Structural Grade: **0**
O&M Grade: **0**
Clock Start/From:
Clock To:
1st Value:
2nd Value:
Value Percent:
Continuous Index:
Within 8" of Joint: **NO**
Remarks: **M-706-11.8**

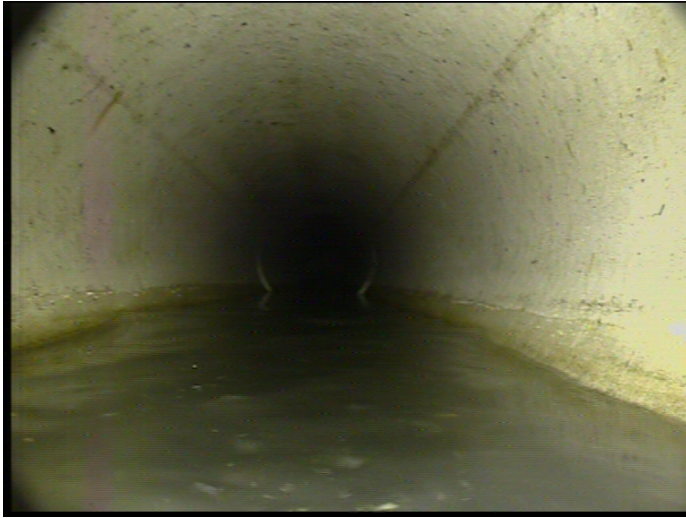
Code: **MWL**
Description: **Water Level**

Distance (ft): **.0**
Structural Grade: **0**
O&M Grade: **0**
Clock Start/From:
Clock To:
1st Value:
2nd Value:
Value Percent: **10.000**
Continuous Index:
Within 8" of Joint: **NO**
Remarks:

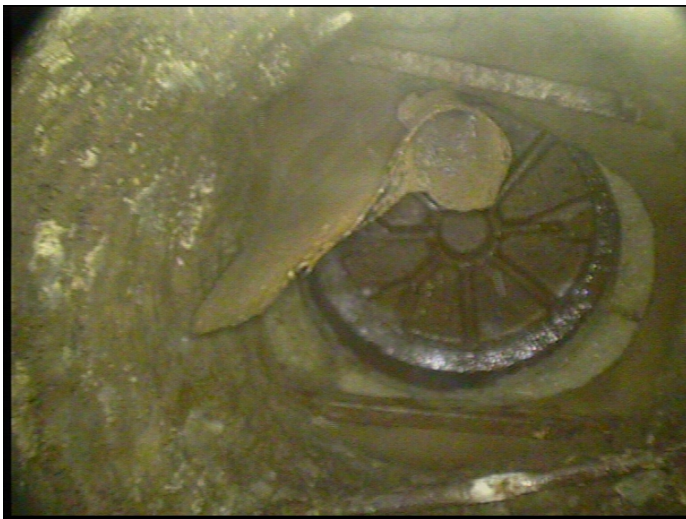
Code: **AMH**
Description: **Manhole**

Distance (ft): **24.8**
Structural Grade: **0**
O&M Grade: **0**
Clock Start/From:
Clock To:
1st Value:
2nd Value:
Value Percent:
Continuous Index:
Within 8" of Joint: **NO**
Remarks: **M-707-68**
