## **Profile/Photo Observation Report**

Profile/Photo Observation Report							
Date: Pipe Length ( P.O.#: Customer:	05/02/2018 (ft): 279 City of Hobart	Weather: Owner: Surveyor: Clean Date:	City of Hobart B. Helbling	Coding: Pre Clean: PSR: Shape:	PACP 6.0 Not Known P-706-013-012 C		
Street:	Water Street		Flow Control:	Not Controlled			
City:	Hobart, IN		Year Renewed:				
Location:	<b>Light Highway</b>		Tape/Media #:	DEP279			
Purpose:	Routine Assessment	:	Dia/Height:	12"			
Use:	Sanitary		Material:	PVC			
Drain Area:			Lining:				
Category:	NA						
Comment:	5-21-2018						
Location Details:			Direction of Survey	: Downstream			
US MH:	M-706-012	DS MH:	M-706-013	Total Length Surveyed (ft)	: <b>126.2</b>		
O&M Index:	0.00	O&M Quick:	0000	O&M Rating:	0.00		
Structural Inde	ex: 0.00	 Structural Qui	ck: <b>0000</b>	Structural Rating:	0.00		
Overall Index:	0.00	— Overall Quick:	0000	Overall Rating:	0.00

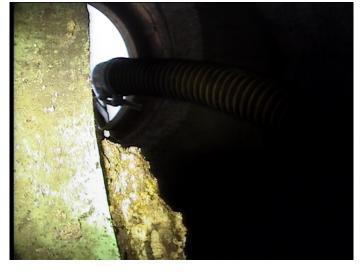
Description:	Manhole		
Distance (ft):	.0		
Structural Grade:	0		
O&M Grade:	0		
Clock Start/From:			
Clock To:			
1st Value:			
2nd Value:			
Value Percent:			
Continuous Index:			
Within 8" of Joint:	NO		
Remarks:	M-706-013

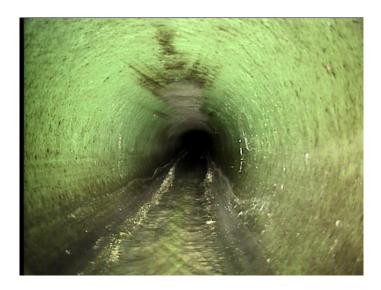
Code: MWL
Description: Water Level

Distance (ft): .0
Structural Grade: 0
O&M Grade: 0
Clock Start/From:

Value Percent: 5.000

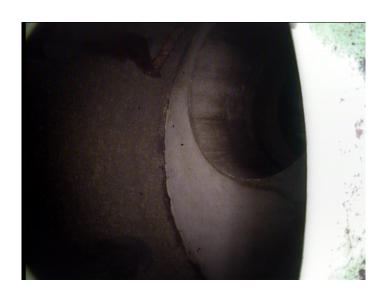
Code: AMH
Description: Manhole

Distance (ft): 126.2
Structural Grade: 0
O&M Grade: 0
Clock Start/From:

Remarks: M-706-012
