## Profile/Photo Observation Report

Street:	<b>Capitol</b>	Flow Control:	<b>Not Controlled</b>
City:	<b>Hobart, IN</b>	Year Renewed:	
Location:	<b>Light Highway</b>	Tape/Media #:	
Purpose:	<b>Maintenance Related</b>	Dia/Height:	<b>12"</b>
Use:	<b>Sanitary</b>	Material:	<b>PVC</b>
Drain Area:	<b>NA</b>	Lining:	<b>Cured in Place</b>
Category:	<b>NA</b>		
Comment:	<b>Reverse setup. blk silt at 101'.</b>

Location Details:		Direction of Survey:	<b>Upstream</b>
US MH:	<b>M-706-013</b>	DS MH:	<b>M-706-013.1</b>
		Total Length Surveyed (ft):	<b>102.9</b>

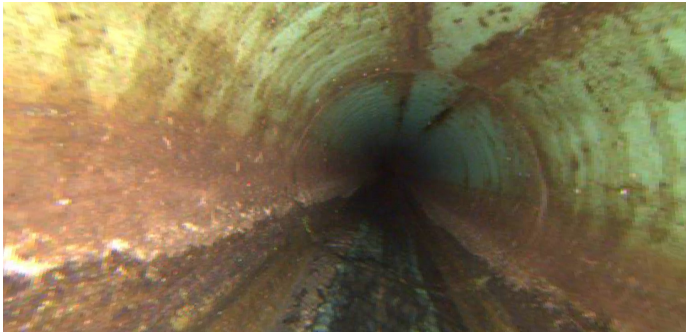
Code:	<b>MWL</b>
Description:	<b>Water Level</b>

Distance (ft):	<b>.0</b>
Structural Grade:	<b>0</b>
O&M Grade:	<b>0</b>
Clock Start/From:	
Clock To:	
1st Value:	
2nd Value:	
Value Percent:	<b>5.000</b>
Continuous Index:	
Within 8" of Joint:	<b>NO</b>
Remarks:

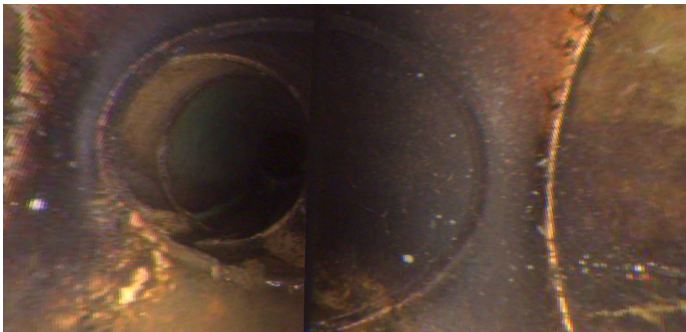
Code:	<b>TF</b>
Description:	<b>Tap Factory</b>

Distance (ft):	<b>53.8</b>
Structural Grade:	<b>0</b>
O&M Grade:	<b>0</b>
Clock Start/From:	<b>9</b>
Clock To:	
1st Value:	<b>4.000</b>
2nd Value:	
Value Percent:	
Continuous Index:	
Within 8" of Joint:	<b>YES</b>
Remarks:

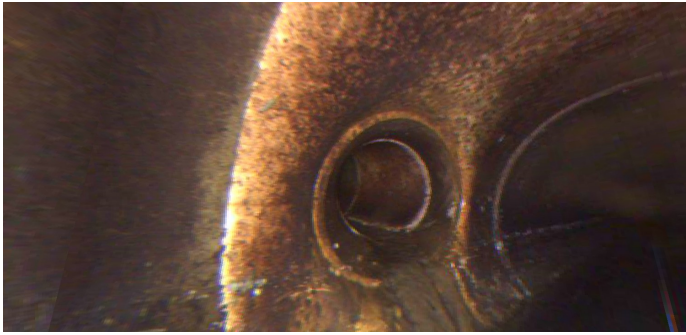
Code: **TF**  
Description: **Tap Factory**

Distance (ft): **63.7**  
Structural Grade: **0**  
O&M Grade: **0**  
Clock Start/From: **3**  
Clock To:  
1st Value: **4.000**  
2nd Value:  
Value Percent:  
Continuous Index:  
Within 8" of Joint: **YES**  
Remarks:

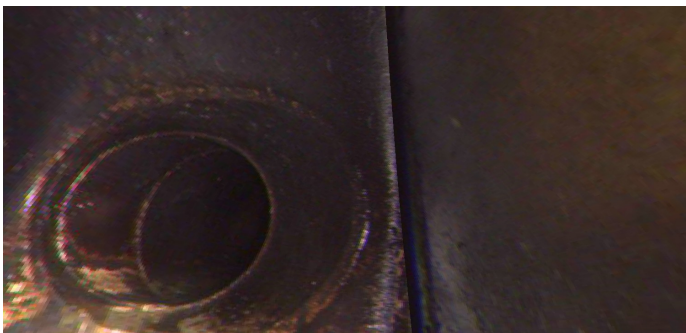
Code: **TF**  
Description: **Tap Factory**

Distance (ft): **84.6**  
Structural Grade: **0**  
O&M Grade: **0**  
Clock Start/From: **10**  
Clock To:  
1st Value: **4.000**  
2nd Value:  
Value Percent:  
Continuous Index:  
Within 8" of Joint: **YES**  
Remarks:

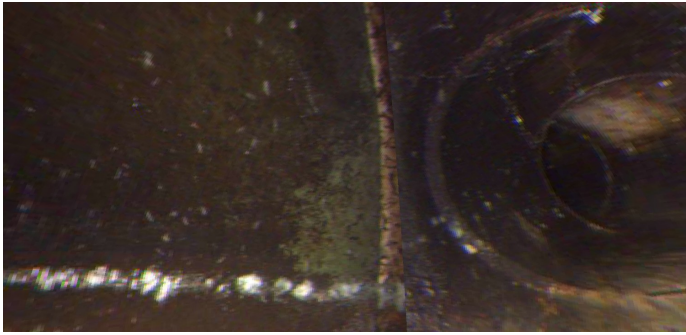
Code: **TF**  
Description: **Tap Factory**

Distance (ft): **98.2**  
Structural Grade: **0**  
O&M Grade: **0**  
Clock Start/From: **3**  
Clock To:  
1st Value: **4.000**  
2nd Value:  
Value Percent:  
Continuous Index:  
Within 8" of Joint: **YES**  
Remarks:

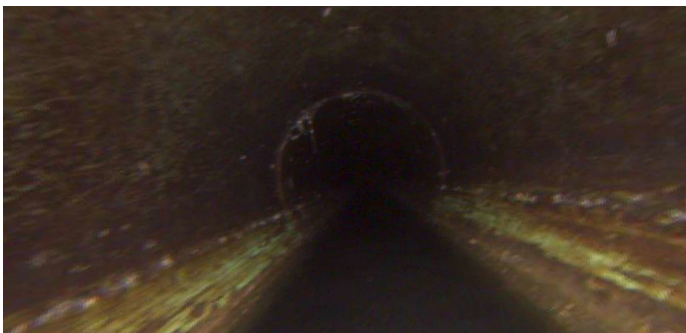
Code: **MSA**  
Description: **Abandoned Survey**

Distance (ft): **102.9**  
Structural Grade: **0**  
O&M Grade: **0**  
Clock Start/From:  
Clock To:  
1st Value:  
2nd Value:  
Value Percent:  
Continuous Index:  
Within 8" of Joint: **NO**  
Remarks: **no blockage**
