Profile/Photo Observation Report

Date:	04/19/2018	Weather:		Coding:	PACP 6.0
Pipe Length (ft):	335.8	Owner:	NA	Pre Clean:	Not Known
P.O.#:		Surveyor:	Jen Costello	PSR:	P-706-013.2-013.1
Customer:		Clean Date:	01/01/1900	Shape:	C

Street:	WATER ST	Flow Control:	Not Controlled
City:	Hobart, IN	Year Renewed:	
Location:	Light Highway	Tape/Media #:	
Purpose:	Maintenance Related	Dia/Height:	12"
Use:	Sanitary	Material:	PVC
Drain Area:	NA	Lining:	Cured in Place
Category:	NA		
Comment:	Debris pile at 20'.

Location Details:		Direction of Survey:	Downstream
US MH:	M-706-013.1	DS MH:	M-706-013.2
		Total Length Surveyed (ft):	21.4

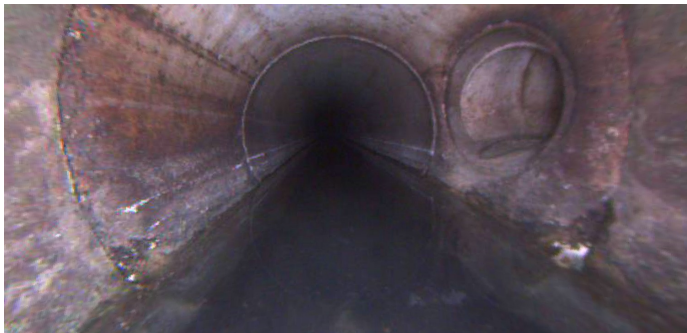
Code: **AMH**
Description: **Manhole**

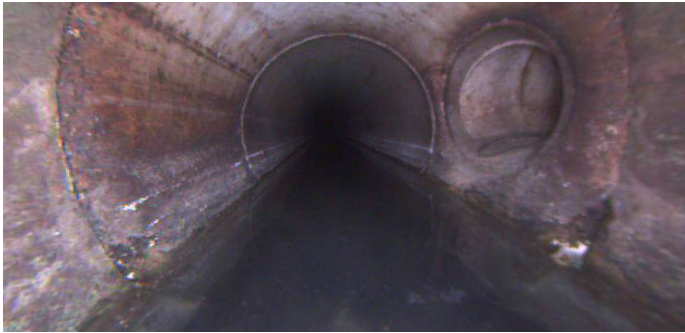
Code:	MWL
Description:	Water Level

Distance (ft):	.0
Structural Grade:	0
O&M Grade:	0
Clock Start/From:	
Clock To:	
1st Value:	
2nd Value:	
Value Percent:	10.000
Continuous Index:	
Within 8" of Joint:	NO
Remarks:

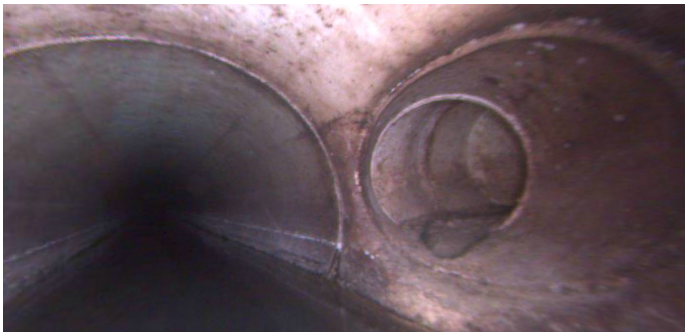
Code:	TF
Description:	Tap Factory

Distance (ft):	2.0
Structural Grade:	0
O&M Grade:	0
Clock Start/From:	3
Clock To:	
1st Value:	4.000
2nd Value:	
Value Percent:	
Continuous Index:	
Within 8" of Joint:	
Remarks:

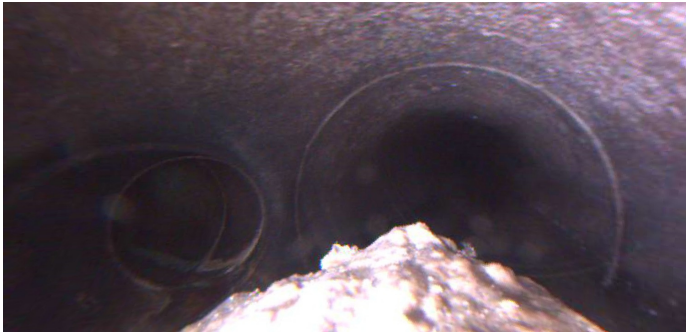
Code: **TFA**
Description: **Tap Factory Active**

Distance (ft): **20.3**
Structural Grade: **0**
O&M Grade: **0**
Clock Start/From: **9**
Clock To:
1st Value: **4.000**
2nd Value:
Value Percent:
Continuous Index:
Within 8" of Joint:
Remarks:

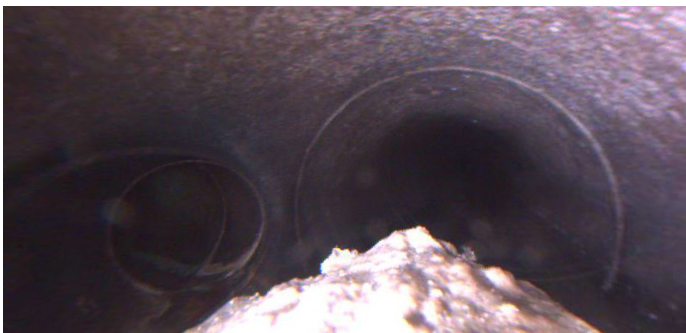
Code: **DSZ**
Description: **Deposits Settled Other**

Distance (ft): **20.3**
Structural Grade: **0**
O&M Grade: **4**
Clock Start/From: **4**
Clock To: **8**
1st Value:
2nd Value:
Value Percent: **30.000**
Continuous Index:
Within 8" of Joint: **NO**
Remarks: **MSA**

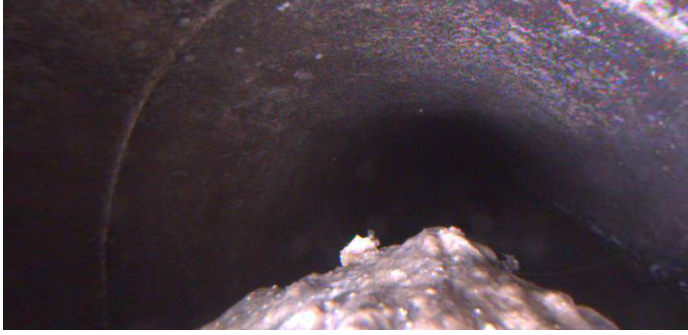
Code:	MSA
Description:	Abandoned Survey
Distance (ft):	21.4
Structural Grade:	0
O&M Grade:	0
Clock Start/From:	
Clock To:	
1st Value:	
2nd Value:	
Value Percent:	
Continuous Index:	
Within 8" of Joint:	NO
Remarks:	DSZ
