Profile/Photo Observation Report

Date:	04/16/2018	Weather:		Coding:	PACP 6.0
Pipe Length (ft):	195.3	Owner:	NA	Pre Clean:	Not Known
P.O.#:		Surveyor:	Selasie Honu	PSR:	P-706-013.3-013.2
Customer:		Clean Date:	01/01/1900	Shape:	C

Street:	WATER ST	Flow Control:	Not Controlled
City:	Hobart, IN	Year Renewed:	
Location:	Light Highway	Tape/Media #:	
Purpose:	Maintenance Related	Dia/Height:	12"
Use:	Sanitary	Material:	PVC
Drain Area:	NA	Lining:	Cured in Place
Category:	NA		
Comment:	heavy blk silt at 5'. flow is incorrect.

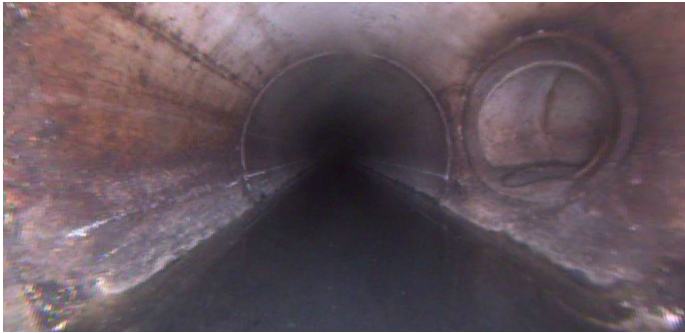
Code:	AMH
Description:	Manhole

Distance (ft):	.0
Structural Grade:	0
O&M Grade:	0
Clock Start/From:	
Clock To:	
1st Value:	
2nd Value:	
Value Percent:	
Continuous Index:	
Within 8" of Joint:	NO
Remarks:	M-706-013.2

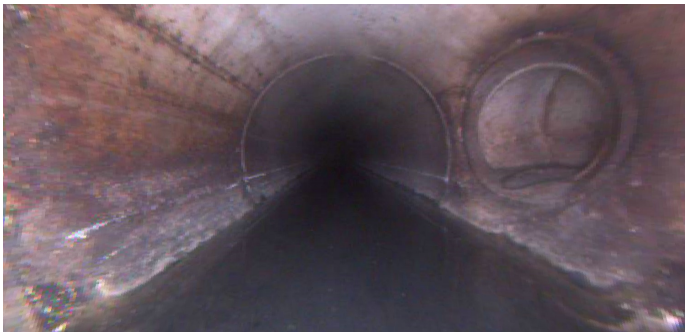
Code:	MWL
Description:	Water Level

Distance (ft):	.0
Structural Grade:	0
O&M Grade:	0
Clock Start/From:	
Clock To:	
1st Value:	
2nd Value:	
Value Percent:	5.000
Continuous Index:	
Within 8" of Joint:	NO
Remarks:

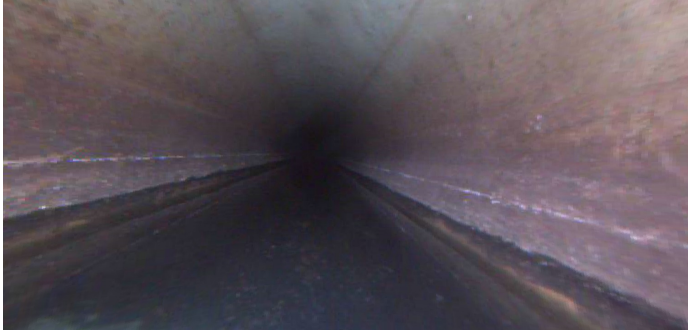
Code:	MSA
Description:	Abandoned Survey
Distance (ft):	6.5
Structural Grade:	0
O&M Grade:	0
Clock Start/From:	
Clock To:	
1st Value:	
2nd Value:	
Value Percent:	
Continuous Index:	
Within 8" of Joint:	NO
Remarks:	debris under water
