Profile/Photo Observation Report

Date:	04/16/2018	Weather:		Coding:	PACP 6.0
Pipe Length (ft):	195.3	Owner:	NA	Pre Clean:	Not Known
P.O.#:		Surveyor:	Selasie Honu	PSR:	P-706-013.3-013.2
Customer:		Clean Date:	01/01/1900	Shape:	C

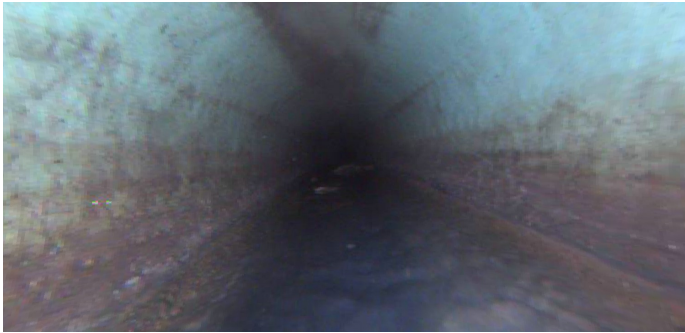
Code:	MWL
Description:	Water Level

Distance (ft):	.0
Structural Grade:	0
O&M Grade:	0
Clock Start/From:	
Clock To:	
1st Value:	
2nd Value:	
Value Percent:	5.000
Continuous Index:	
Within 8" of Joint:	NO
Remarks:

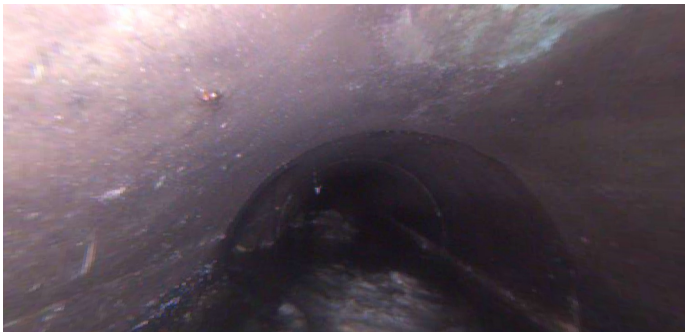
Code:	TF
Description:	Tap Factory

Distance (ft):	8.8
Structural Grade:	0
O&M Grade:	0
Clock Start/From:	9
Clock To:	
1st Value:	4.000
2nd Value:	
Value Percent:	
Continuous Index:	
Within 8" of Joint:	
Remarks:

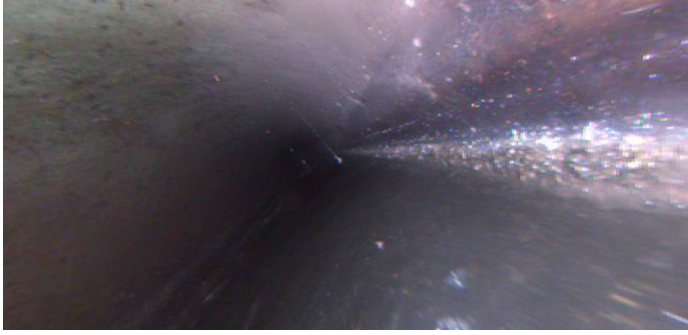
Code:	MSA
Description:	Abandoned Survey
Distance (ft):	12.0
Structural Grade:	0
O&M Grade:	0
Clock Start/From:	
Clock To:	
1st Value:	
2nd Value:	
Value Percent:	
Continuous Index:	
Within 8" of Joint:	NO
Remarks:	debris under water
