## Profile/Photo Observation Report

Date:	<b>04/16/2018</b>	Weather:		Coding:	<b>PACP 6.0</b>
Pipe Length (ft):	<b>195.3</b>	Owner:	<b>NA</b>	Pre Clean:	<b>Not Known</b>
P.O.#:		Surveyor:	<b>Selasie Honu</b>	PSR:	<b>P-706-013.3-013.2</b>
Customer:		Clean Date:	<b>01/01/1900</b>	Shape:	<b>C</b>

Street:	<b>Capitol</b>	Flow Control:	<b>Not Controlled</b>
City:	<b>Hobart, IN</b>	Year Renewed:	
Location:	<b>Light Highway</b>	Tape/Media #:	
Purpose:	<b>Maintenance Related</b>	Dia/Height:	<b>12"</b>
Use:	<b>Sanitary</b>	Material:	<b>PVC</b>
Drain Area:	<b>NA</b>	Lining:	<b>Cured in Place</b>
Category:	<b>NA</b>		
Comment:	<b>Reverse setup. flow is incorrect. debris and silt at 10'.</b>		
Location Details:		Direction of Survey:	<b>Upstream</b>
US MH:	<b>M-706-013.2</b>	DS MH:	<b>M-706-013.3</b>
		Total Length Surveyed (ft):	<b>12.0</b>

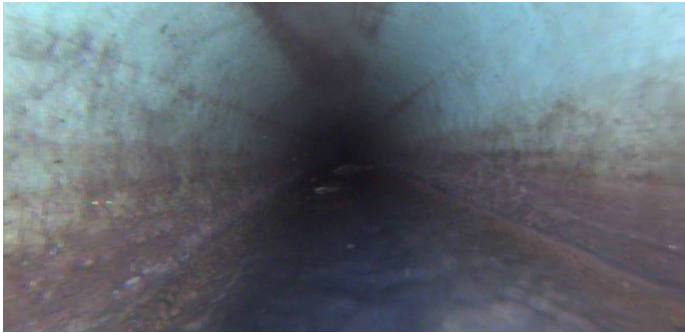
Code:	<b>MWL</b>
Description:	<b>Water Level</b>

Distance (ft):	<b>.0</b>
Structural Grade:	<b>0</b>
O&M Grade:	<b>0</b>
Clock Start/From:	
Clock To:	
1st Value:	
2nd Value:	
Value Percent:	<b>5.000</b>
Continuous Index:	
Within 8" of Joint:	<b>NO</b>
Remarks:

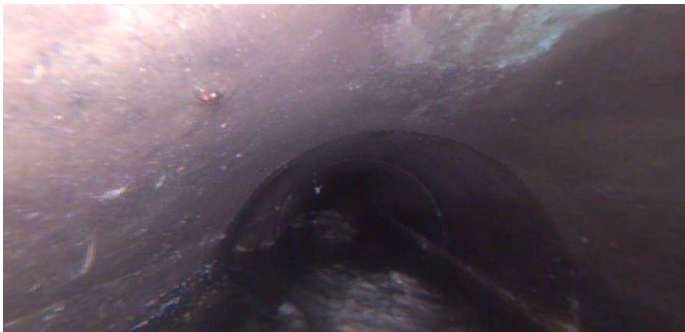
Code:	<b>TF</b>
Description:	<b>Tap Factory</b>

Distance (ft):	<b>8.8</b>
Structural Grade:	<b>0</b>
O&M Grade:	<b>0</b>
Clock Start/From:	<b>9</b>
Clock To:	
1st Value:	<b>4.000</b>
2nd Value:	
Value Percent:	
Continuous Index:	
Within 8" of Joint:	
Remarks:

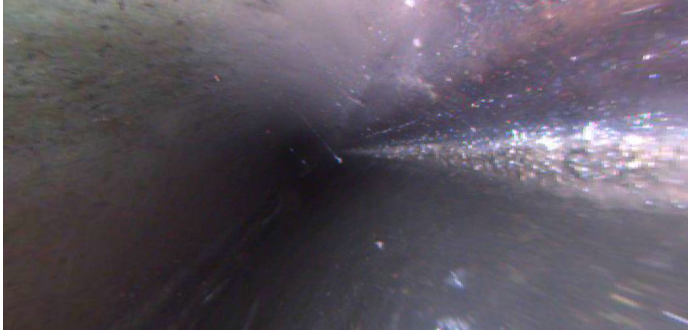
Code:	<b>MSA</b>
Description:	<b>Abandoned Survey</b>
Distance (ft):	<b>12.0</b>
Structural Grade:	<b>0</b>
O&M Grade:	<b>0</b>
Clock Start/From:	
Clock To:	
1st Value:	
2nd Value:	
Value Percent:	
Continuous Index:	
Within 8" of Joint:	<b>NO</b>
Remarks:	<b>debris under water</b>
