Profile/Photo Observation Report

| Street: | WATER ST | Flow Control: | Not Controlled |
| City: | Hobart, IN | Year Renewed: | |

| US MH: | M-706-013.3 | DS MH: | M-706-013.4 |

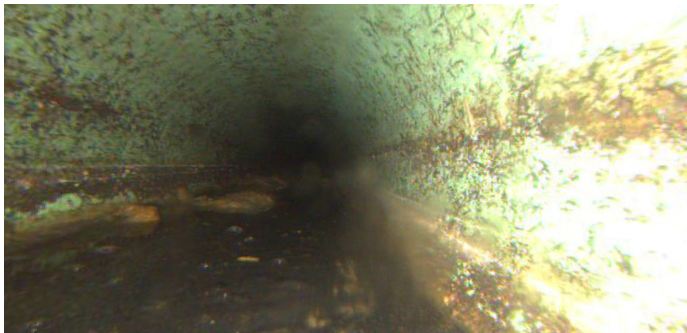
Code: **AMH**
Description: **Manhole**

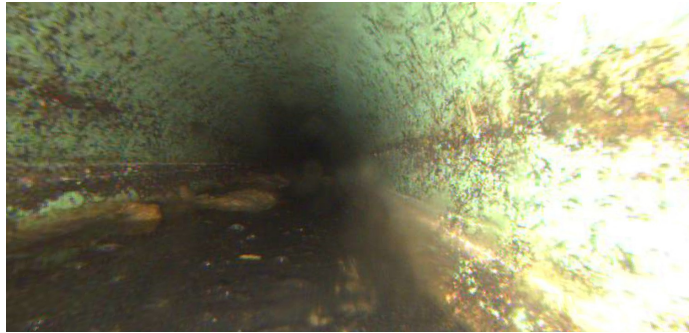
Code: **MWL**
Description: **Water Level**

Distance (ft): **.0**
Structural Grade: **0**
O&M Grade: **0**
Clock Start/From:
Clock To:
1st Value:
2nd Value:
Value Percent: **30.000**
Continuous Index:
Within 8" of Joint: **NO**
Remarks:

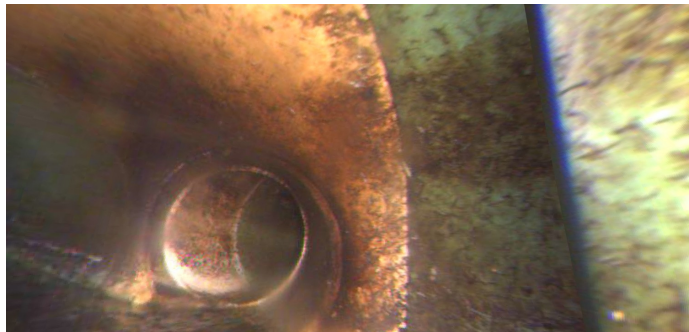
Code: **TFA**
Description: **Tap Factory Active**

Distance (ft): **24.1**
Structural Grade: **0**
O&M Grade: **0**
Clock Start/From: **9**
Clock To:
1st Value: **4.000**
2nd Value:
Value Percent:
Continuous Index:
Within 8" of Joint:
Remarks:

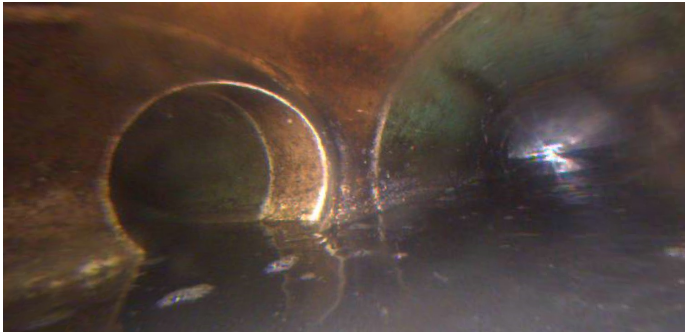
Code: **TFA**
Description: **Tap Factory Active**

Distance (ft): **26.2**
Structural Grade: **0**
O&M Grade: **0**
Clock Start/From: **3**
Clock To:
1st Value: **4.000**
2nd Value:
Value Percent:
Continuous Index:
Within 8" of Joint:
Remarks:

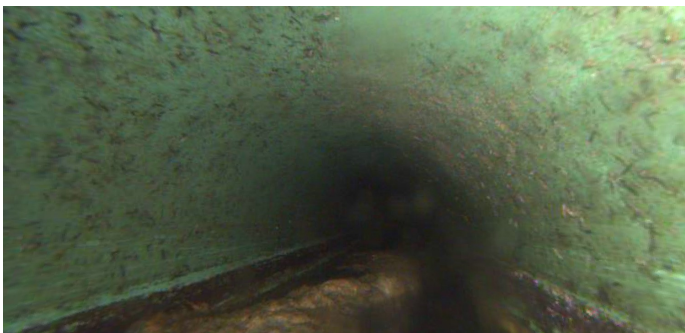
| Comment: | debris at 39'. flow incorrect. | | |

Code: **MSA**
Description: **Abandoned Survey**

Distance (ft): **40.9**
Structural Grade: **0**
O&M Grade: **0**
Clock Start/From:
Clock To:
1st Value:
2nd Value:
Value Percent:
Continuous Index:
Within 8" of Joint: **NO**
Remarks: **debris under water**
