## Profile/Photo Observation Report

Date:	<b>04/14/2018</b>	Weather:		Coding:	<b>PACP 6.0</b>
Pipe Length (ft):	<b>199.8</b>	Owner:	<b>NA</b>	Pre Clean:	<b>Not Known</b>
P.O.#:		Surveyor:	<b>Jen Costello</b>	PSR:	<b>P-706-013.4-013.3</b>
Customer:		Clean Date:	<b>01/01/1900</b>	Shape:	<b>C</b>

Location Details:		Direction of Survey:	<b>Upstream</b>
US MH:	<b>M-706-013.3</b>	DS MH:	<b>M-706-013.4</b>
		Total Length Surveyed (ft):	<b>40.9</b>

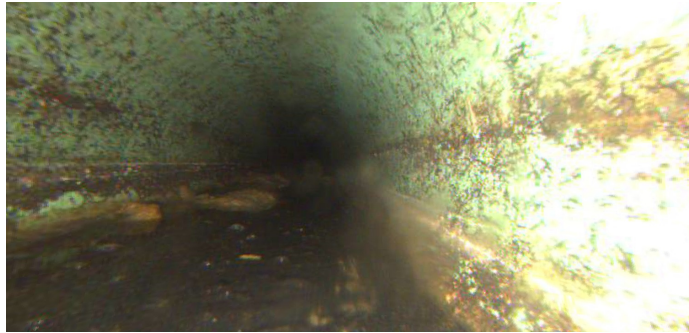
Code: **MWL**  
Description: **Water Level**

Distance (ft): **.0**  
Structural Grade: **0**  
O&M Grade: **0**  
Clock Start/From:  
Clock To:  
1st Value:  
2nd Value:  
Value Percent: **30.000**  
Continuous Index:  
Within 8" of Joint: **NO**  
Remarks:

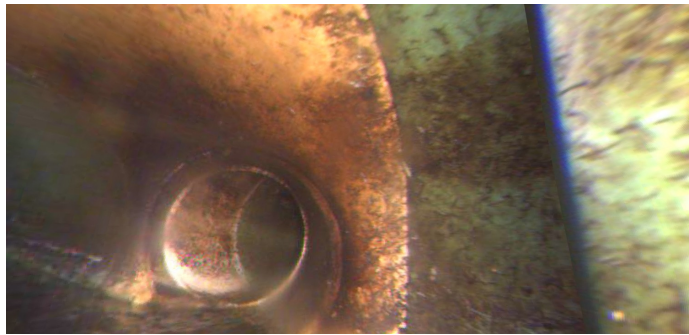
Code: **TFA**  
Description: **Tap Factory Active**

Distance (ft): **24.1**  
Structural Grade: **0**  
O&M Grade: **0**  
Clock Start/From: **9**  
Clock To:  
1st Value: **4.000**  
2nd Value:  
Value Percent:  
Continuous Index:  
Within 8" of Joint:  
Remarks:

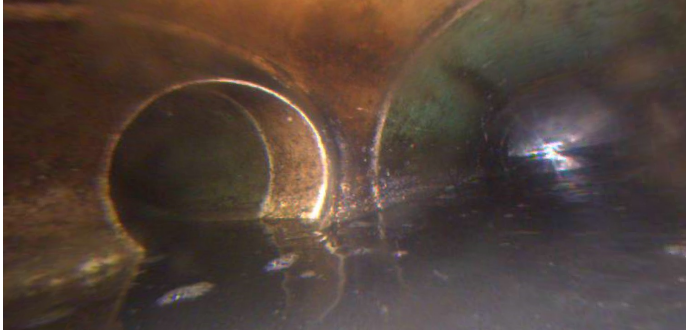
Code: **TFA**  
Description: **Tap Factory Active**

Distance (ft): **26.2**  
Structural Grade: **0**  
O&M Grade: **0**  
Clock Start/From: **3**  
Clock To:  
1st Value: **4.000**  
2nd Value:  
Value Percent:  
Continuous Index:  
Within 8" of Joint:  
Remarks:

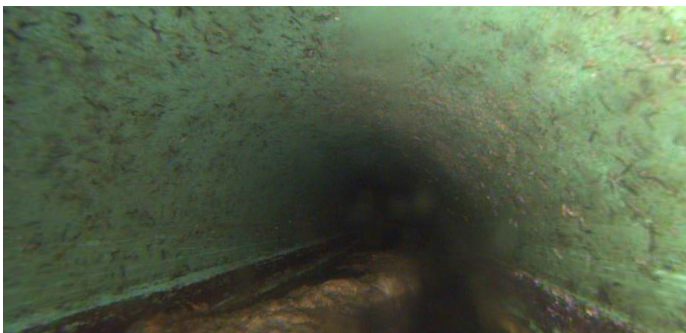
Street:	<b>Capitol</b>	Flow Control:	<b>Not Controlled</b>
City:	<b>Hobart, IN</b>	Year Renewed:	
Location:	<b>Light Highway</b>	Tape/Media #:	
Purpose:	<b>Maintenance Related</b>	Dia/Height:	<b>8"</b>
Use:	<b>Sanitary</b>	Material:	<b>PVC</b>
Drain Area:	<b>NA</b>	Lining:	<b>Cured in Place</b>
Category:	<b>NA</b>		
Comment:	<b>debris at 39'. flow incorrect.</b>

Code: **MSA**  
Description: **Abandoned Survey**

Distance (ft): **40.9**  
Structural Grade: **0**  
O&M Grade: **0**  
Clock Start/From:  
Clock To:  
1st Value:  
2nd Value:  
Value Percent:  
Continuous Index:  
Within 8" of Joint: **NO**  
Remarks: **debris under water**
