Profile/Photo Observation Report

Date:	04/14/2018	Weather:		Coding:	PACP 6.0
Pipe Length (ft):	199.8	Owner:	NA	Pre Clean:	Not Known
P.O.#:		Surveyor:	Jen Costello	PSR:	P-706-013.4-013.3
Customer:		Clean Date:	01/01/1900	Shape:	C

Street:	WATER ST	Flow Control:	Not Controlled
City:	Hobart, IN	Year Renewed:	
Location:	Light Highway	Tape/Media #:	
Purpose:	Maintenance Related	Dia/Height:	8"
Use:	Sanitary	Material:	PVC
Drain Area:	NA	Lining:	Cured in Place
Category:	NA		
Comment:	Reverse setup. mh found. flow incorrect.

Location Details:		Direction of Survey:	Downstream
US MH:	M-706-013.3	DS MH:	M-706-013.4
		Total Length Surveyed (ft):	201.2

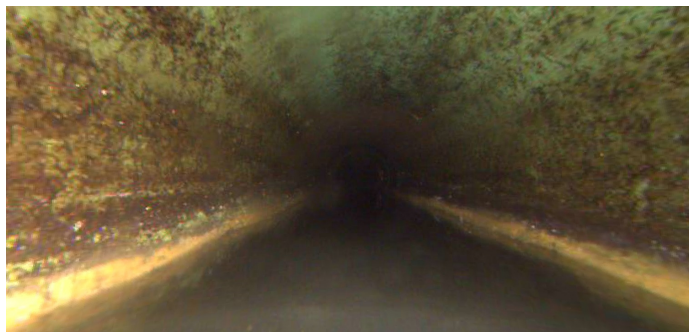
Code: **AMH**
Description: **Manhole**

Distance (ft): **.0**
Structural Grade: **0**
O&M Grade: **0**
Clock Start/From:
Clock To:
1st Value:
2nd Value:
Value Percent:
Continuous Index:
Within 8" of Joint: **NO**
Remarks: **M-706-013.3**

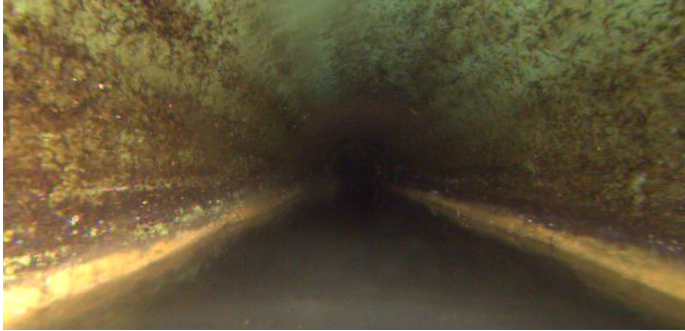
Code:	MWL
Description:	Water Level

Distance (ft):	.0
Structural Grade:	0
O&M Grade:	0
Clock Start/From:	
Clock To:	
1st Value:	
2nd Value:	
Value Percent:	20.000
Continuous Index:	
Within 8" of Joint:	NO
Remarks:

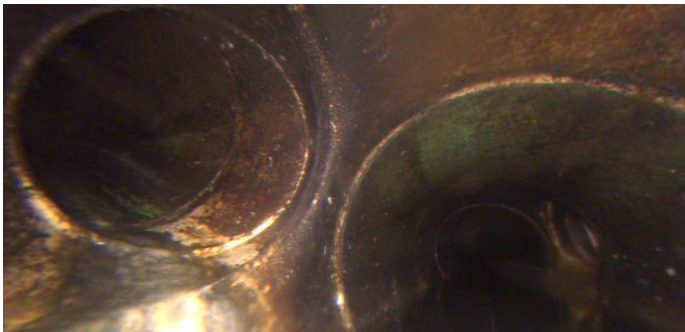
Code:	TFA
Description:	Tap Factory Active

Distance (ft):	4.2
Structural Grade:	0
O&M Grade:	0
Clock Start/From:	10
Clock To:	
1st Value:	4.000
2nd Value:	
Value Percent:	
Continuous Index:	
Within 8" of Joint:	
Remarks:

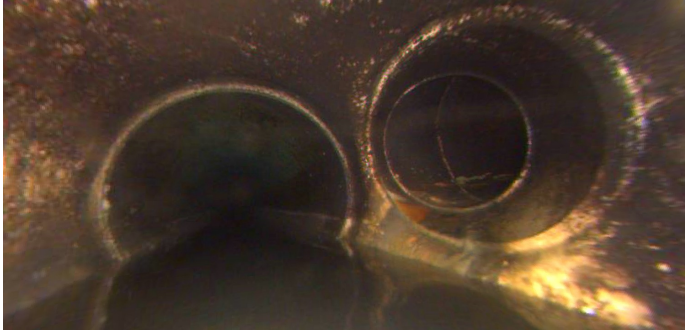
Code: **TF**
Description: **Tap Factory**

Distance (ft): **5.8**
Structural Grade: **0**
O&M Grade: **0**
Clock Start/From: **3**
Clock To:
1st Value: **4.000**
2nd Value:
Value Percent:
Continuous Index:
Within 8" of Joint:
Remarks:

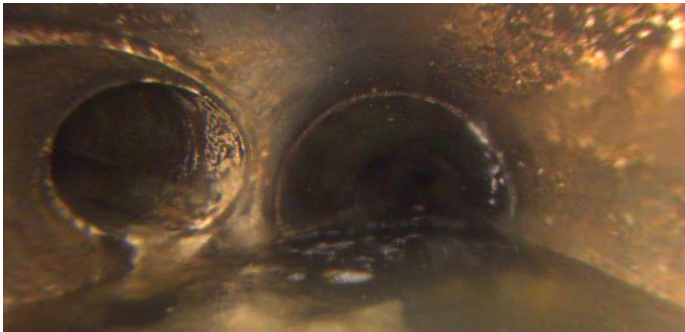
Code: **TFA**
Description: **Tap Factory Active**

Distance (ft): **73.7**
Structural Grade: **0**
O&M Grade: **0**
Clock Start/From: **9**
Clock To:
1st Value: **4.000**
2nd Value:
Value Percent:
Continuous Index:
Within 8" of Joint:
Remarks:

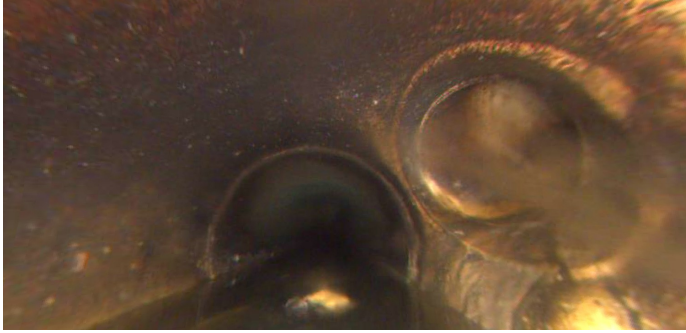
Code: **TF**
Description: **Tap Factory**

Distance (ft): **75.8**
Structural Grade: **0**
O&M Grade: **0**
Clock Start/From: **2**
Clock To:
1st Value: **4.000**
2nd Value:
Value Percent:
Continuous Index:
Within 8" of Joint:
Remarks:

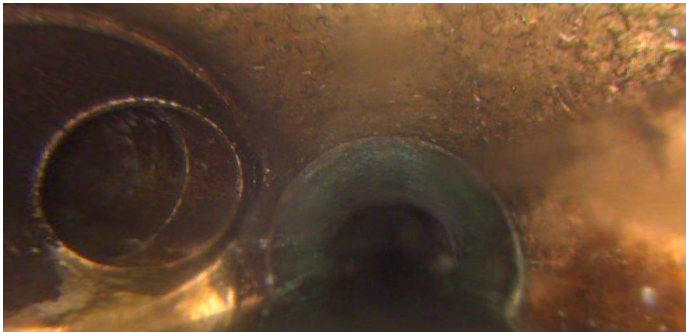
Code: **TF**
Description: **Tap Factory**

Distance (ft): **117.3**
Structural Grade: **0**
O&M Grade: **0**
Clock Start/From: **9**
Clock To:
1st Value: **4.000**
2nd Value:
Value Percent:
Continuous Index:
Within 8" of Joint:
Remarks:

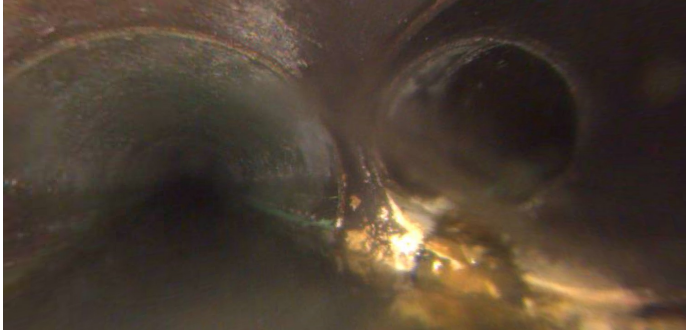
Code: **TFA**
Description: **Tap Factory Active**

Distance (ft): **119.4**
Structural Grade: **0**
O&M Grade: **0**
Clock Start/From: **3**
Clock To:
1st Value: **4.000**
2nd Value:
Value Percent:
Continuous Index:
Within 8" of Joint:
Remarks:

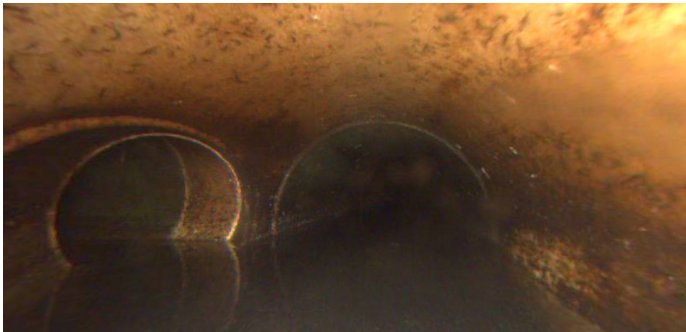
Code: **TFA**
Description: **Tap Factory Active**

Distance (ft): **172.5**
Structural Grade: **0**
O&M Grade: **0**
Clock Start/From: **9**
Clock To:
1st Value: **4.000**
2nd Value:
Value Percent:
Continuous Index:
Within 8" of Joint:
Remarks:

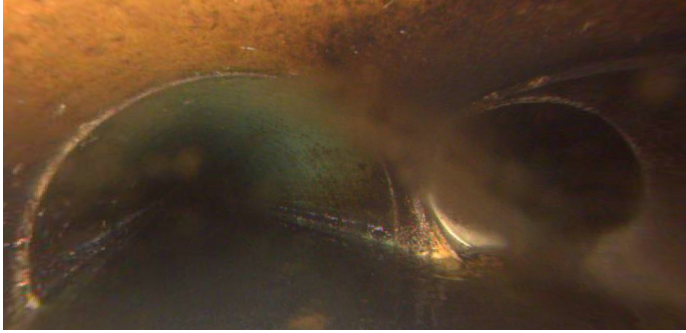
Code: **TFA**
Description: **Tap Factory Active**

Distance (ft): **175.0**
Structural Grade: **0**
O&M Grade: **0**
Clock Start/From: **3**
Clock To:
1st Value: **4.000**
2nd Value:
Value Percent:
Continuous Index:
Within 8" of Joint:
Remarks:

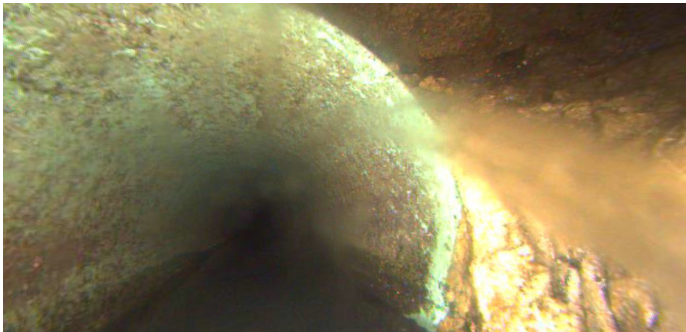
Code: **AMH**
Description: **Manhole**

Distance (ft): **201.2**
Structural Grade: **0**
O&M Grade: **0**
Clock Start/From:
Clock To:
1st Value:
2nd Value:
Value Percent:
Continuous Index:
Within 8" of Joint: **NO**
Remarks: **M-706-013.4**
