Profile/Photo Observation Report

Date:	04/14/2018	Weather:		Coding:	PACP 6.0
Pipe Length (ft):	199.8	Owner:	NA	Pre Clean:	Not Known
P.O.#:		Surveyor:	Jen Costello	PSR:	P-706-013.4-013.3
Customer:		Clean Date:	01/01/1900	Shape:	C

Street:	Capitol	Flow Control:	Not Controlled
City:	Hobart, IN	Year Renewed:	
Location:	Light Highway	Tape/Media #:	
Purpose:	Maintenance Related	Dia/Height:	8"
Use:	Sanitary	Material:	PVC
Drain Area:	NA	Lining:	Cured in Place
Category:	NA		
Comment:	Reverse setup. mh found. flow incorrect.

Location Details:		Direction of Survey:	Downstream
US MH:	M-706-013.3	DS MH:	M-706-013.4
		Total Length Surveyed (ft):	201.2

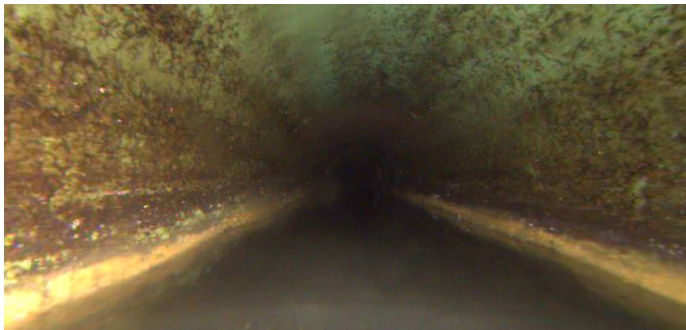
Code: **AMH**
Description: **Manhole**

Distance (ft): **.0**
Structural Grade: **0**
O&M Grade: **0**
Clock Start/From:
Clock To:
1st Value:
2nd Value:
Value Percent:
Continuous Index:
Within 8" of Joint: **NO**
Remarks: **M-706-013.3**

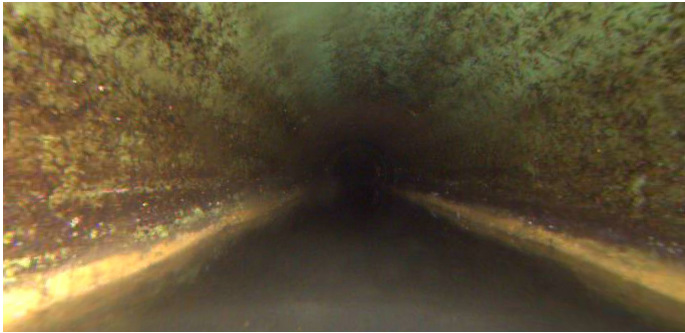
Code:	MWL
Description:	Water Level

Distance (ft):	.0
Structural Grade:	0
O&M Grade:	0
Clock Start/From:	
Clock To:	
1st Value:	
2nd Value:	
Value Percent:	20.000
Continuous Index:	
Within 8" of Joint:	NO
Remarks:

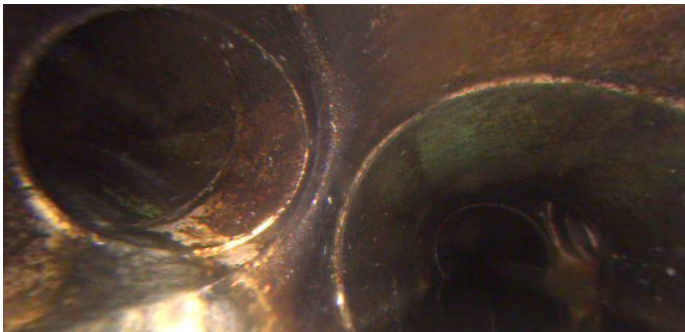
Code:	TFA
Description:	Tap Factory Active

Distance (ft):	4.2
Structural Grade:	0
O&M Grade:	0
Clock Start/From:	10
Clock To:	
1st Value:	4.000
2nd Value:	
Value Percent:	
Continuous Index:	
Within 8" of Joint:	
Remarks:

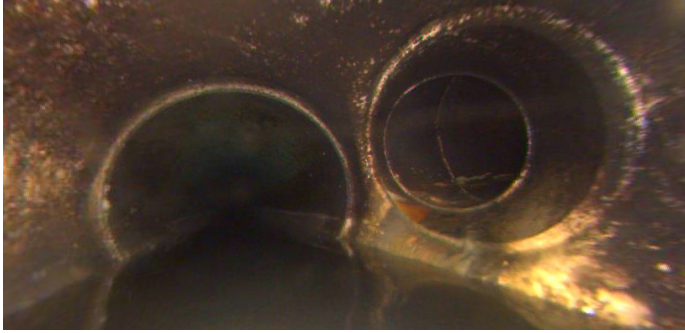
Code: **TF**
Description: **Tap Factory**

Distance (ft): **5.8**
Structural Grade: **0**
O&M Grade: **0**
Clock Start/From: **3**
Clock To:
1st Value: **4.000**
2nd Value:
Value Percent:
Continuous Index:
Within 8" of Joint:
Remarks:

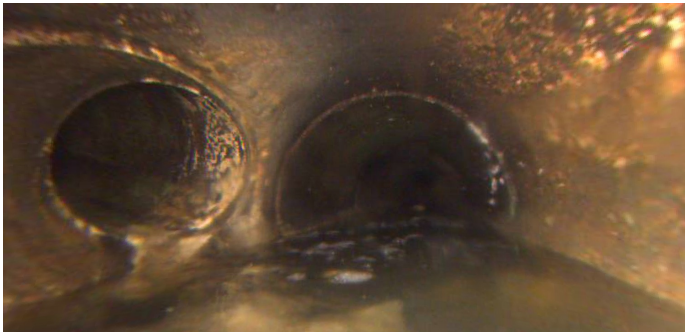
Code: **TFA**
Description: **Tap Factory Active**

Distance (ft): **73.7**
Structural Grade: **0**
O&M Grade: **0**
Clock Start/From: **9**
Clock To:
1st Value: **4.000**
2nd Value:
Value Percent:
Continuous Index:
Within 8" of Joint:
Remarks:

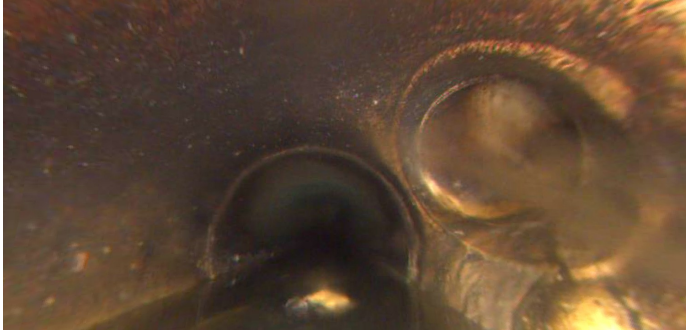
Code: **TF**
Description: **Tap Factory**

Distance (ft): **75.8**
Structural Grade: **0**
O&M Grade: **0**
Clock Start/From: **2**
Clock To:
1st Value: **4.000**
2nd Value:
Value Percent:
Continuous Index:
Within 8" of Joint:
Remarks:

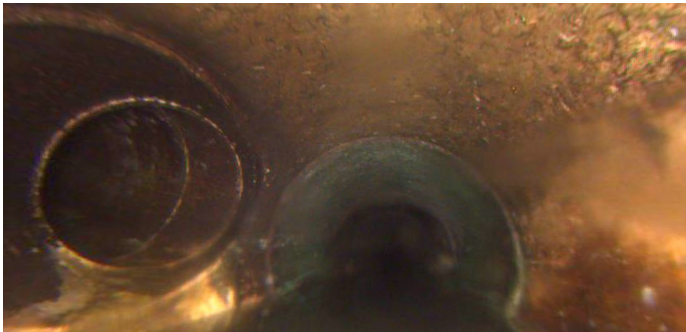
Code: **TF**
Description: **Tap Factory**

Distance (ft): **117.3**
Structural Grade: **0**
O&M Grade: **0**
Clock Start/From: **9**
Clock To:
1st Value: **4.000**
2nd Value:
Value Percent:
Continuous Index:
Within 8" of Joint:
Remarks:

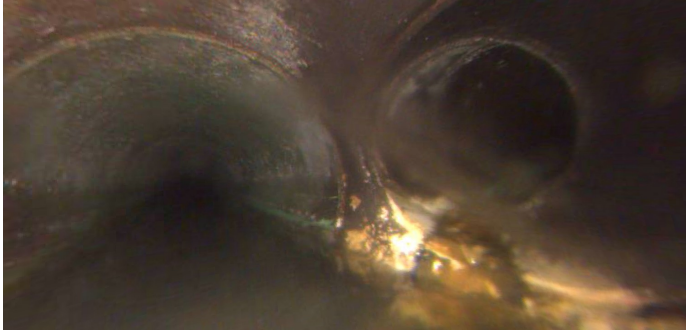
Code: **TFA**
Description: **Tap Factory Active**

Distance (ft): **119.4**
Structural Grade: **0**
O&M Grade: **0**
Clock Start/From: **3**
Clock To:
1st Value: **4.000**
2nd Value:
Value Percent:
Continuous Index:
Within 8" of Joint:
Remarks:

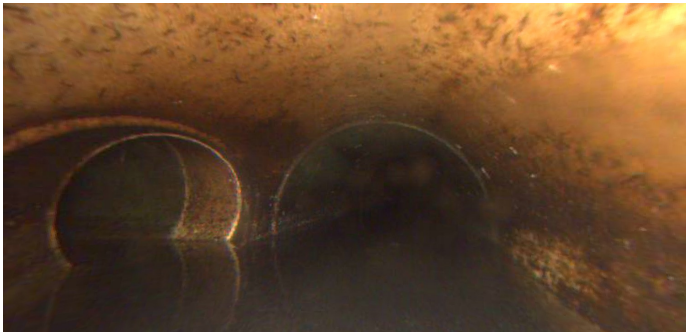
Code: **TFA**
Description: **Tap Factory Active**

Distance (ft): **172.5**
Structural Grade: **0**
O&M Grade: **0**
Clock Start/From: **9**
Clock To:
1st Value: **4.000**
2nd Value:
Value Percent:
Continuous Index:
Within 8" of Joint:
Remarks:

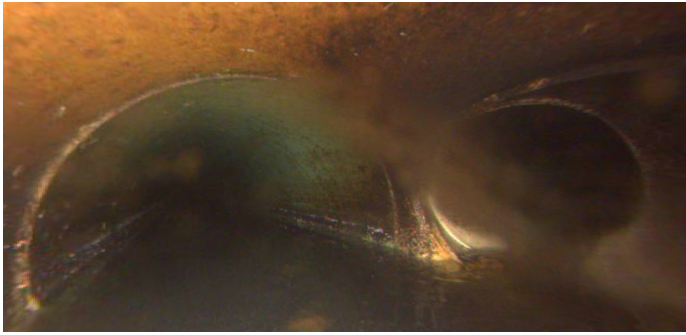
Code: **TFA**
Description: **Tap Factory Active**

Distance (ft): **175.0**
Structural Grade: **0**
O&M Grade: **0**
Clock Start/From: **3**
Clock To:
1st Value: **4.000**
2nd Value:
Value Percent:
Continuous Index:
Within 8" of Joint:
Remarks:

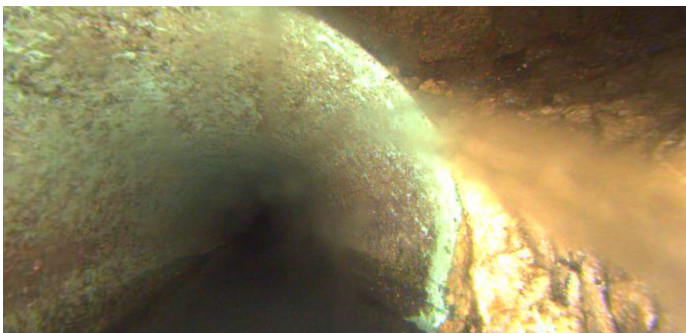
Code: **AMH**
Description: **Manhole**

Distance (ft): **201.2**
Structural Grade: **0**
O&M Grade: **0**
Clock Start/From:
Clock To:
1st Value:
2nd Value:
Value Percent:
Continuous Index:
Within 8" of Joint: **NO**
Remarks: **M-706-013.4**
