## Profile/Photo Observation Report

Street:	<b>WATER ST</b>	Flow Control:	<b>Not Controlled</b>
City:	<b>Hobart, IN</b>	Year Renewed:	
Location:	<b>Light Highway</b>	Tape/Media #:	
Purpose:	<b>Maintenance Related</b>	Dia/Height:	<b>8"</b>
Use:	<b>Sanitary</b>	Material:	<b>PVC</b>
Drain Area:	<b>NA</b>	Lining:	<b>Cured in Place</b>
Category:	<b>NA</b>		
Comment:	<b>heavy blk silt at 42'.</b>

Location Details:		Direction of Survey:	<b>Downstream</b>
US MH:	<b>M-706-013.4</b>	DS MH:	<b>M-706-013.5</b>
		Total Length Surveyed (ft):	<b>43.1</b>

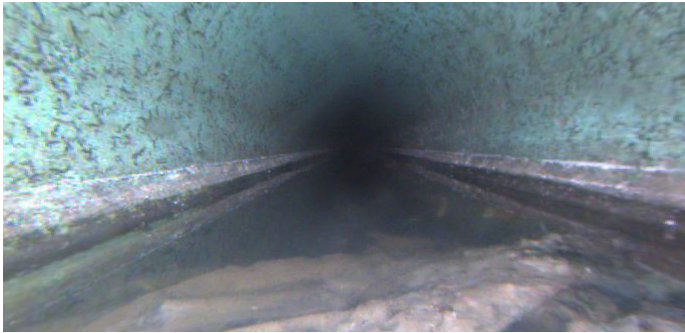
Code:	<b>MWL</b>
Description:	<b>Water Level</b>

Distance (ft):	<b>.0</b>
Structural Grade:	<b>0</b>
O&M Grade:	<b>0</b>
Clock Start/From:	
Clock To:	
1st Value:	
2nd Value:	
Value Percent:	<b>40.000</b>
Continuous Index:	
Within 8" of Joint:	<b>NO</b>
Remarks:

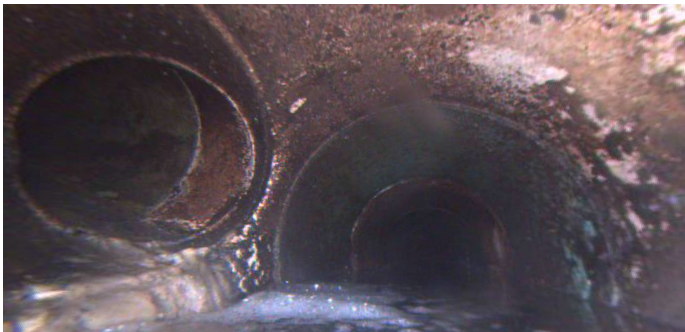
Code:	<b>TFA</b>
Description:	<b>Tap Factory Active</b>

Distance (ft):	<b>33.8</b>
Structural Grade:	<b>0</b>
O&M Grade:	<b>0</b>
Clock Start/From:	<b>9</b>
Clock To:	
1st Value:	<b>4.000</b>
2nd Value:	
Value Percent:	
Continuous Index:	
Within 8" of Joint:	
Remarks:

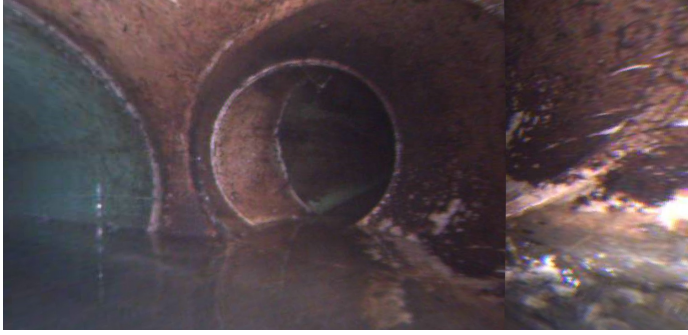
Code: **TFA**  
Description: **Tap Factory Active**

Distance (ft): **35.7**  
Structural Grade: **0**  
O&M Grade: **0**  
Clock Start/From: **3**  
Clock To:  
1st Value: **4.000**  
2nd Value:  
Value Percent:  
Continuous Index:  
Within 8" of Joint:  
Remarks:

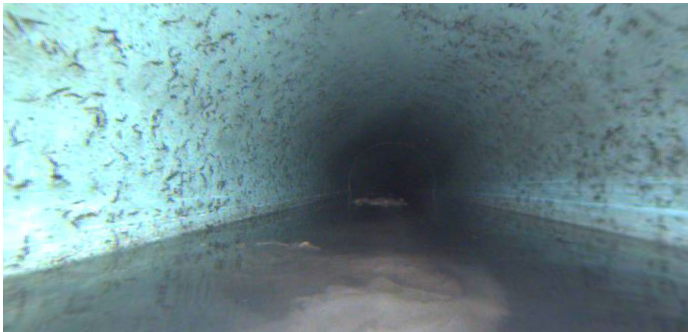
Code: **MSA**  
Description: **Abandoned Survey**

Distance (ft): **43.1**  
Structural Grade: **0**  
O&M Grade: **0**  
Clock Start/From:  
Clock To:  
1st Value:  
2nd Value:  
Value Percent:  
Continuous Index:  
Within 8" of Joint: **NO**  
Remarks: **debris under water**
