Profile/Photo Observation Report

Date:	04/14/2018	Weather:		Coding:	PACP 6.0
Pipe Length (ft):	193.4	Owner:	NA	Pre Clean:	Not Known
P.O.#:		Surveyor:	Jen Costello	PSR:	P-706-013.5-013.4
Customer:		Clean Date:	01/01/1900	Shape:	C

Location Details:		Direction of Survey:	Downstream
US MH:	M-706-013.4	DS MH:	M-706-013.5
		Total Length Surveyed (ft):	43.1

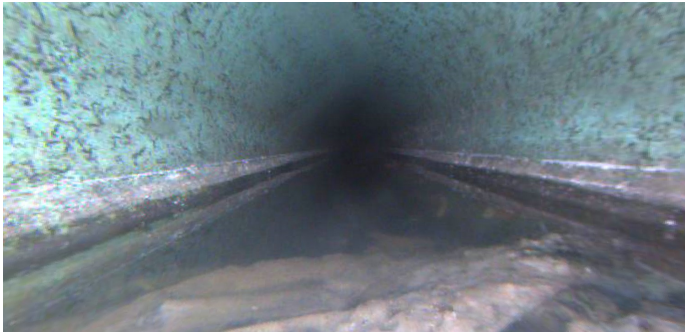
Code:	MWL
Description:	Water Level

Distance (ft):	.0
Structural Grade:	0
O&M Grade:	0
Clock Start/From:	
Clock To:	
1st Value:	
2nd Value:	
Value Percent:	40.000
Continuous Index:	
Within 8" of Joint:	NO
Remarks:

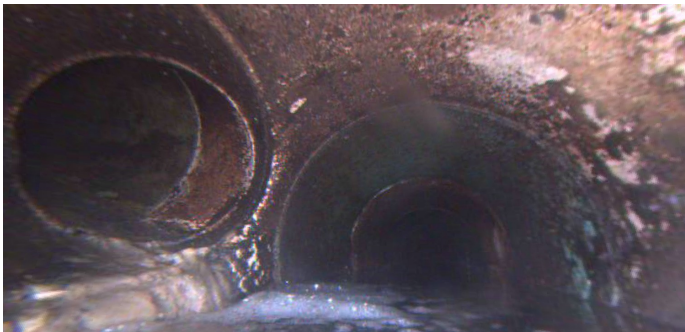
Code:	TFA
Description:	Tap Factory Active

Distance (ft):	33.8
Structural Grade:	0
O&M Grade:	0
Clock Start/From:	9
Clock To:	
1st Value:	4.000
2nd Value:	
Value Percent:	
Continuous Index:	
Within 8" of Joint:	
Remarks:

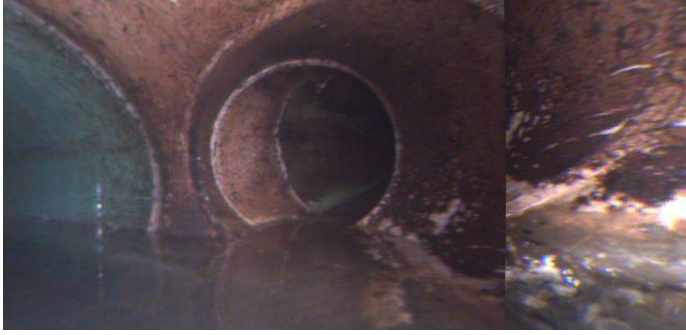
Code: **TFA**
Description: **Tap Factory Active**

Distance (ft): **35.7**
Structural Grade: **0**
O&M Grade: **0**
Clock Start/From: **3**
Clock To:
1st Value: **4.000**
2nd Value:
Value Percent:
Continuous Index:
Within 8" of Joint:
Remarks:

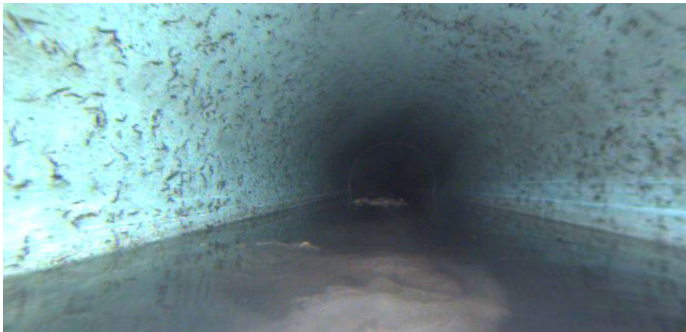
Code: **MSA**
Description: **Abandoned Survey**

Distance (ft): **43.1**
Structural Grade: **0**
O&M Grade: **0**
Clock Start/From:
Clock To:
1st Value:
2nd Value:
Value Percent:
Continuous Index:
Within 8" of Joint: **NO**
Remarks: **debris under water**
