Profile/Photo Observation Report

Date:	04/15/2018	Weather:		Coding:	PACP 6.0
Pipe Length (ft):	193.4	Owner:	NA	Pre Clean:	Not Known
P.O.#:		Surveyor:	Mark Ruby	PSR:	P-706-013.5-013.4
Customer:		Clean Date:	01/01/1900	Shape:	C

Street:	WATER ST	Flow Control:	Not Controlled
City:	Hobart, IN	Year Renewed:	
Location:	Light Highway	Tape/Media #:	
Purpose:	Maintenance Related	Dia/Height:	10"
Use:	Sanitary	Material:	PVC
Drain Area:	NA	Lining:	Cured in Place
Category:	NA		
Comment:	Reverse setup.blk silt at 133'.		
Location Details:		Direction of Survey:	Upstream
US MH:	M-706-013.4	DS MH:	M-706-013.5
		Total Length Surveyed (ft):	134.4

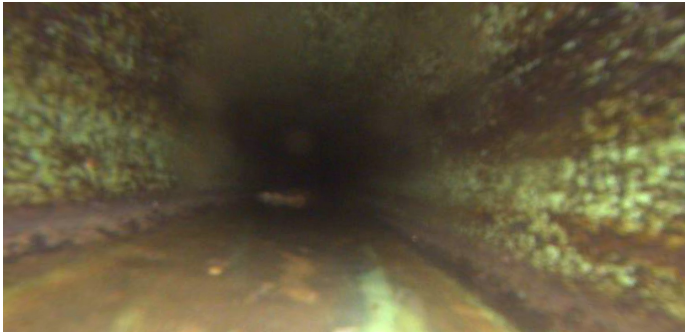
Code: **AMH**
Description: **Manhole**

Code:	MWL
Description:	Water Level

Distance (ft):	.0
Structural Grade:	0
O&M Grade:	0
Clock Start/From:	
Clock To:	
1st Value:	
2nd Value:	
Value Percent:	10.000
Continuous Index:	
Within 8" of Joint:	NO
Remarks:

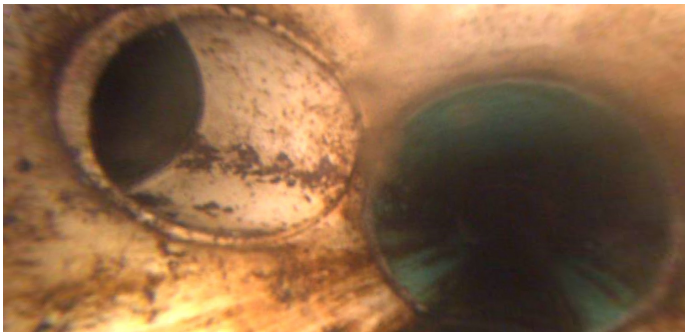
Code:	TF
Description:	Tap Factory

Distance (ft):	27.2
Structural Grade:	0
O&M Grade:	0
Clock Start/From:	9
Clock To:	
1st Value:	4.000
2nd Value:	
Value Percent:	
Continuous Index:	
Within 8" of Joint:	
Remarks:

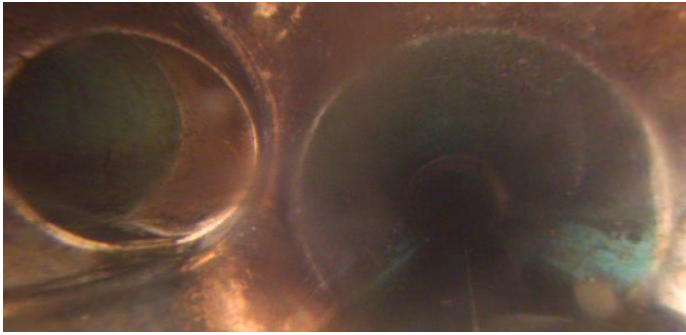
Code: **TF**
Description: **Tap Factory**

Distance (ft): **31.0**
Structural Grade: **0**
O&M Grade: **0**
Clock Start/From: **3**
Clock To:
1st Value: **4.000**
2nd Value:
Value Percent:
Continuous Index:
Within 8" of Joint:
Remarks:

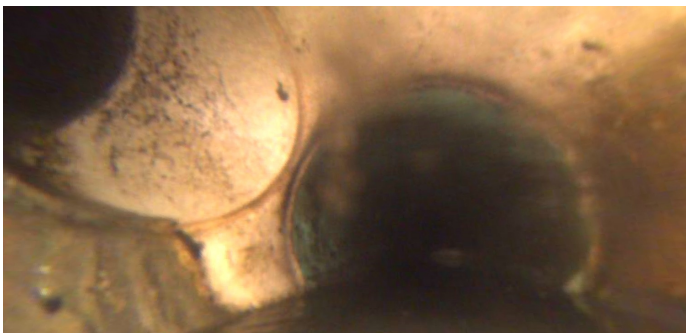
Code: **TF**
Description: **Tap Factory**

Distance (ft): **58.4**
Structural Grade: **0**
O&M Grade: **0**
Clock Start/From: **10**
Clock To:
1st Value: **4.000**
2nd Value:
Value Percent:
Continuous Index:
Within 8" of Joint:
Remarks:

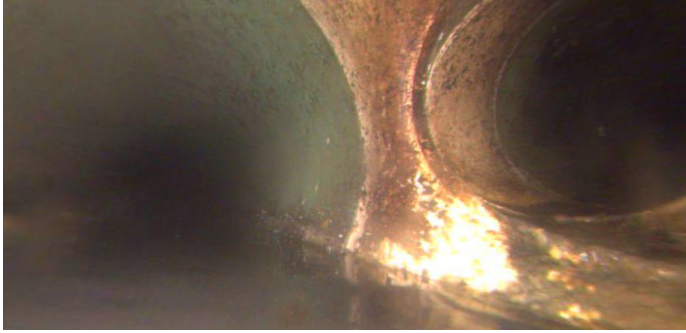
Code: **TF**
Description: **Tap Factory**

Distance (ft): **106.0**
Structural Grade: **0**
O&M Grade: **0**
Clock Start/From: **8**
Clock To:
1st Value: **4.000**
2nd Value:
Value Percent:
Continuous Index:
Within 8" of Joint:
Remarks: **Photo taken from rear camera.**

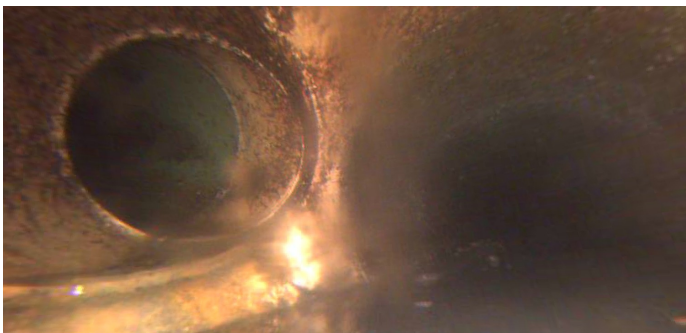
Code: **TF**
Description: **Tap Factory**

Distance (ft): **114.5**
Structural Grade: **0**
O&M Grade: **0**
Clock Start/From: **4**
Clock To:
1st Value: **4.000**
2nd Value:
Value Percent:
Continuous Index:
Within 8" of Joint:
Remarks:

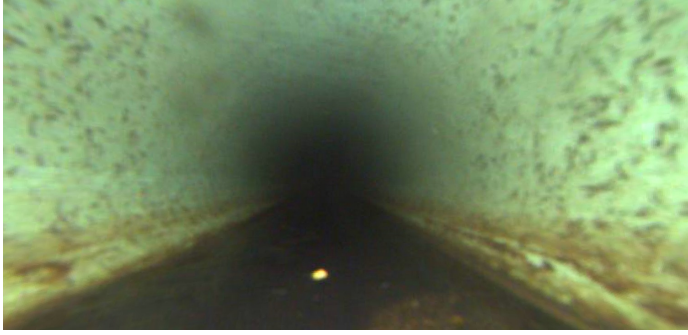
Code:	MSA
Description:	Abandoned Survey
Distance (ft):	134.4
Structural Grade:	0
O&M Grade:	0
Clock Start/From:	
Clock To:	
1st Value:	
2nd Value:	
Value Percent:	
Continuous Index:	
Within 8" of Joint:	NO
Remarks:	No blockage
