Profile/Photo Observation Report

Date:	04/15/2018	Weather:		Coding:	PACP 6.0
Pipe Length (ft):	193.4	Owner:	NA	Pre Clean:	Not Known
P.O.#:		Surveyor:	Mark Ruby	PSR:	P-706-013.5-013.4
Customer:		Clean Date:	01/01/1900	Shape:	C

Street:	Capitol	Flow Control:	Not Controlled
City:	Hobart, IN	Year Renewed:	
Location:	Light Highway	Tape/Media #:	
Purpose:	Maintenance Related	Dia/Height:	10"
Use:	Sanitary	Material:	PVC
Drain Area:	NA	Lining:	Cured in Place
Category:	NA		
Comment:	Reverse setup.blk silt at 133'.		
Location Details:		Direction of Survey:	Upstream
US MH:	M-706-013.4	DS MH:	M-706-013.5
		Total Length Surveyed (ft):	134.4

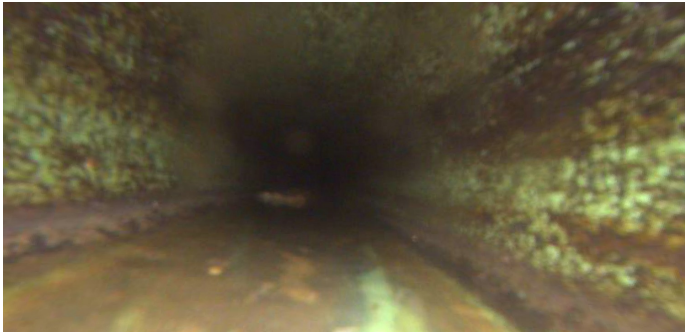
Code:	MWL
Description:	Water Level

Distance (ft):	.0
Structural Grade:	0
O&M Grade:	0
Clock Start/From:	
Clock To:	
1st Value:	
2nd Value:	
Value Percent:	10.000
Continuous Index:	
Within 8" of Joint:	NO
Remarks:

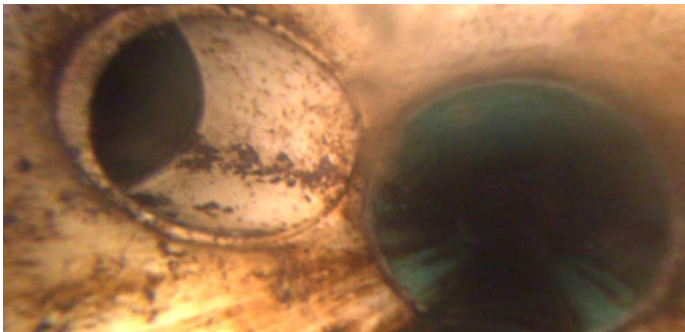
Code:	TF
Description:	Tap Factory

Distance (ft):	27.2
Structural Grade:	0
O&M Grade:	0
Clock Start/From:	9
Clock To:	
1st Value:	4.000
2nd Value:	
Value Percent:	
Continuous Index:	
Within 8" of Joint:	
Remarks:

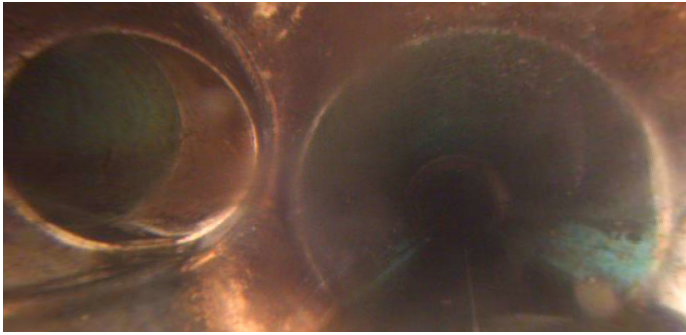
Code: **TF**
Description: **Tap Factory**

Distance (ft): **31.0**
Structural Grade: **0**
O&M Grade: **0**
Clock Start/From: **3**
Clock To:
1st Value: **4.000**
2nd Value:
Value Percent:
Continuous Index:
Within 8" of Joint:
Remarks:

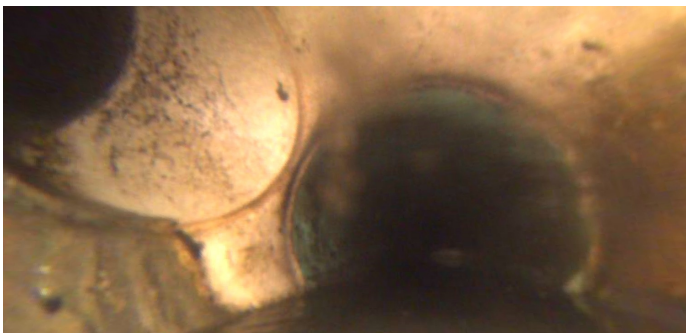
Code: **TF**
Description: **Tap Factory**

Distance (ft): **58.4**
Structural Grade: **0**
O&M Grade: **0**
Clock Start/From: **10**
Clock To:
1st Value: **4.000**
2nd Value:
Value Percent:
Continuous Index:
Within 8" of Joint:
Remarks:

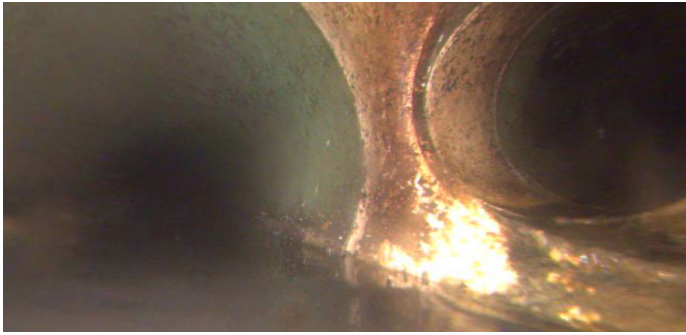
Code: **TF**
Description: **Tap Factory**

Distance (ft): **106.0**
Structural Grade: **0**
O&M Grade: **0**
Clock Start/From: **8**
Clock To:
1st Value: **4.000**
2nd Value:
Value Percent:
Continuous Index:
Within 8" of Joint:
Remarks: **Photo taken from rear camera.**

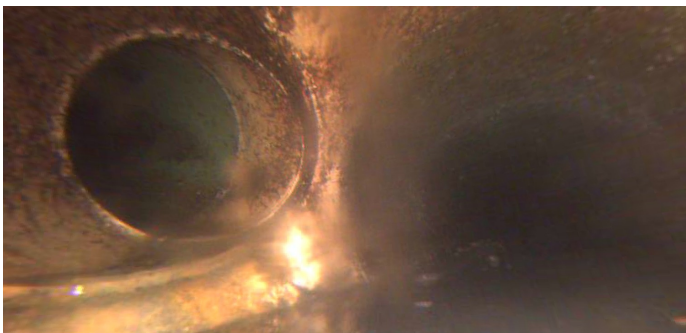
Code: **TF**
Description: **Tap Factory**

Distance (ft): **114.5**
Structural Grade: **0**
O&M Grade: **0**
Clock Start/From: **4**
Clock To:
1st Value: **4.000**
2nd Value:
Value Percent:
Continuous Index:
Within 8" of Joint:
Remarks:

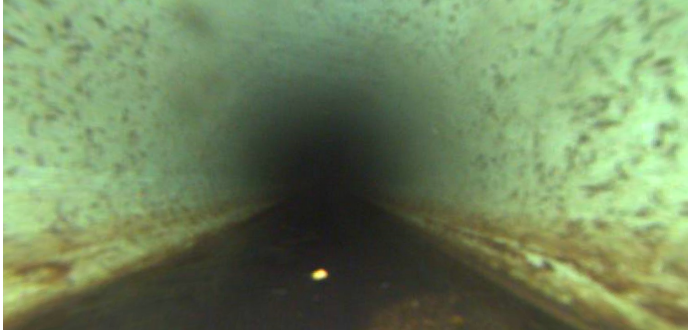
Code:	MSA
Description:	Abandoned Survey
Distance (ft):	134.4
Structural Grade:	0
O&M Grade:	0
Clock Start/From:	
Clock To:	
1st Value:	
2nd Value:	
Value Percent:	
Continuous Index:	
Within 8" of Joint:	NO
Remarks:	No blockage
