Profile/Photo Observation Report

Date:	10/21/2021	Weather:		Coding:	PACP 6.0
Pipe Length (ft):		Owner:	Hobart, IN	Pre Clean:	Not Known
P.O.#:	939_1	Surveyor:	M. Pielacha	PSR:	P-706-013.6-013.5
Customer:	Hobart, IN	Clean Date:		Shape:	C

Street:	Water Street	Flow Control:	
City:	Hobart, IN	Year Renewed:	
Location:	Light Highway	Tape/Media #:	939
Purpose:	Routine Assessment	Dia/Height:	10"
Use:	Sanitary	Material:	PVC
Drain Area:		Lining:

US MH: **M-706-13.5** DS MH: **M-706-13.6** Total Length Surveyed (ft): **28.6**

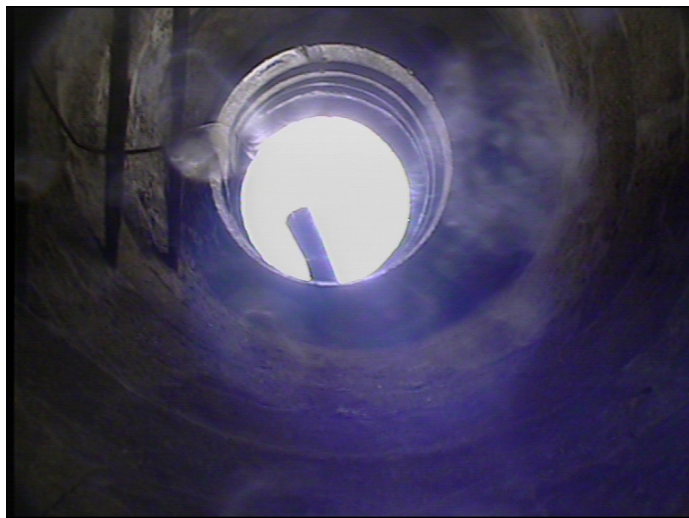
Code: **AMH**
Description: **Manhole**

Distance (ft): **.0**
Structural Grade: **0**
O&M Grade: **0**
Clock Start/From:
Clock To:
1st Value:
2nd Value:
Value Percent:
Continuous Index:
Within 8" of Joint: **NO**
Remarks: **M-706-13.6**

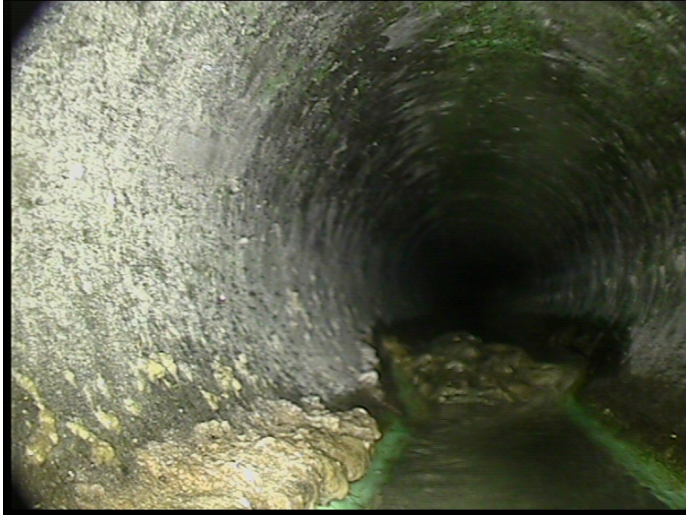
Code: **MWL**
Description: **Water Level**

Distance (ft): **.0**
Structural Grade: **0**
O&M Grade: **0**
Clock Start/From:
Clock To:
1st Value:
2nd Value:
Value Percent: **5.000**
Continuous Index:
Within 8" of Joint: **NO**
Remarks:

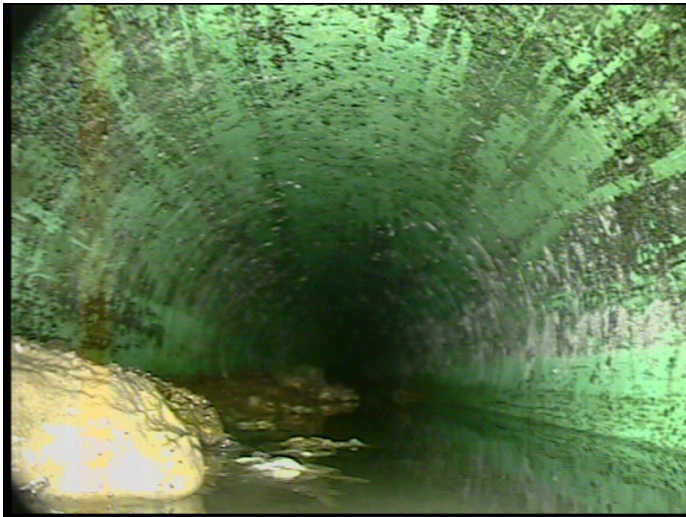
Code: **DSF**
Description: **Deposits Settled Fine**

Distance (ft): **25.7**
Structural Grade: **0**
O&M Grade: **3**
Clock Start/From: **5**
Clock To: **8**
1st Value:
2nd Value:
Value Percent: **20.000**
Continuous Index:
Within 8" of Joint: **YES**
Remarks:

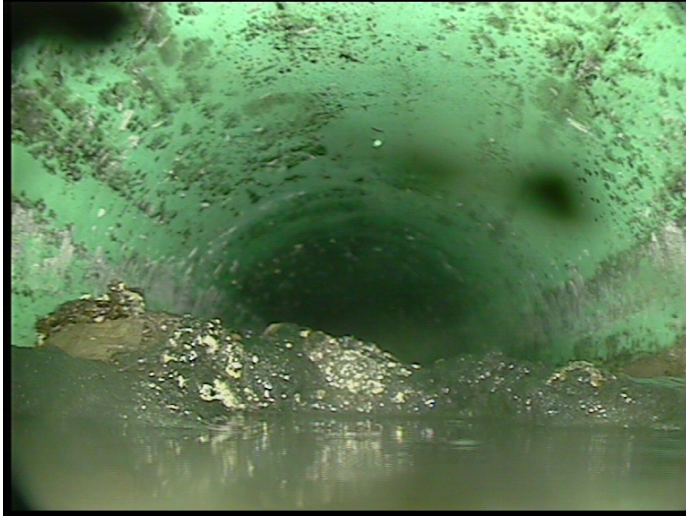
Code:	MSA
Description:	Abandoned Survey
Distance (ft):	28.6
Structural Grade:	0
O&M Grade:	0
Clock Start/From:	
Clock To:	
1st Value:	
2nd Value:	
Value Percent:	
Continuous Index:	
Within 8" of Joint:	NO
Remarks:	MSA deep sediment
