Profile/Photo Observation Report

Street:	MAIN ST	Flow Control:	Not Controlled
City:	Hobart, IN	Year Renewed:	
Location:	Light Highway	Tape/Media #:	
Purpose:	Maintenance Related	Dia/Height:	12"
Use:	Sanitary	Material:	VCP
Drain Area:	NA	Lining:	Cured in Place
Category:	NA		
Comment:	debris at 2', may be fallen brick		
Location Details:		Direction of Survey:	Upstream
US MH:	M-706-018	DS MH:	M-806-024
		Total Length Surveyed (ft):	3.6

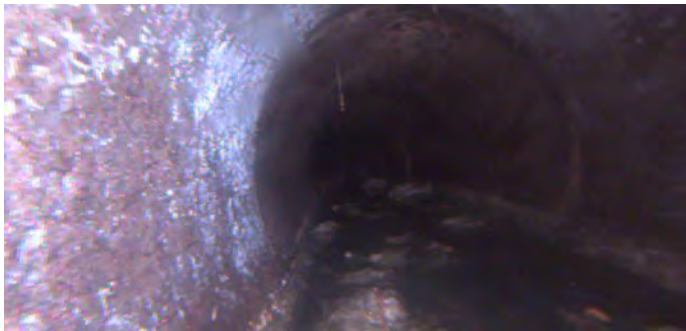
Code: **AMH**
Description: **Manhole**

Distance (ft): **.0**
Structural Grade: **0**
O&M Grade: **0**
Clock Start/From:
Clock To:
1st Value:
2nd Value:
Value Percent:
Continuous Index:
Within 8" of Joint: **NO**
Remarks: **M-806-024**

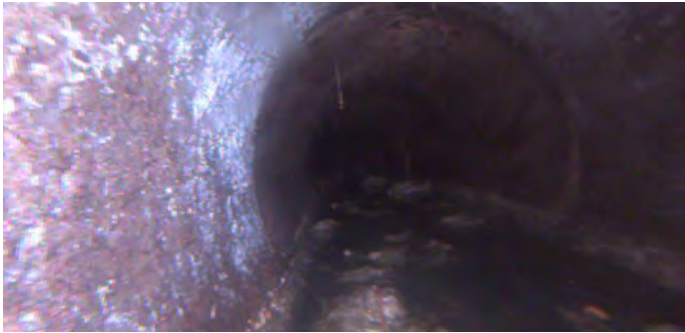
Code:	MWL
Description:	Water Level

Distance (ft):	.0
Structural Grade:	0
O&M Grade:	0
Clock Start/From:	
Clock To:	
1st Value:	
2nd Value:	
Value Percent:	5.000
Continuous Index:	
Within 8" of Joint:	NO
Remarks:

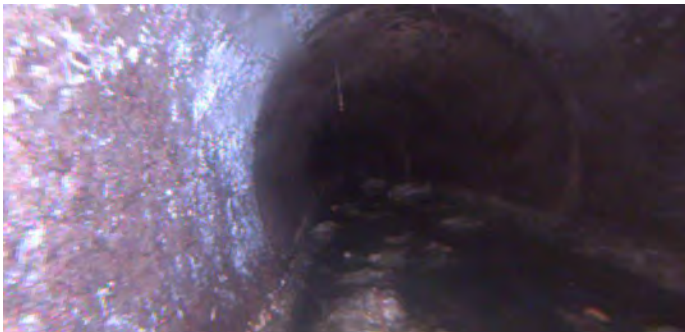
Code:	DSZ
Description:	Deposits Settled Other

Distance (ft):	.0
Structural Grade:	0
O&M Grade:	2
Clock Start/From:	6
Clock To:	
1st Value:	
2nd Value:	
Value Percent:	5.000
Continuous Index:	
Within 8" of Joint:	NO
Remarks:	debris
