Profile/Photo Observation Report

Street:	Capitol	Flow Control:	Not Controlled
City:	Hobart, IN	Year Renewed:	
Location:	Light Highway	Tape/Media #:	
Purpose:	Maintenance Related	Dia/Height:	12"
Use:	Sanitary	Material:	VCP
Drain Area:	NA	Lining:	Cured in Place
Category:	NA		
Comment:	debris at 2', may be fallen brick		
Location Details:		Direction of Survey:	Upstream
US MH:	M-706-018	DS MH:	M-806-024
		Total Length Surveyed (ft):	3.6

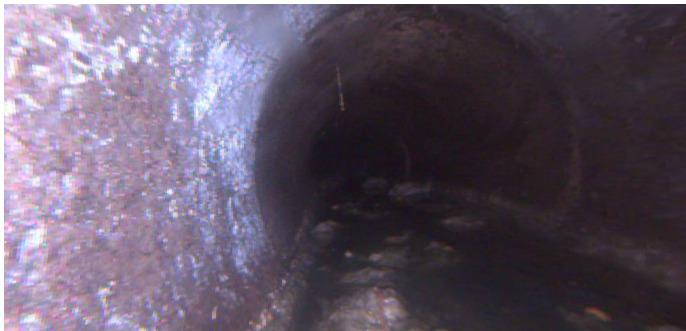
Code: **AMH**
Description: **Manhole**

Distance (ft): **.0**
Structural Grade: **0**
O&M Grade: **0**
Clock Start/From:
Clock To:
1st Value:
2nd Value:
Value Percent:
Continuous Index:
Within 8" of Joint: **NO**
Remarks: **M-806-024**

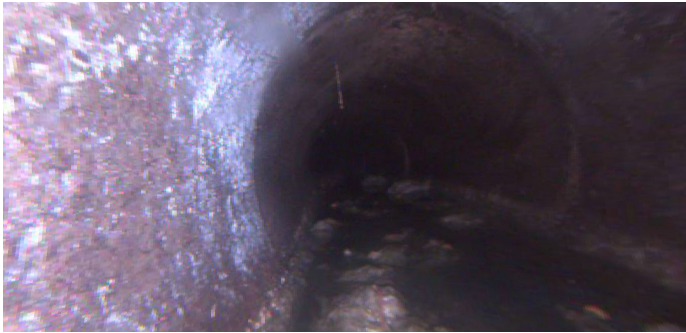
Code:	MWL
Description:	Water Level

Distance (ft):	.0
Structural Grade:	0
O&M Grade:	0
Clock Start/From:	
Clock To:	
1st Value:	
2nd Value:	
Value Percent:	5.000
Continuous Index:	
Within 8" of Joint:	NO
Remarks:

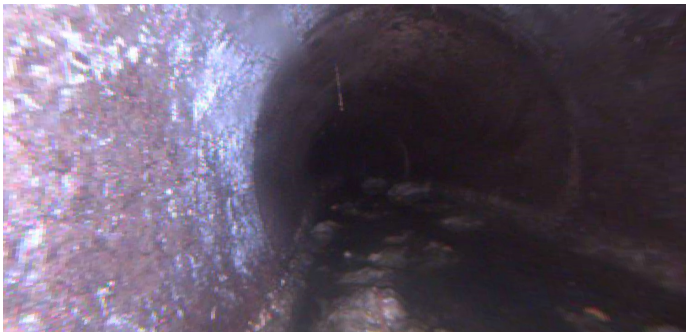
Code:	DSZ
Description:	Deposits Settled Other

Distance (ft):	.0
Structural Grade:	0
O&M Grade:	2
Clock Start/From:	6
Clock To:	
1st Value:	
2nd Value:	
Value Percent:	5.000
Continuous Index:	
Within 8" of Joint:	NO
Remarks:	debris
